# Wasaga Beach Shoreline Investigation Summary

Nottawasaga Valley Conservation Authority

P/N 16-2971 | February 21, 2017

**SBA** Skelton Brumwell  
& Associates Inc.  
ENGINEERING PLANNING ENVIRONMENTAL CONSULTANTS

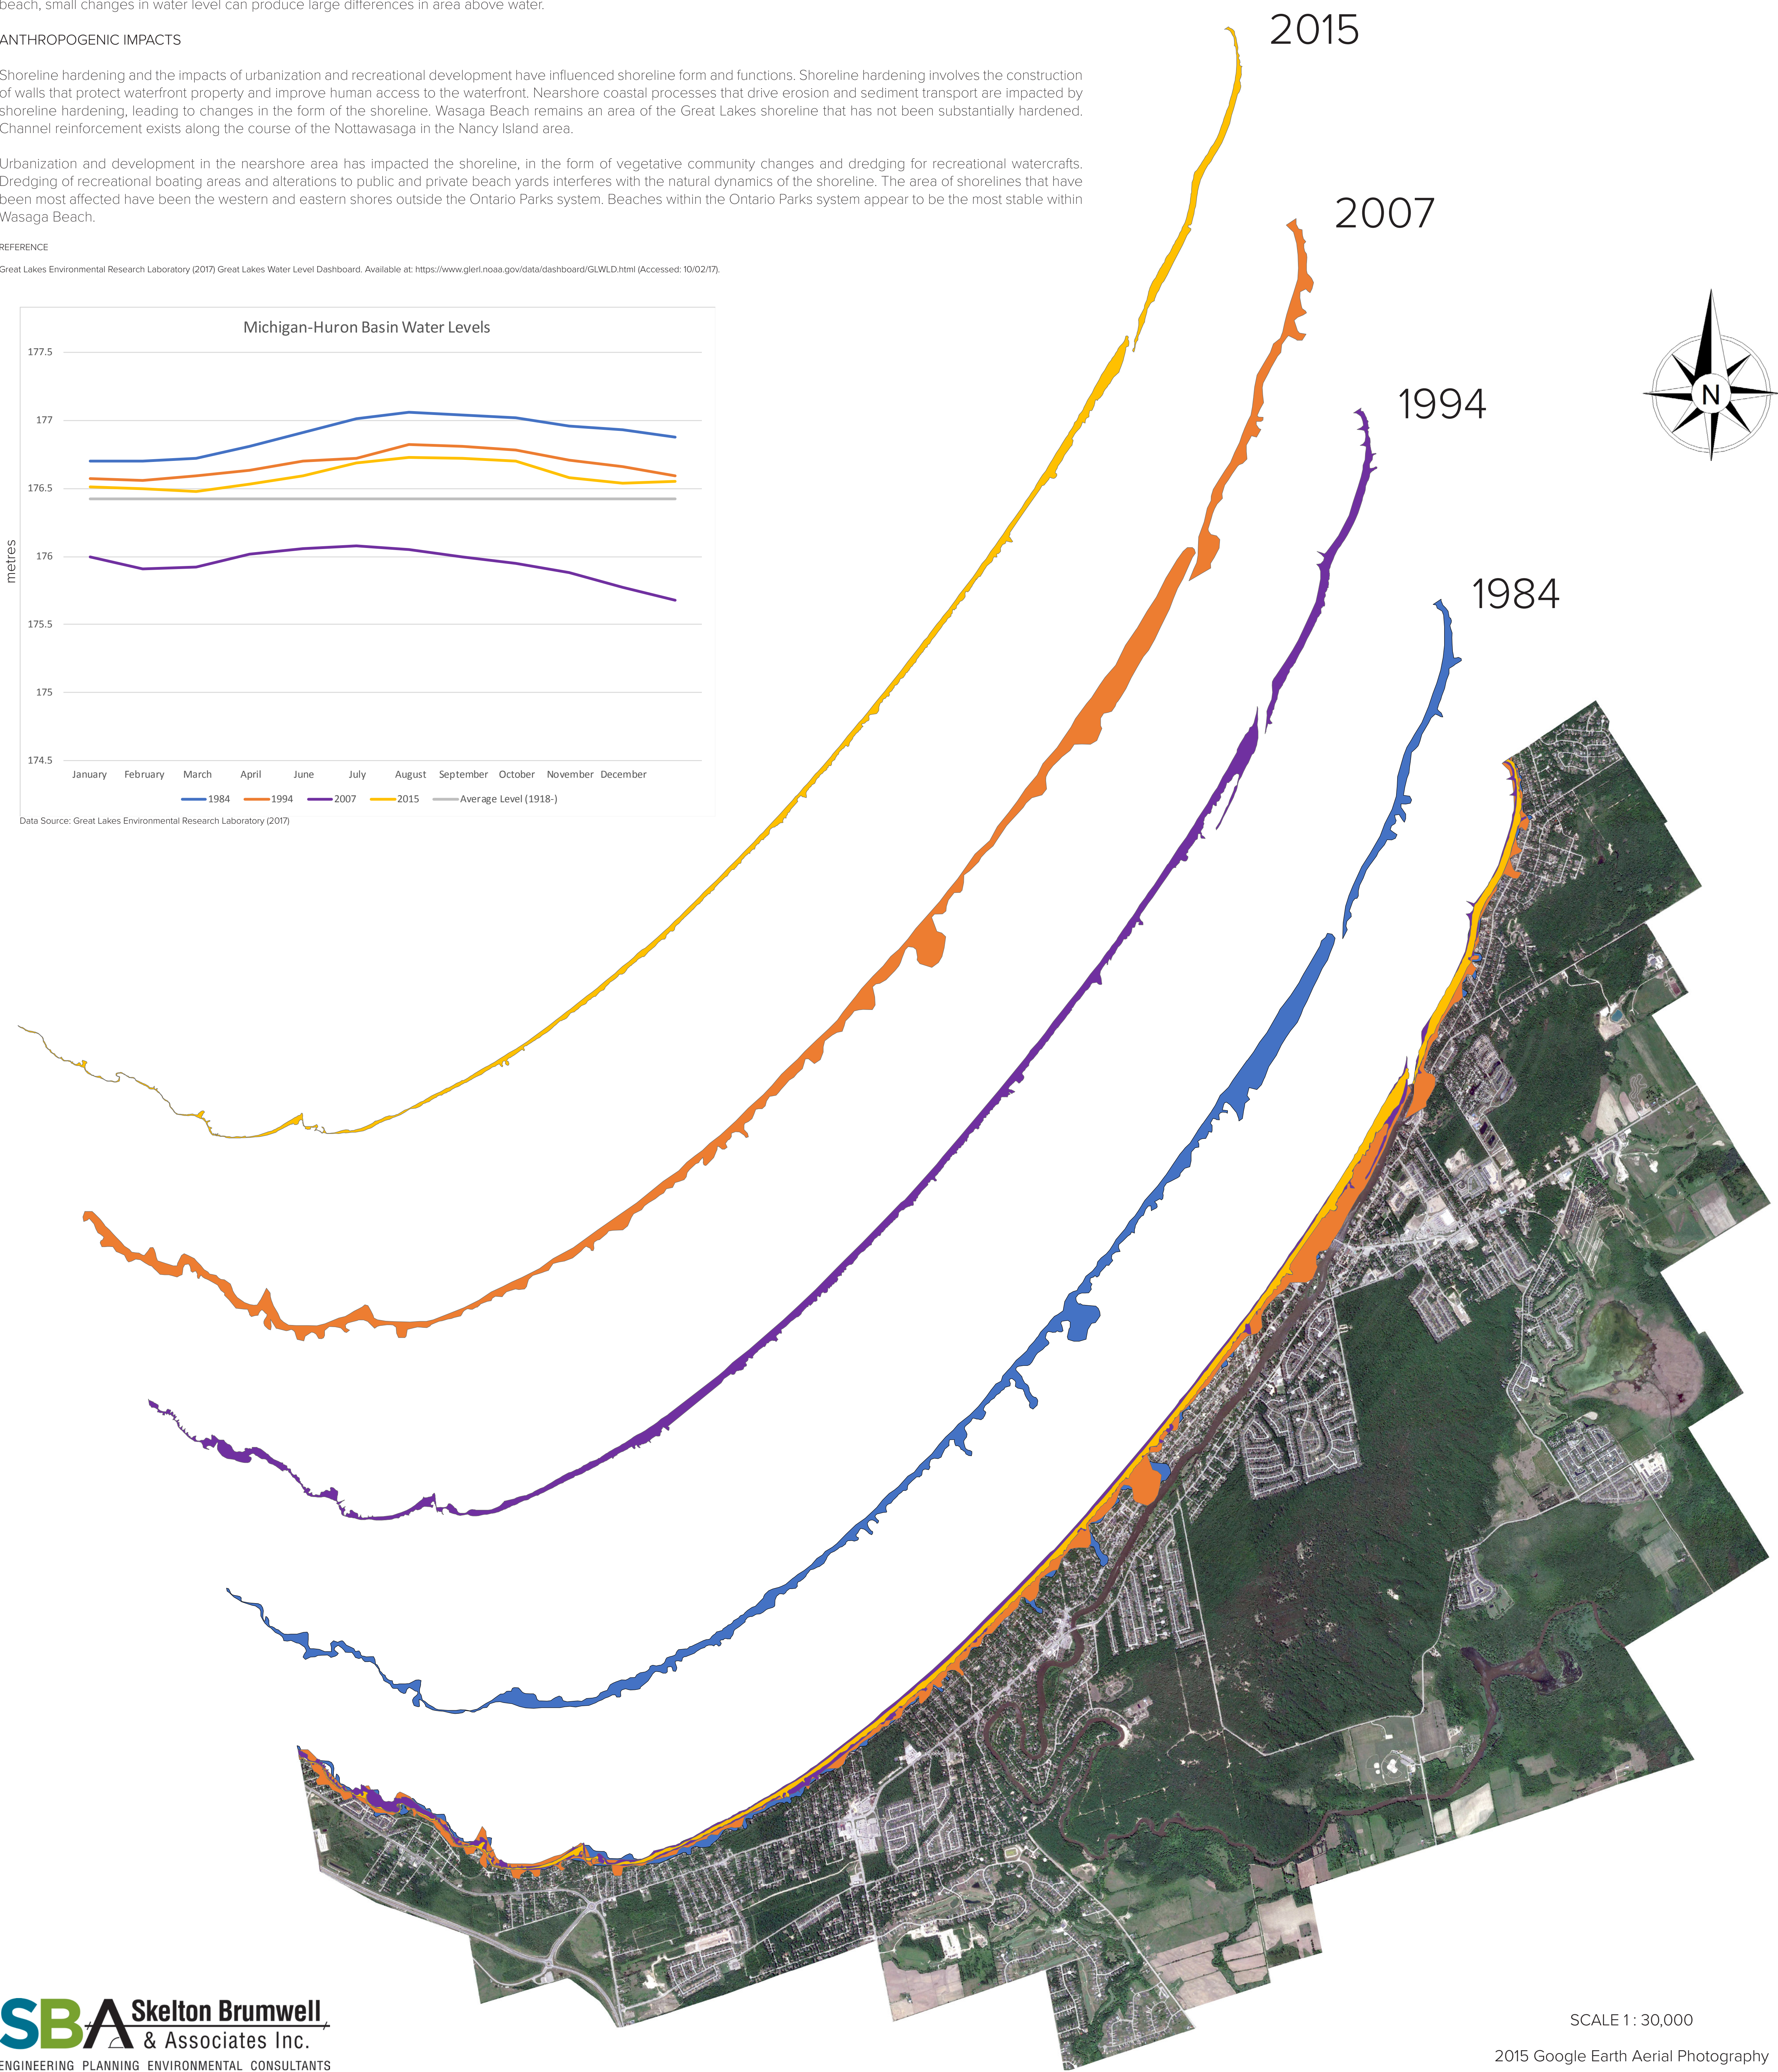
Orthoimagery from the years 1984, 1994, 2007, and 2015 were interpreted, digitized and analyzed using GIS (ESRI ArcMap) to determine the shape and extent of the shoreline area.

The digitized beach area was delineated from the waterline inshore to the edge of wooded vegetative communities or developed area. Fluctuations were noted in both the waterline and the vegetated/disturbed area limits.

Fairly significant vegetation has occurred on the peninsula forming the western bank of the Nottawasaga River in the period of study. It is possible that the installed car park on the peninsula has introduced seed stock through vehicle transport and that wind erosion and water collection has been altered to facilitate woody species of plants. The increasing extent of vegetated areas in the nearshore zone has resulted in an overall reduction in the shoreline area with the highest level of vegetation existing in 2015.

Although water levels have naturally fluctuated in the Great Lakes over the past centuries, there is a recent and persistent trend of low water levels. Low water levels impact the dynamics of waves and currents, in addition to altering the transport of sediment. The Great Lakes Environmental Research Laboratory (2017) data indicates that 2007 was one of the lowest recorded water levels in the Michigan-Huron basin with all monthly averages well below the historical average. Conversely, 1984, 1994 and 2015 levels were above the historical average for every month. This is reflected in the location of the waterline as well as the amount of beach above water. Due to the shallow nature of the beach, small changes in water level can produce large differences in area above water.

Shoreline hardening and the impacts of urbanization and recreational development have influenced shoreline form and functions. Shoreline hardening involves the construction of walls that protect waterfront property and improve human access to the waterfront. Nearshore coastal processes that drive erosion and sediment transport are impacted by shoreline hardening, leading to changes in the form of the shoreline. Wasaga Beach remains an area of the Great Lakes shoreline that has not been substantially hardened. Channel reinforcement exists along the course of the Nottawasaga in the Nancy Island area.

Urbanization and development in the nearshore area has impacted the shoreline, in the form of vegetative community changes and dredging for recreational watercrafts. Dredging of recreational boating areas and alterations to public and private beach yards interferes with the natural dynamics of the shoreline. The area of shorelines that have been most affected have been the western and eastern shores outside the Ontario Parks system. Beaches within the Ontario Parks system appear to be the most stable within Wasaga Beach.
