Key River Walleye Spawning Rehabilitation Update - 2018

Eastern Georgian Bay Stewardship Council

July 2018

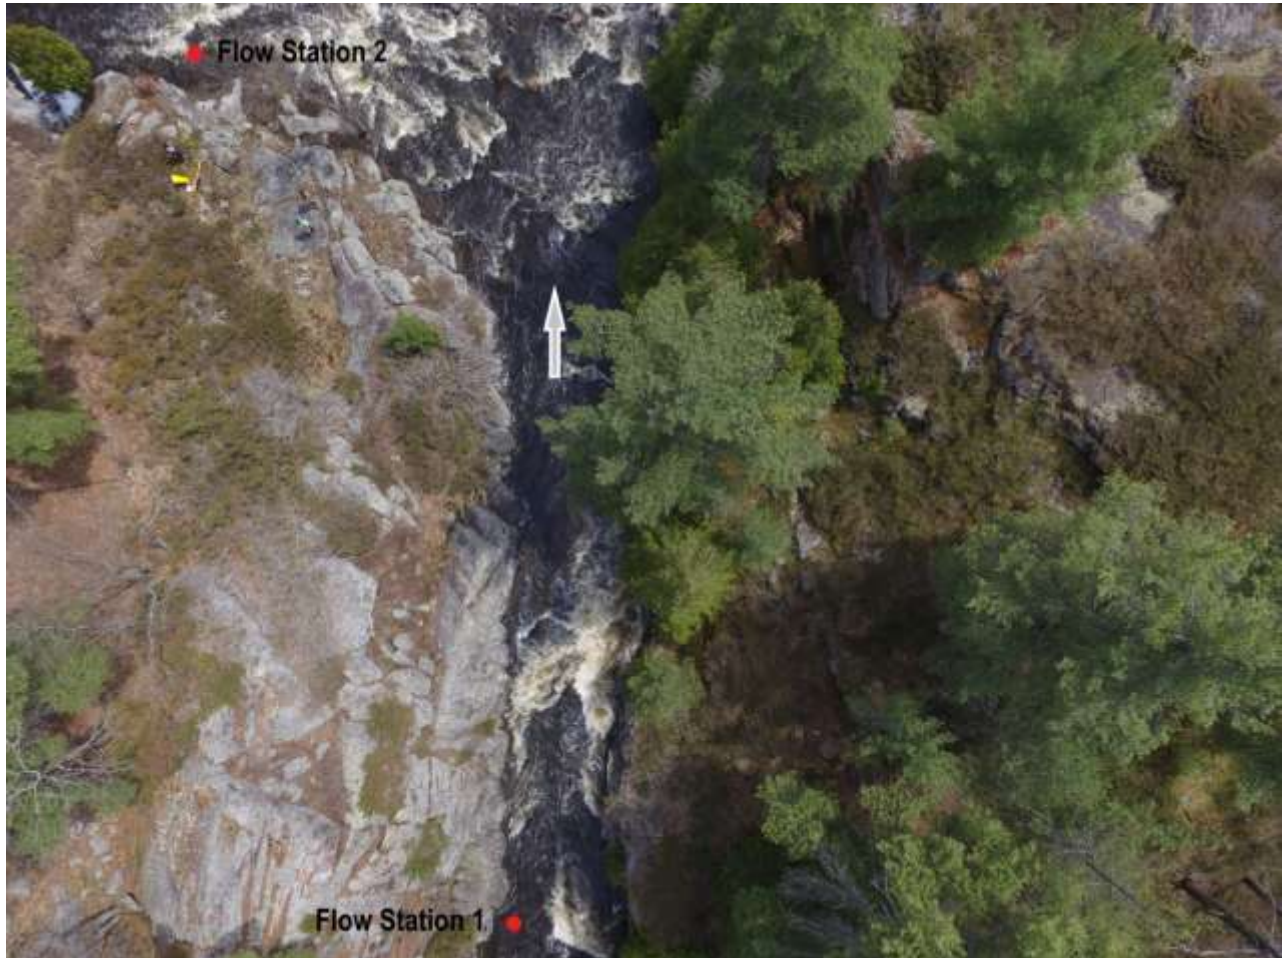
Figure 2. Flow station locations at the upper spawning site

In 2017 and 2018, flow was measured at two locations per spawning site (Figures 2 and 3). Results are presented in Tables 3 and 4.

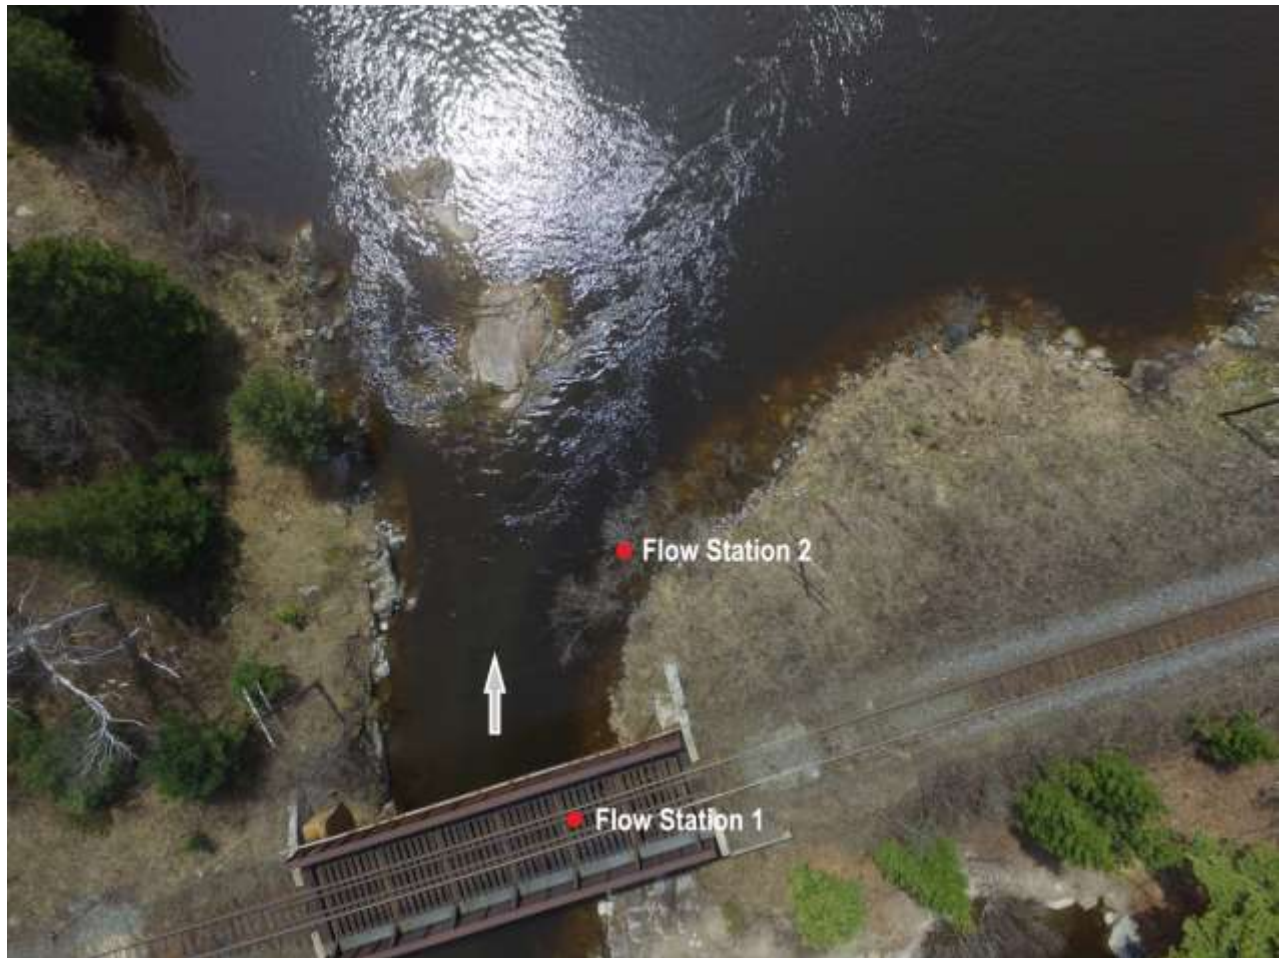
Figure 3. Flow station locations at the lower spawning site

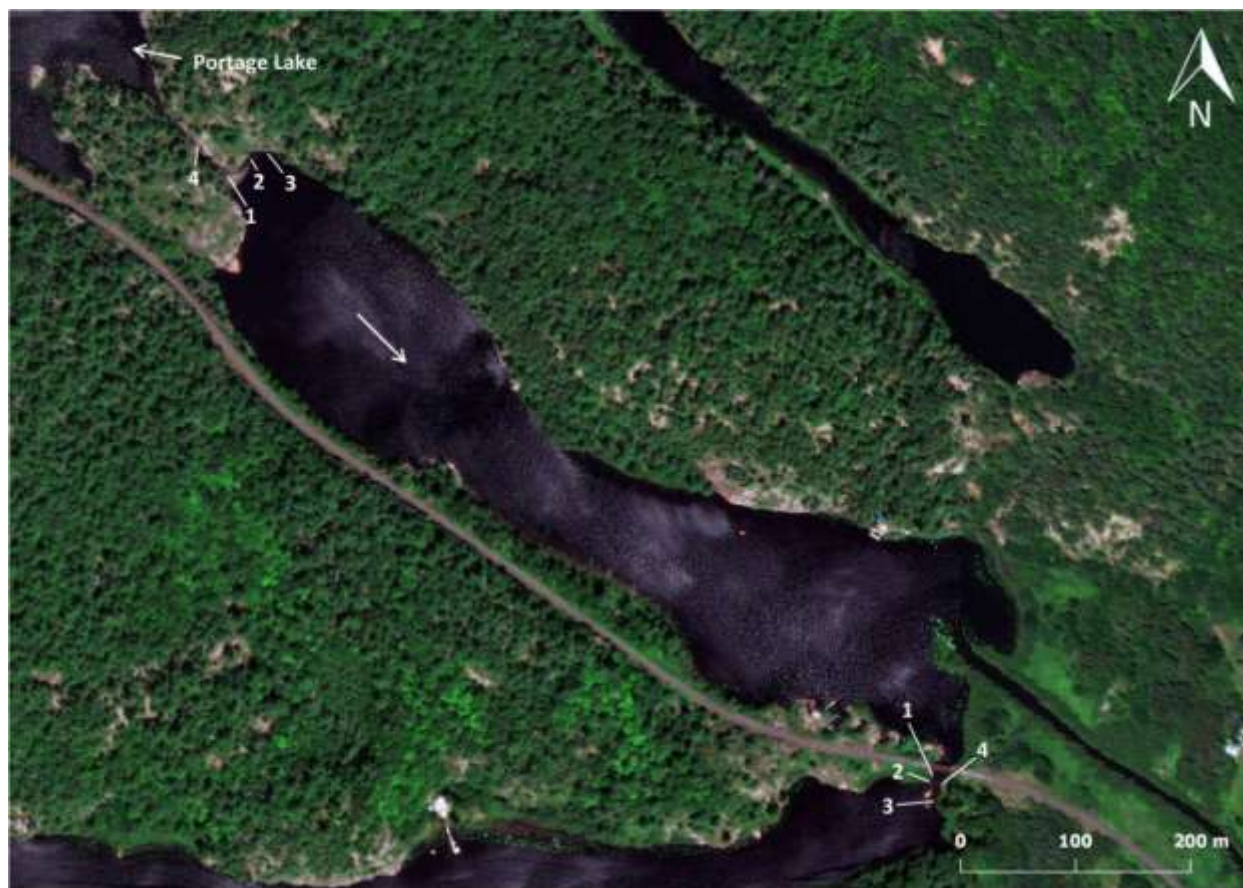
Figure 5. Egg mat locations 1-4 at both the upper and lower sites were sampled in 2017. Egg mat locations 1-3 at both sites were sampled in 2018.

At each site, egg mats were used to help assess the number of walleye eggs deposited. Egg mat locations are shown in Figure 5 and egg count totals for each egg mat are presented in Tables 5 and 6.
