Executive Summary

The Eastern Georgian Bay Stewardship Council (EGBSC) received funding from Environment and Climate Change Canada to carry out a 32-month project to assess spawning, nursery, rearing, and foraging habitat in eight tributaries to eastern Georgian Bay, which included the Key River. Fish habitat assessments were focused on Walleye, Lake Sturgeon, and Sucker species, between the river mouths and the first major spawning area or barrier to fish passage.

Project Overview and Methodologies

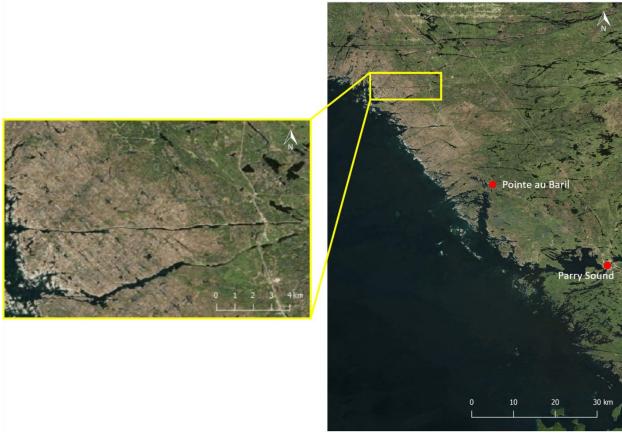
Figure 1. Location of the Key River in relation to Parry Sound and Pointe au Baril

The Key River is situated north of the Magnetawan River and south of the Pickerel and French Rivers (Figure 1). The Key River falls within the Henvey Inlet-Key River quaternary watershed draining an area of 197 km² (Figure 2). The river and its watershed are situated in the ancestral and traditional territory of the Anishinabek people.

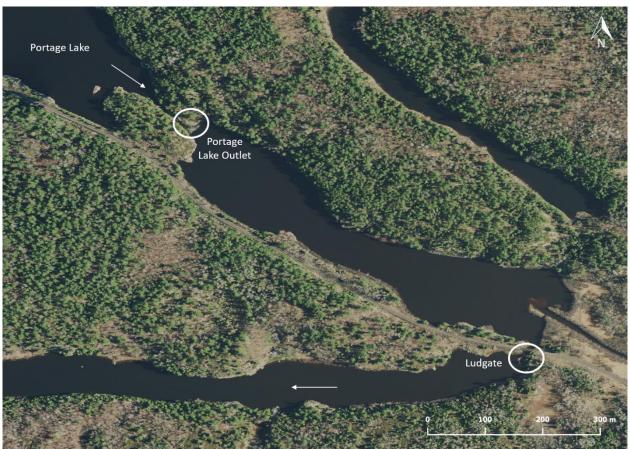
Figure 3. Location of Ludgate and Portage Lake Outlet spawning beds

There are two spawning areas located between the Key River outlet to Georgian Bay and Portage Lake. The lower spawning site (hereafter referred to as Ludgate) is situated approximately 15 km east of the Key River outlet, at the train bridge at Ludgate, immediately downstream of the Little Key River outlet. The upper spawning area (hereafter referred to as Portage Lake Outlet) is located approximately 820 m further upstream from Ludgate, at the outlet from Portage Lake (Figure 3).

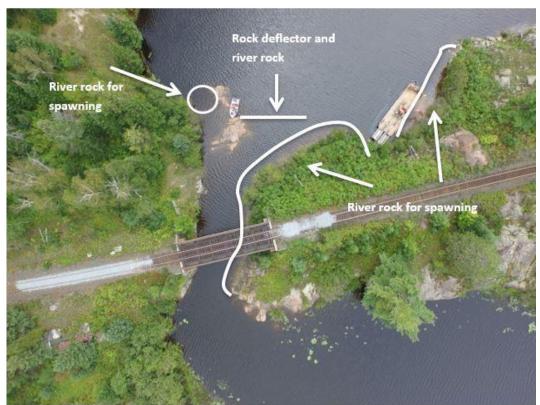
Figure 4. Locations of enhanced spawning habitat at Ludgate

Project construction took place in fall 2015. River rock between 6 cm and 25 cm was barged to the spawning beds and placed using a small excavator. The rock was placed at a variety of depths to try and ensure that some amount of spawning habitat would be available during a variety of water levels. Large boulders were used in specific locations to help influence flow direction, the speed of water flow, and to create resting areas (Figures 4 and 5).

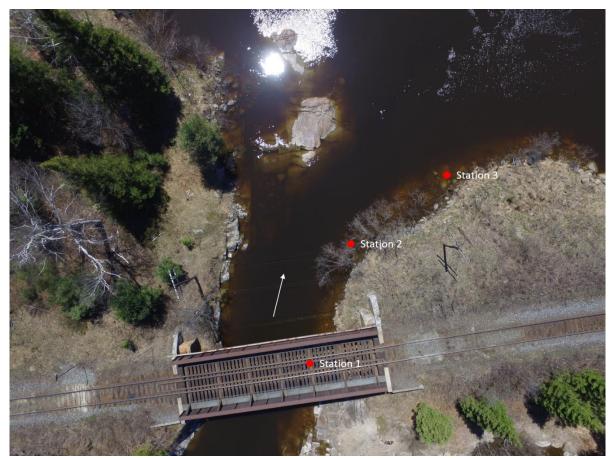
Figure 10. Water velocity (1 and 2) and depth stations (3) at Ludgate

Three stations were established at Ludgate to collect information on water velocity and water level fluctuations from April 18 to June 8 (Figure 10). Figure 11 displays velocity measurements recorded at stations 1 and 2.

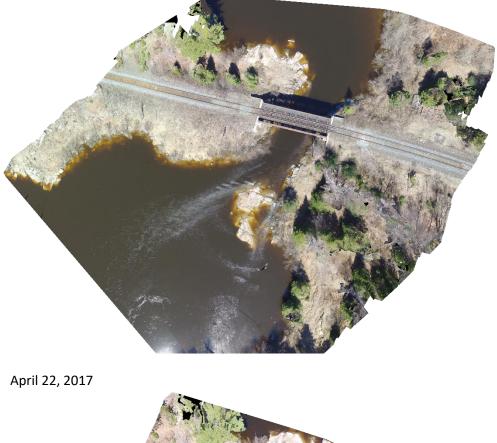
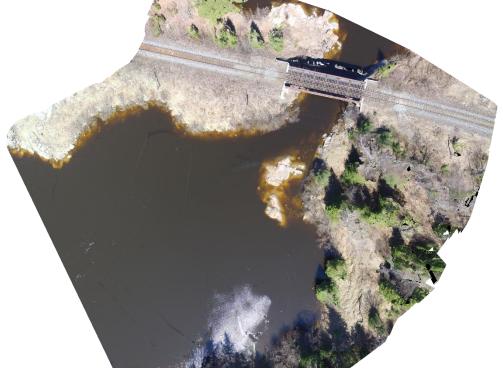
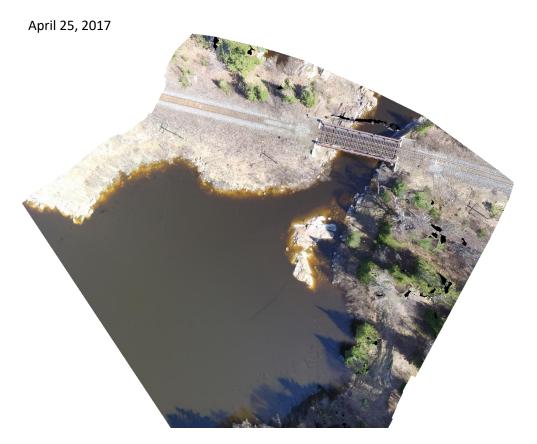
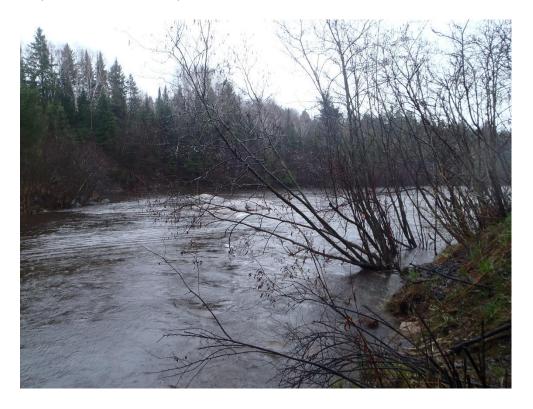
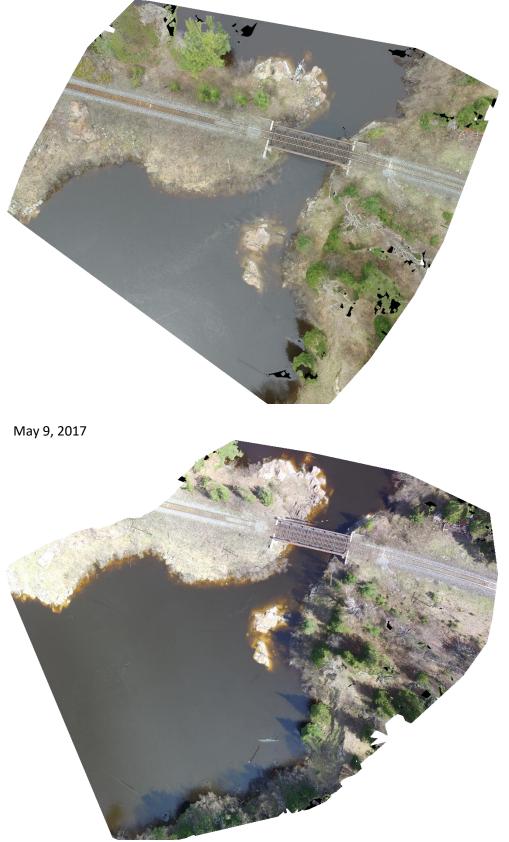
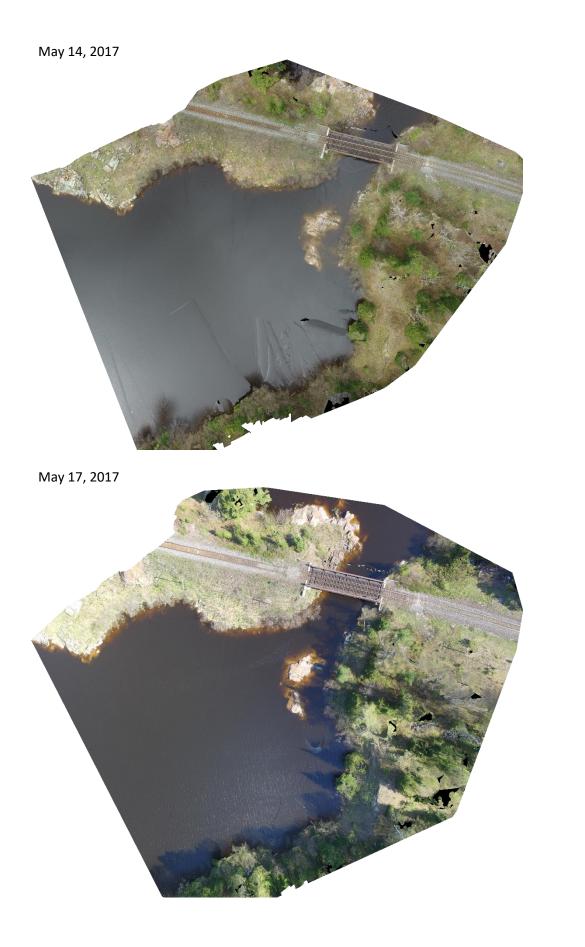
Ludgate

The following orthomosaics illustrate changes in water levels at both spawning beds from April 18 to June 20. The images show that the created habitat remained underwater at both sites, which is crucial for successful egg incubation. A small number of eggs were observed stranded out of water at Ludgate, upstream of the train bridge and the created habitat. At Portage Lake Outlet, the middle of the lower end of the rapids, where the flow splits to the right and left banks, experienced a notable drop in water level leaving most of the rock out of water.

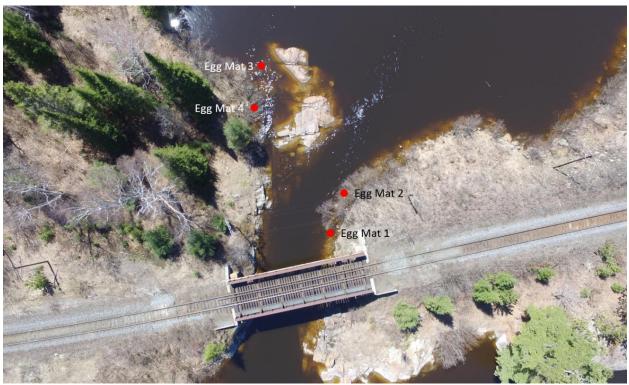
Figure 16. Location of egg mats installed at Ludgate in 2017

EGBSC set four egg mats at Ludgate to help assess the amount, type, and location of egg deposition (Figure 16). Egg mats were only placed on a small portion of the spawning bed, and therefore, only represent a small portion of the entire spawning area. Based on size, eggs could be differentiated between Walleye and Sucker species, but it was not possible to identify the Sucker eggs to species level. Had Lake Sturgeon eggs been deposited, they would have also been distinguishable by size and colour.

Egg mats were installed at various times throughout the study period (see <u>Appendix C</u> for more detail). Egg deposition on the mats was quite low. From April 18 to June 20, a total of 1,840 Walleye eggs were counted and no Sucker eggs were observed. Egg mat 2 had the greatest total number of Walleye eggs (863). Egg mat 1 had the next highest Walleye egg count at 722. No eggs were counted on egg mat 4 which was installed later in the season, on May 14.

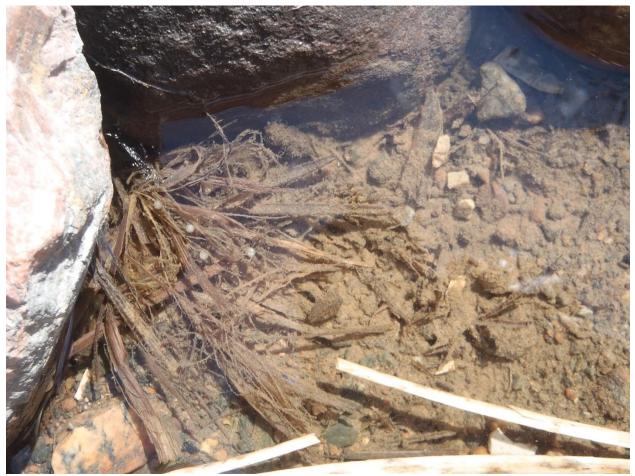
Figure 17. Walleye eggs in very shallow water at Ludgate on April 27, others were already stranded out of water

In addition to the eggs counted on egg mats, Walleye eggs were also seen in the substrate upstream of egg mat 1 on April 25. On April 27, Walleye eggs were observed in the substrate again, some upstream of the train bridge. Some of the eggs observed on April 27 were in very shallow water or already stranded out of water (Figure 17).

Water level fluctuations were observed at Ludgate and Portage Lake Outlet throughout the spawning and egg incubation periods. At Ludgate, eggs were seen deposited in the substrate just upstream of the train bridge where the water became very shallow, and in some cases, in places where the water had receded below the substrate leaving the eggs stranded. While most eggs were observed in areas that stayed underwater for the entire egg incubation period, the potential for egg stranding is still a concern. Importantly, the newly created habitat at both sites was observed to be functioning as intended with sufficient water depth over the habitat.

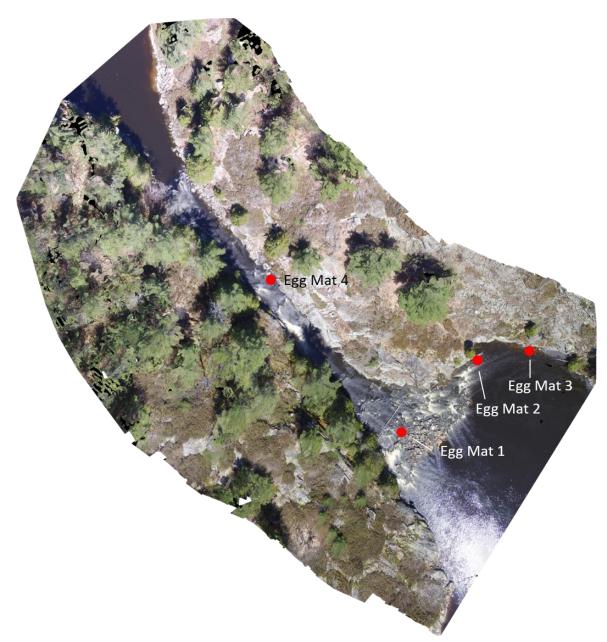
Figure 18. Location of egg mats installed at Portage Lake Outlet in 2017

Four egg mats were set at Portage Lake Outlet to help assess the amount, type, and location of egg deposition (Figure 18). Egg mats were only placed on a small portion of the spawning bed, and therefore, only represent a small portion of the entire spawning area. Based on size, eggs could be differentiated between Walleye and Sucker species, but it was not possible to identify the Sucker eggs to species level. Had Lake Sturgeon eggs been deposited, they would have also been distinguishable by size and colour.

Egg mats were installed at various times throughout the study period (see <u>Appendix C</u> for more detail). Egg deposition on the mats at Portage Lake Outlet was higher than at Ludgate. From April 18 to June 20, a total of 7,017 Walleye eggs and only 1 Sucker egg were counted. Egg mat 2 had the greatest total number of Walleye eggs (6,594). Egg mat 1 had the only Sucker egg. No eggs were counted on egg mat 4 which was installed later in the season on May 17.

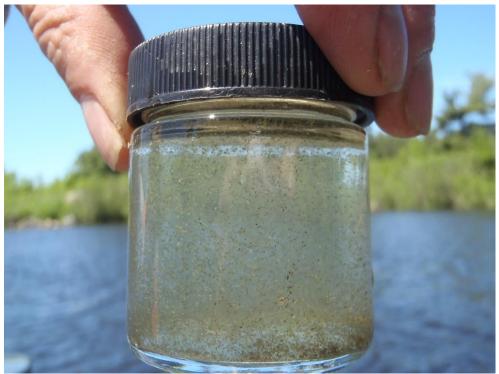
Figure 19. Ludgate composite plankton sample (June 8, 2017)

On June 8, three plankton samples were taken downstream of Ludgate and combined to create one composite sample (Figure 19). Based on the composite sample, the waters downstream of Ludgate can be described as having good plankton production.

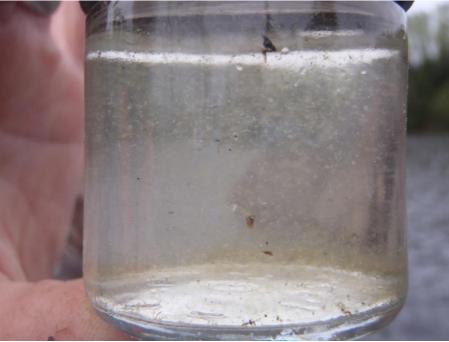
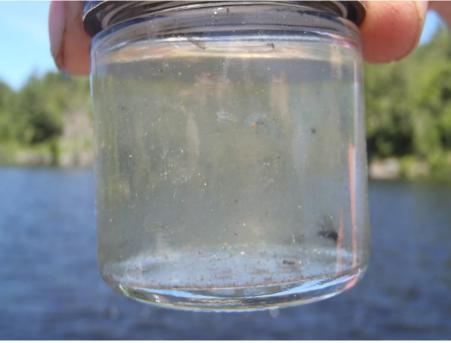
Figure 20. Portage Lake Outlet composite plankton sample (May 22, 2017)

On May 30 and June 8, three plankton samples were taken downstream of Portage Lake Outlet and combined to create one composite sample each time (Figures 20 and 21). Based on the composite samples, the waters downstream of Portage Lake Outlet can also be described as having good plankton production.

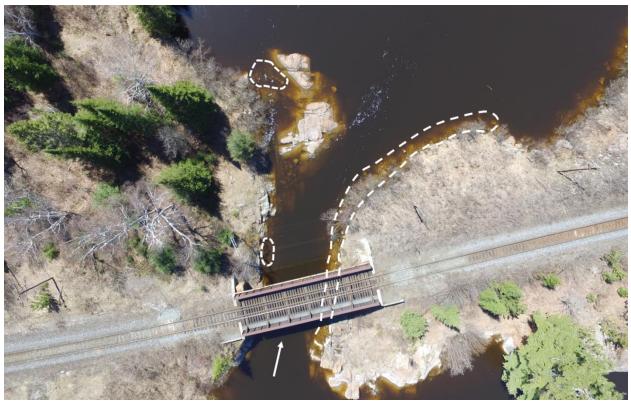
Figure 22. Areas of ideal spawning substrate observed at Ludgate

Substrate visible from the banks was recorded at Ludgate. Figure 22 outlines the areas considered to have substrate suitable for Walleye and Lake Sturgeon. As expected, most of the areas outlined in Figure 22 correspond with the areas where river rock was placed as part of EGBSC's 2015 spawning bed enhancement work (see <u>Background Information</u>). Very little substrate observed at Ludgate was considered ideal for Sucker.

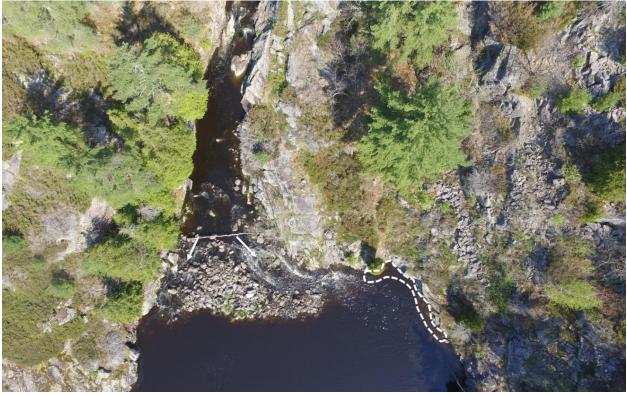
Figure 23. Area of ideal spawning substrate observed at Portage Lake Outlet

Substrate visible from the right bank at Portage Lake Outlet was recorded. Figure 23 illustrates the area with substrate considered ideal for Walleye and Lake Sturgeon. Similar to Ludgate, this area corresponds with the area of focus for EGBSC's spawning bed enhancement work in 2015. No substrate smaller than cobble was observed in a large enough quantity to constitute an area of ideal Sucker spawning substrate.

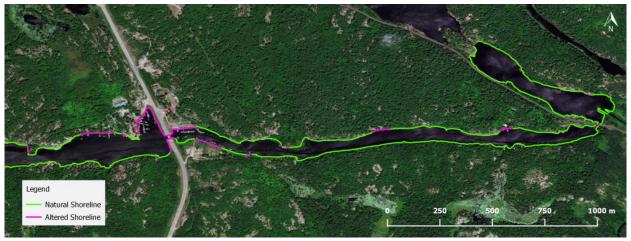
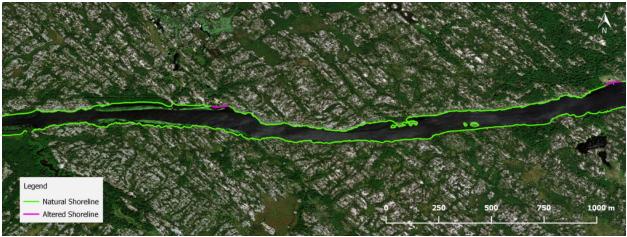
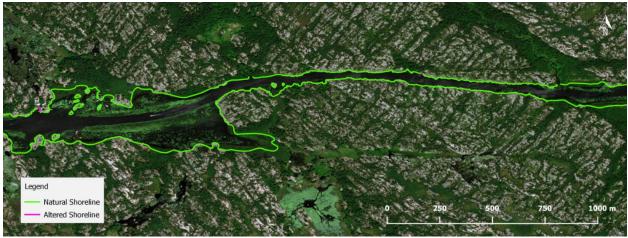
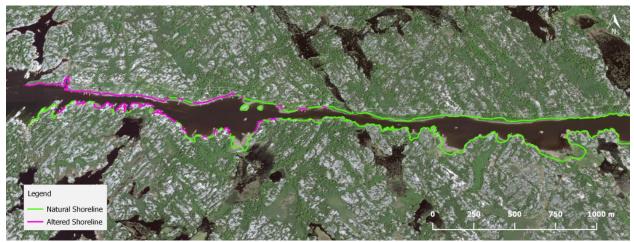
Along each of the ten (10) underwater surveys, shoreline characteristics were also recorded and photographed. The Key River, downstream of the spawning bed to the outlet, has predominantly natural shoreline (88% natural, 12% altered) (Figures 25-29). Observed alterations included train and highway bridges, marinas, mown grass close to the shoreline, and docks. The natural shoreline along the surveys consisted mainly of bedrock cliffs, gently sloped bedrock with forest set back, pockets of wetland, and flooded alders. Photos of the shoreline from each survey can be found in <u>Appendix E</u>. It is important to note that surveys did not cover the entire length of the shoreline, therefore, they do not represent all possible alterations or types of natural shoreline.

Figure 25. Natural and altered shoreline downstream of Portage Lake Outlet and Ludgate
