# Magnetawan River Fish Habitat Assessment

# Executive Summary

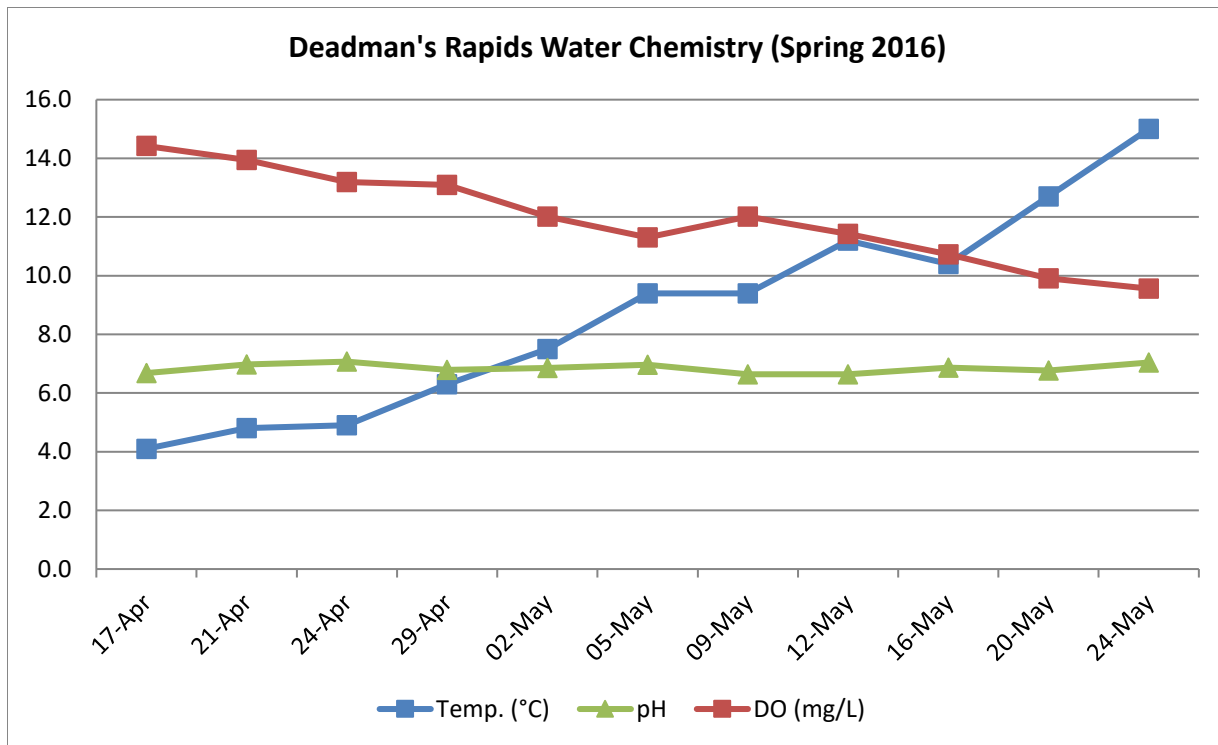
**Figure 6.** Water temperature (°C), dissolved oxygen (mg/L), and pH measurements taken at Deadman’s Rapids in spring 2016

As illustrated in Figure 6, water temperature slowly increased from 4.1°C on April 17 to 18.3°C on June 8. Walleye and White Sucker were observed during night surveys between April 29 and May 5. Redhorse Sucker species were observed on May 24. No Lake Sturgeon were observed.

Figure 6 illustrates changes in temperature, dissolved oxygen, and pH over the spawning and egg incubation periods. pH remained relatively stable, while temperature and dissolved oxygen followed a typical pattern for spring.

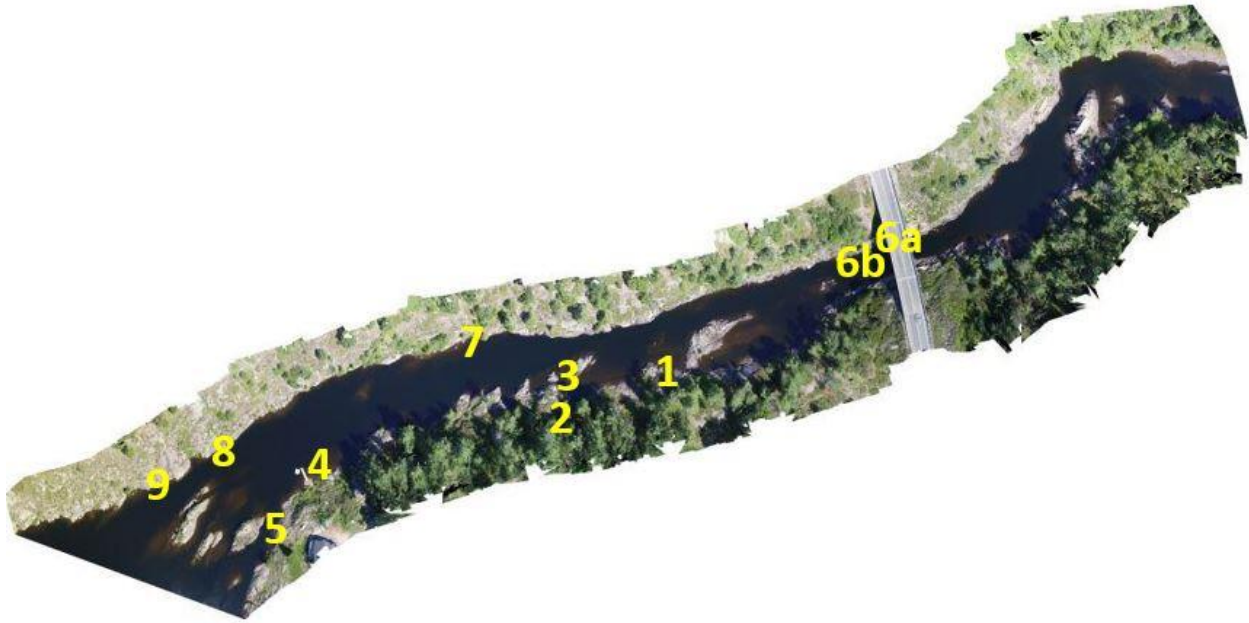
**Figure 8.** Water velocity (1, 3-6b, 7-9) and depth stations (1, 2, 4, 6a, 7-9) at Deadman's Rapids

Seven stations were established along Deadman's Rapids to collect information on water velocity from April 21 to June 8 (Figure 8). Station locations were based on site accessibility. Many areas of the rapids, especially on the north shore, were not accessible due to steep rock faces. Station 6 began as a depth and flow station, but the station went dry on May 9. EGBSC continued to measure water level at this station using a measuring tape and level. The water velocity station, on the other hand, had to be moved 5 m downstream and became station 6b (original station location became 6a). Figure 9 illustrates velocity measurements recorded at each station between April 21 and June 8.

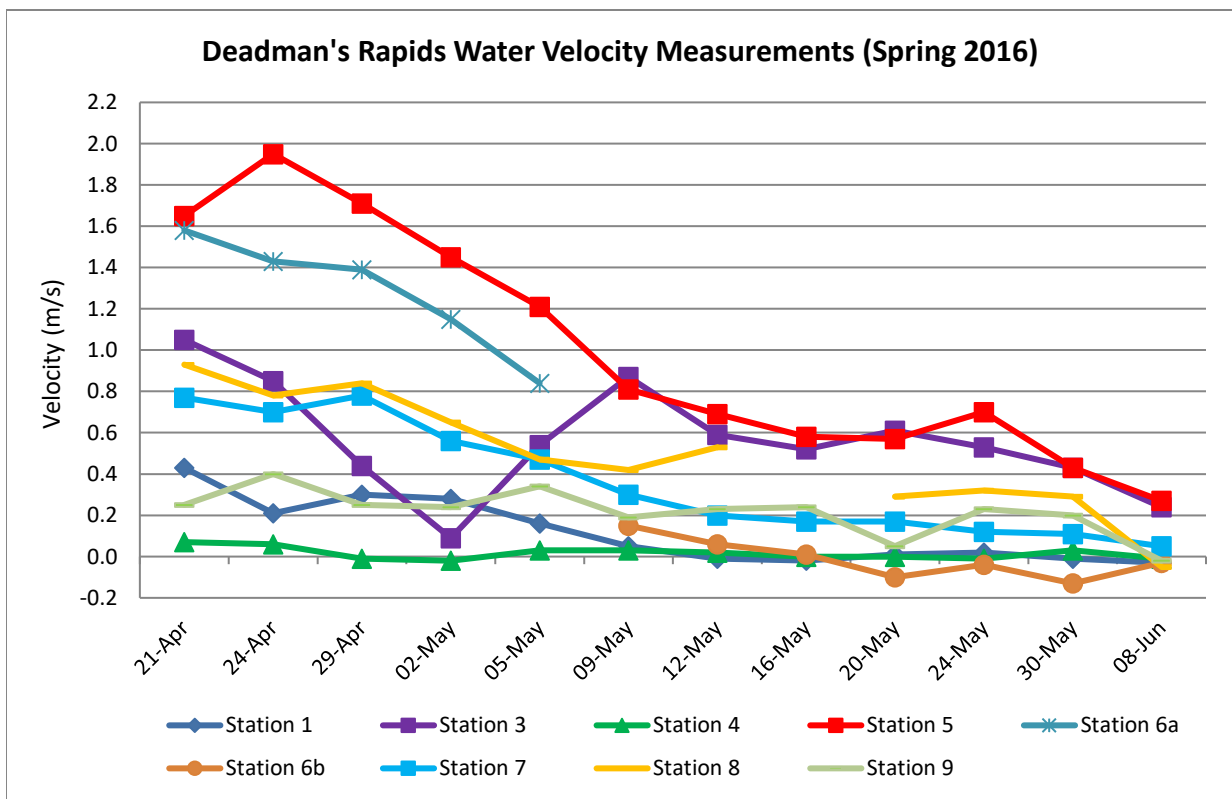
**Figure 9.** Water velocity measurements at Deadman's Rapids in spring 2016

Overall, stations 5 and 6a had the highest velocity, peaking at 1.95 m/s. Station 5 was located at the base of the rapids (where the river breaks into various channels around bedrock islands) between one of the bedrock islands and the bedrock shore. This area creates a narrow chute for the water to flow through,

Stations 3, 5, and 6a experienced the most significant variations in water velocity. Water velocity at station 3 declined significantly from April 21 to May 5, but increased sharply on May 9. After May 9, velocity at station 3 declined more steadily. Stations 1, 4, and 9 all had lower velocities, and did not exceed 0.43 m/s for any measurements between April 21 and June 8. Station 4 had very low flow, peaking at 0.07 m/s and changing into a back eddy on four occasions over the monitoring period. All stations aside from 3, 4, and 5 declined fairly steadily between April 21 and June 8.

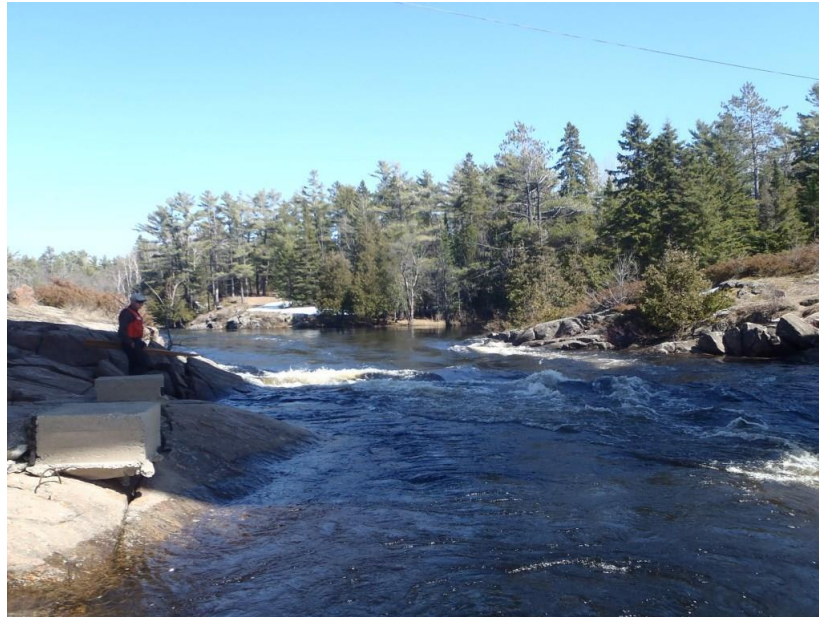
**Figure 10.** Station 6a located underneath the Highway 69 bridge

resulting in higher velocities. Station 6a was located underneath the Highway 69 bridge where the river narrows between the concrete bridge footings (Figure 10). The highest velocity recorded at Station 6a was 1.58 m/s. This velocity would not prevent fish from moving upstream, and there were no steep climbs that fish would need to ascend.

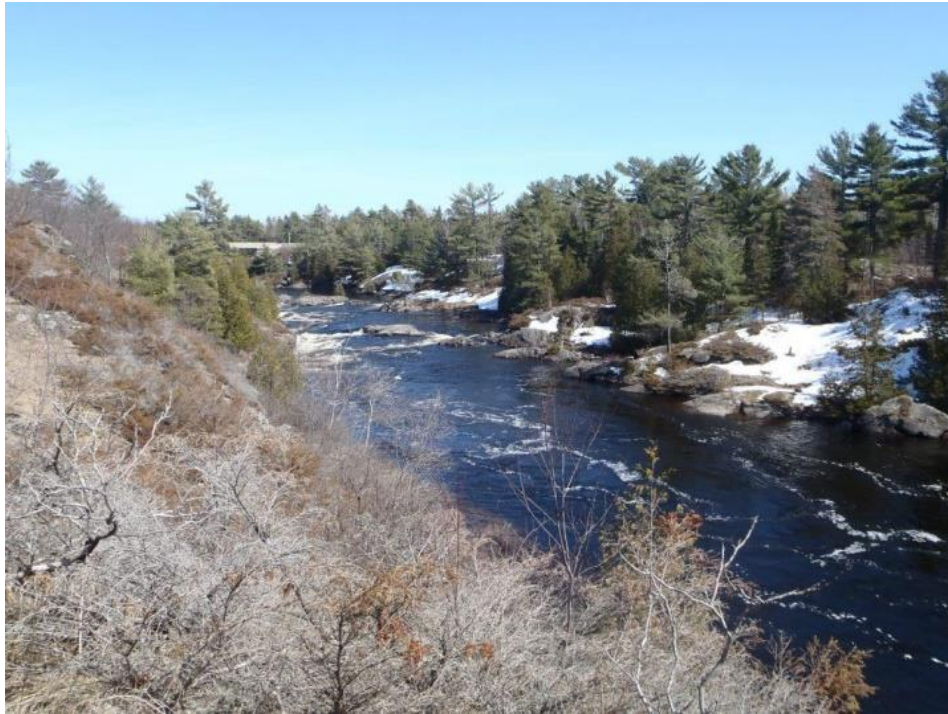
**Figure 12.** Limited safe access to Deadman’s Rapids

rapids have steep, bedrock cliffs for banks and EGBSC was unable to walk along these areas of the shoreline to look for Walleye or eggs (Figure 12).

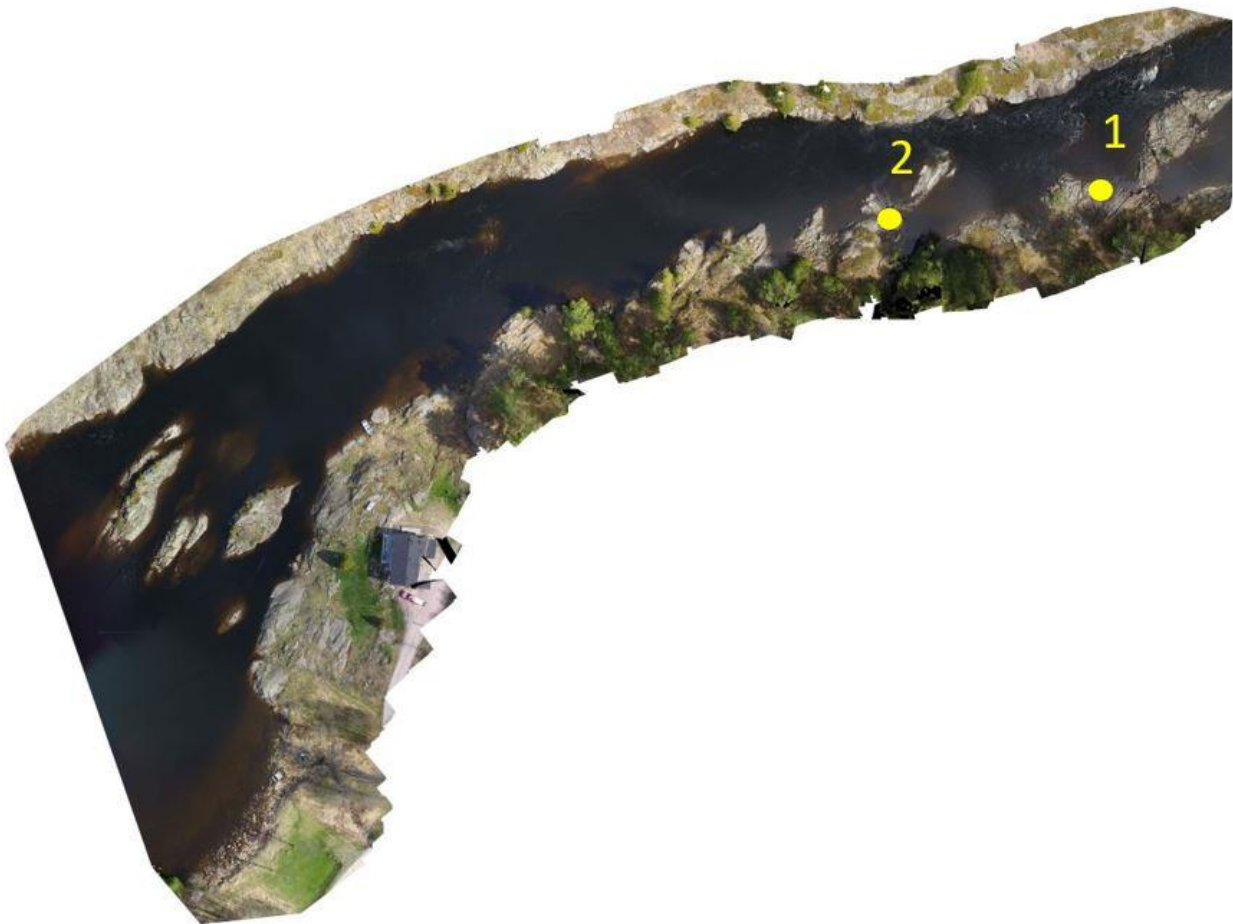
**Figure 13.** Location of egg mats installed at Deadman’s Rapids in 2016

EGBSC set egg mats at Deadman’s Rapids to help assess the amount and location of egg deposition. Due to fast flows, depth, and difficulty with access, EGBSC was limited to setting two egg mats (Figures 13-15). Egg mats were only placed on a small portion of the spawning bed, and therefore, only represent a small portion of the entire spawning area. Based on size, eggs could be differentiated between Walleye and Sucker, but it was not possible to identify the Sucker eggs to species level. Had Lake Sturgeon eggs been deposited, they would also have been distinguishable by size and colour.

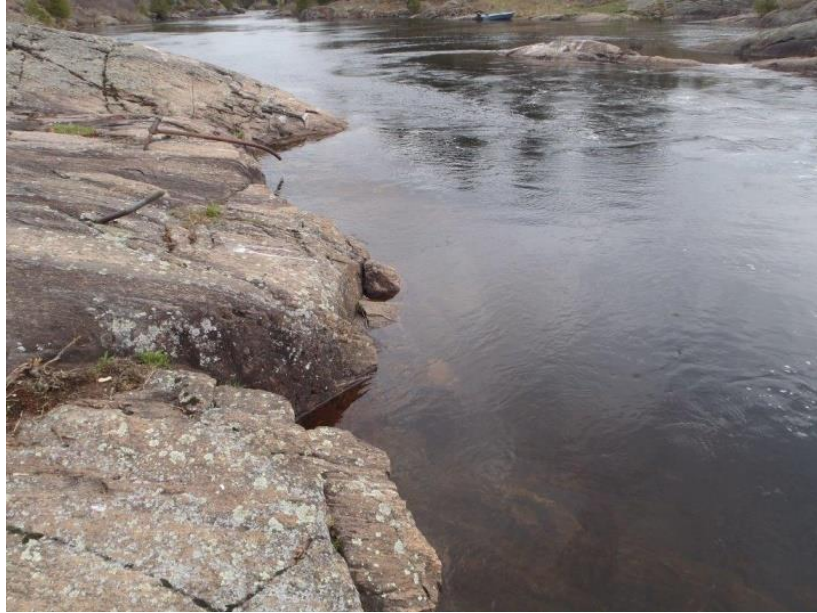
**Figure 16.** Shoreline where egg deposition was observed on May 12, 2016

On May 12, EGBSC discovered another area of Walleye egg deposition on the north shore. Eggs had been deposited in cracks along bedrock shelves near the bottom end of the rapids. As eggs are usually deposited in substrate sized from small cobble to small boulder, this was not a location where egg

deposition would be expected. In years with lower Georgian Bay water levels, the area where the eggs were observed would be out of water. Figure 16 shows the shoreline where the eggs were observed, and Figure 17 shows a close-up of the egg deposition. As demonstrated in these figures, the eggs were collected in very shallow areas which make them prone to stranding.

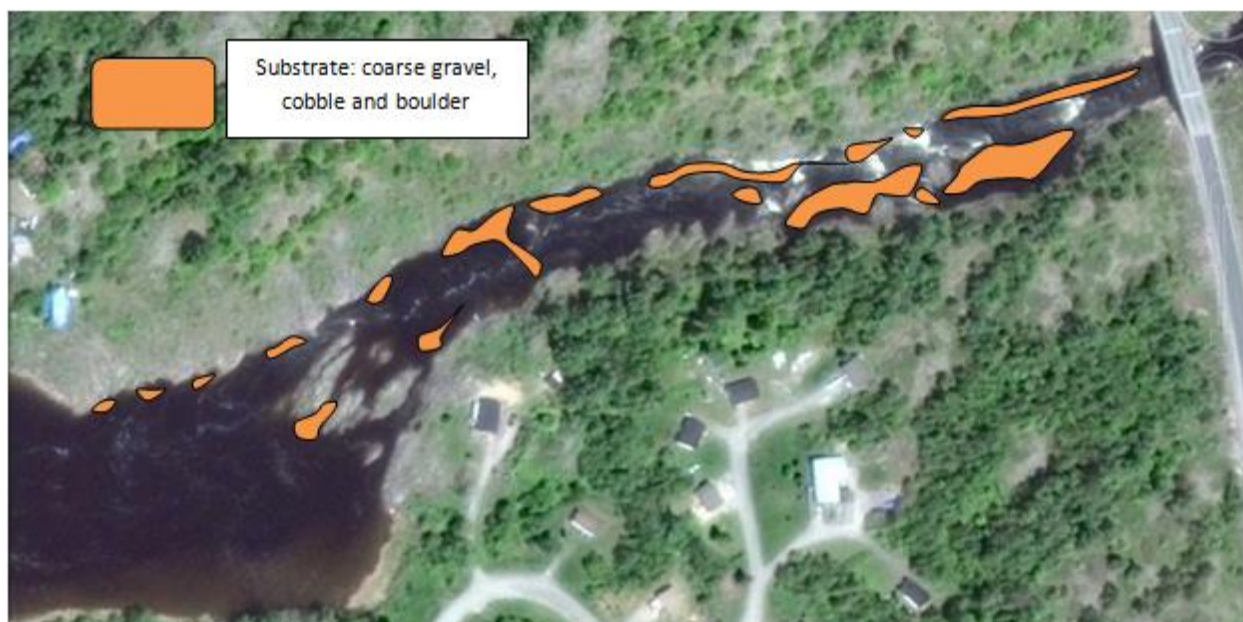
**Figure 22.** Location and extent of suitable spawning substrate at Deadman's Rapids

Because of the water depth at Deadman's Rapids, it was not possible to complete transects to record depth and substrate. Instead, EGBSC, UGLMU staff, and a volunteer completed snorkel surveys of the rapids on August 8 (Figure 21). A grid was used to help confirm substrate size where possible, and a GoPro camera was used to take photos of the habitat. Figure 22 shows where suitable spawning habitat (gravel, cobble, and boulder) are located within the rapids. Most of the habitat is located along the edges of the rapids, and in larger pockets on the south shore, where water velocity is slower.

Deadman's Rapids has an abundance of suitable spawning substrate. The range of substrate included coarse gravel, cobble (5 to 25 cm diameter), boulder (26 to 40 cm diameter), and large boulder (>40 cm diameter). The optimal substrate size for Walleye egg incubation ranges from gravel (0.2 to 6.4 cm) to cobble (6.4 to 25 cm) (Kerr et al., 1997). The optimal substrate size for Lake Sturgeon ranges from 10 to 60 cm in diameter (Golder Associates Ltd., 2011). White Sucker spawn on a clean bottom of coarse sand to gravel ranging from 2 to 16 mm in size (Twomey et al., 1984). Substrate of these sizes was present at the site.

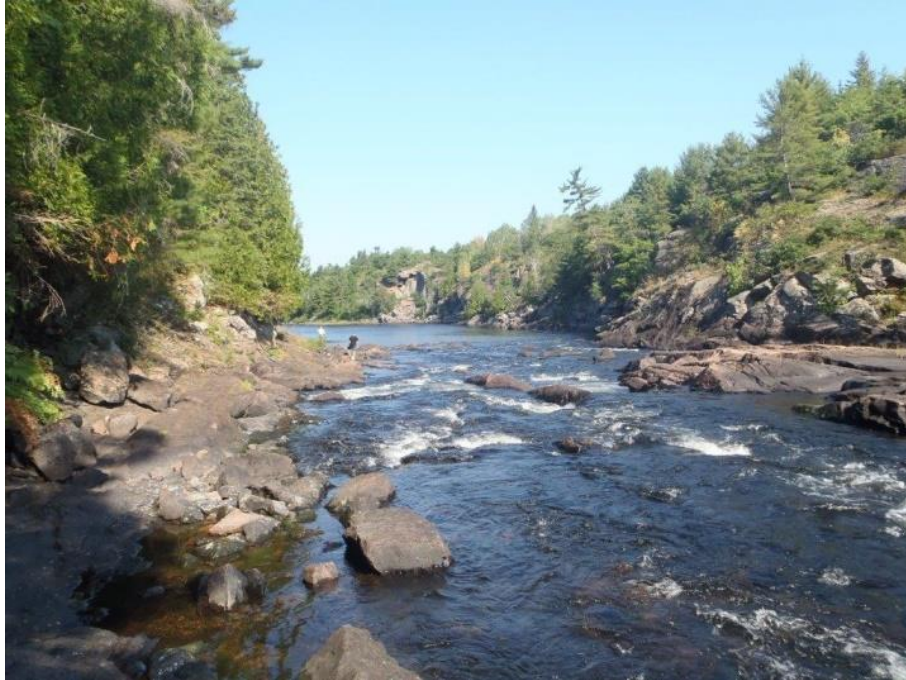
Figure 25. Two Foot Rapids looking downstream

Two Foot Rapids is located approximately 1.7 km upstream of Pine Rapids. Two Foot Rapids is gorge-like with steep shorelines (Figure 25). The high water mark extends almost to the tree line on the south shore. High quality spawning substrate (large gravel, cobble, and boulder) was present at the site in four different areas (Figure 26). EGBSC was unable to investigate the faster flowing areas of the rapids, and therefore, the area with suitable spawning habitat was likely underestimated. EGBSC’s study in 2011 agreed with Kujala’s report in stating that due to the site characteristics and higher flows that would be present during the spring freshet, it is likely that there would be little opportunity for Walleye to find areas of lower velocity to pass by this site. Because EGBSC could not investigate this site until after the spring freshet, it could not be confirmed that fish are, in fact, unable to migrate further upstream. In addition, the past reports from Kujala and EGBSC were focused on Walleye, and it is unknown as to whether this site would be a barrier to Sucker species or Lake Sturgeon, which can typically handle faster velocities than Walleye.

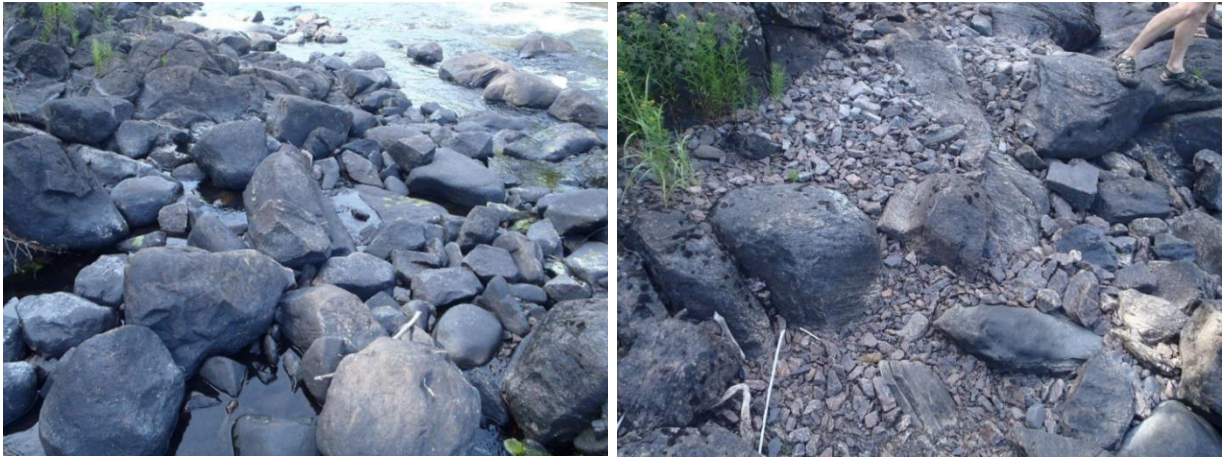
Figure 29. Variety of spawning substrate at Four Foot Rapids

Four Foot Rapids is located approximately 1.2 km upstream of Two Foot Rapids. Figures 27 and 28 provide upstream and downstream views of the rapids and Figure 29 illustrates the variety of substrate at the site. Figure 30 shows the location and extent of spawning habitat at Four Foot Rapids.

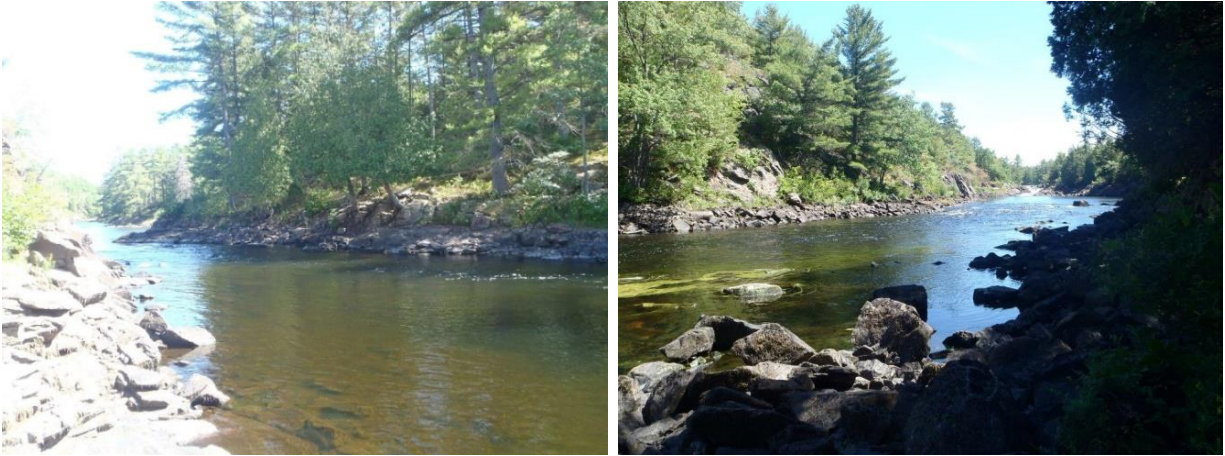
**Figure 31.** Island between Four and Fourteen Foot Rapids (south side shown on left, north side shown on right)

substrate (more available on the north side of the island than the south side) (Figure 31).

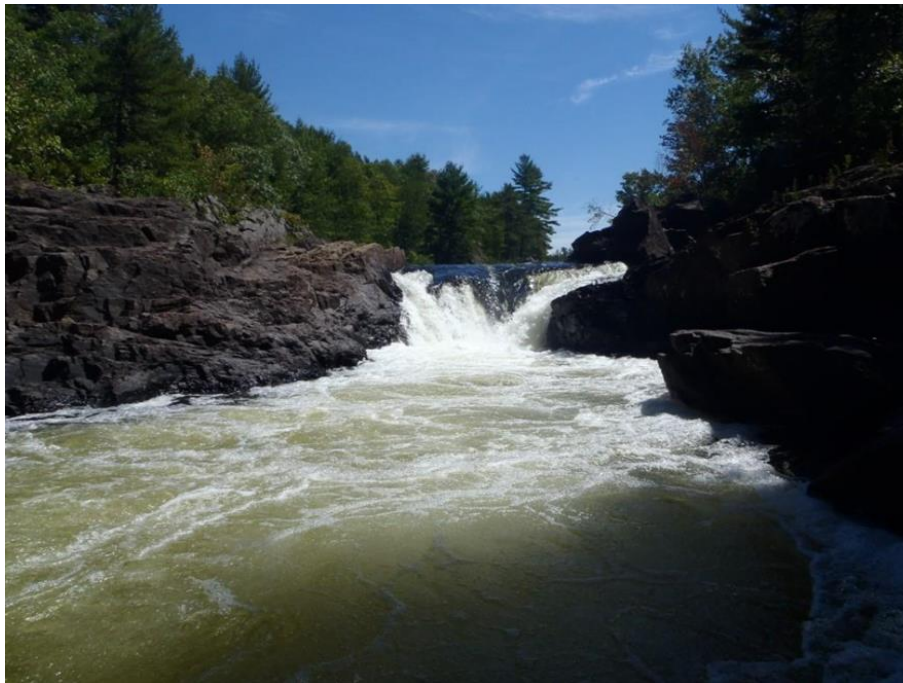
**Figure 32.** Fourteen Foot Rapids looking upstream

Fourteen Foot Rapids, as illustrated in Figures 32 and 33, presents a definite barrier to migration for Walleye, Sucker species, and Lake Sturgeon. Due to flow and white water, it was difficult to assess all potential areas for spawning habitat. Observations were limited to the littoral areas and the downstream end of the rapids (Figure 34).

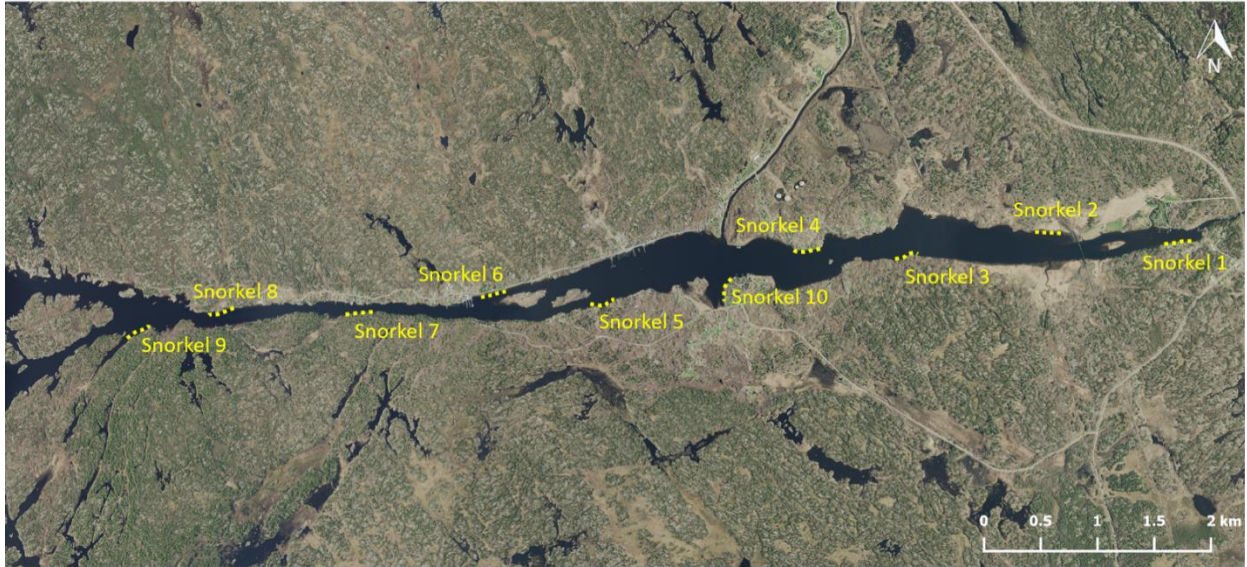
**Figure 35.** Underwater survey locations downstream of Deadman’s Rapids

While snorkelling, underwater videos were taken using a GoPro camera for 100 m approximately every 1 km. In total, EGBSC carried out ten (10) underwater surveys. Each survey location has been identified in Figure 35. Bathymetry maps are presented in [Appendix D](#).
