Pickerel River Fish Habitat Assessment

Executive Summary

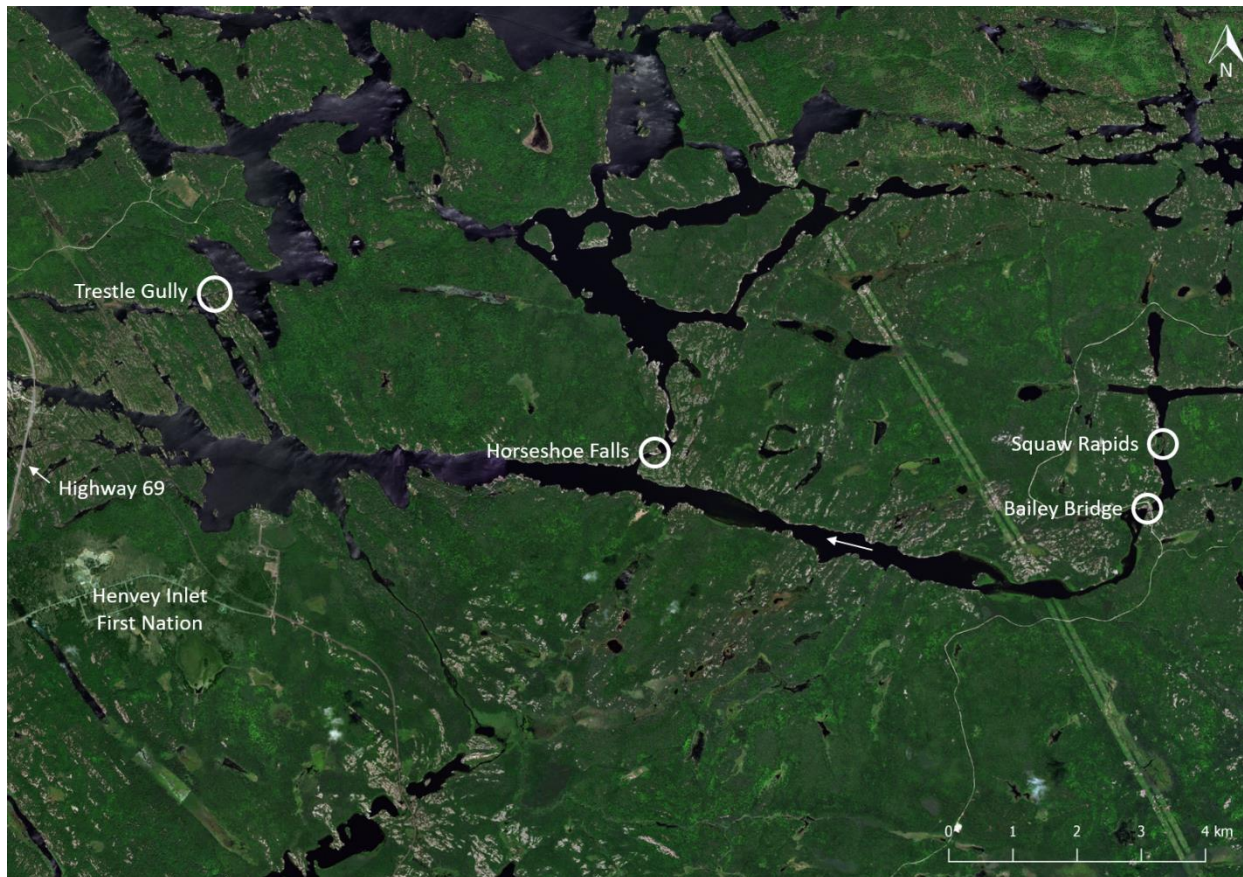
Figure 3. Location of Trestle Gully, Horseshoe Falls, Bailey Bridge, and Squaw Rapids spawning beds

In 2017, EGBSC studied four spawning bed sites upstream of Highway 69 on the Pickerel River – Trestle Gully, Horseshoe Falls, Bailey Bridge, and Squaw Rapids (Figure 3). EGBSC began spring field work on the Pickerel River on April 18 and ended on June 20. During this period, spawning beds were visited approximately every three to four days, whenever possible. Towards the end of the Walleye and Sucker spawning period (end of May, early June), site visits were less frequent. In total, Trestle Gully was visited seventeen (17) times, Horseshoe Falls was visited sixteen (16) times, Bailey Bridge was visited eighteen (18) times, and Squaw Rapids was visited sixteen (16) times.

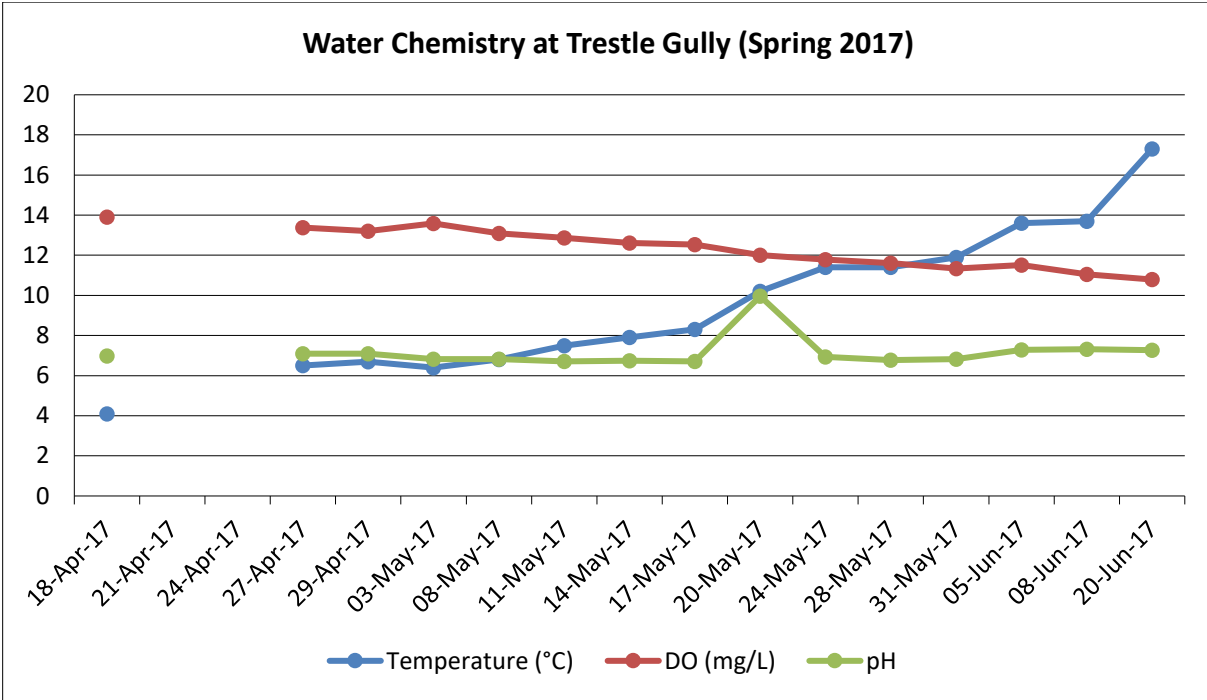
Figure 4. Water temperature (°C), dissolved oxygen (mg/L), and pH measurements taken at Trestle Gully in spring 2017

As illustrated in Figure 4, water temperature at Trestle Gully increased fairly consistently from 4.1°C on April 18 to 17.3°C on June 20. Only one slight drop in temperature was observed from April 29 (6.7°C) to May 3 (6.4°C). Dissolved oxygen levels dropped steadily throughout the study period. The highest level was recorded on April 18 (13.9 mg/L) and reached a low of 10.79 mg/L on June 20. Between April 18 and June 20, all pH levels recorded at Trestle Gully were above 6.0. pH levels ranged from 6.71 to 7.32 with one spike up to 9.96 on May 20. Overall, the pH readings are mildly acidic and typical for Canadian Shield watersheds.

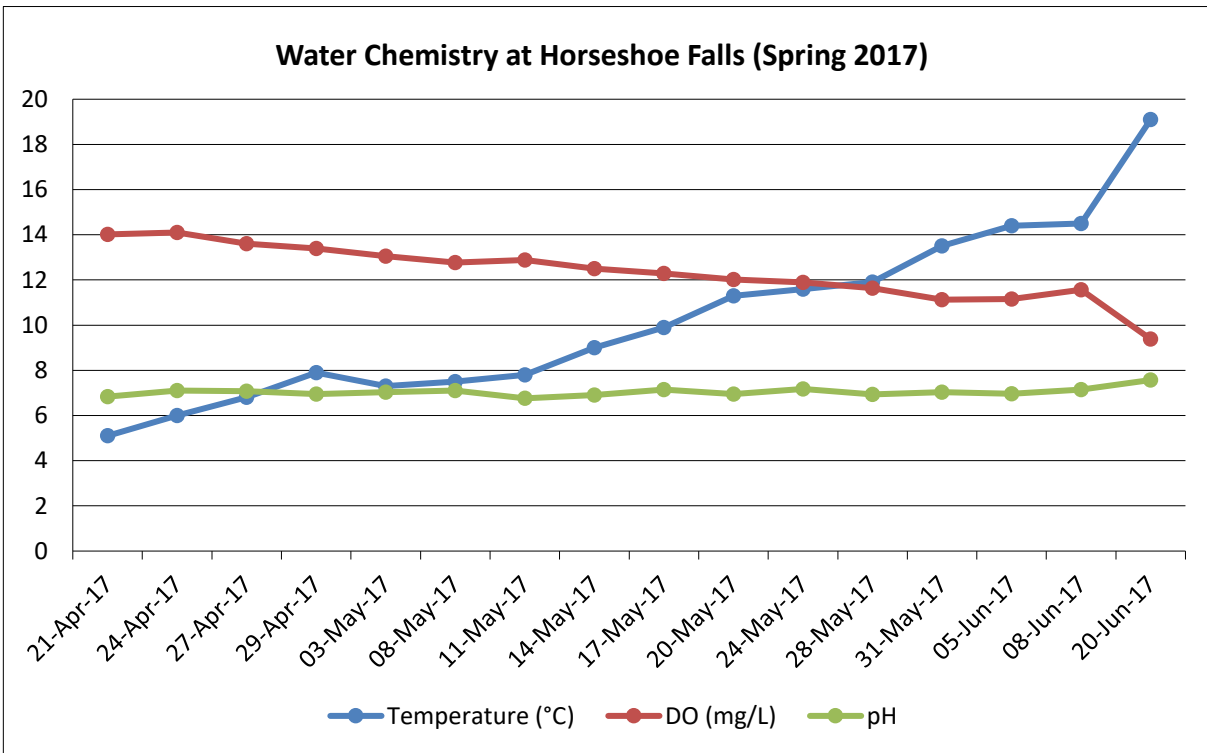
Figure 6. Water temperature (°C), dissolved oxygen (mg/L), and pH measurements taken at Horseshoe Falls in spring 2017

Water temperature at Horseshoe Falls increased steadily from 5.1°C on April 21 to 19.1°C on June 20 (Figure 6). Alike Trestle Gully, one small drop in temperature was observed from April 29 (7.9°C) to May 3 (7.3°C). Dissolved oxygen levels dropped fairly consistently throughout the study period. The highest level was recorded on April 24 (14.10 mg/L) and the lowest level of 9.38 mg/L was recorded on June 20. All pH levels recorded at Horseshoe Falls were above 6.0. The highest pH level was 7.57 on June 20 and

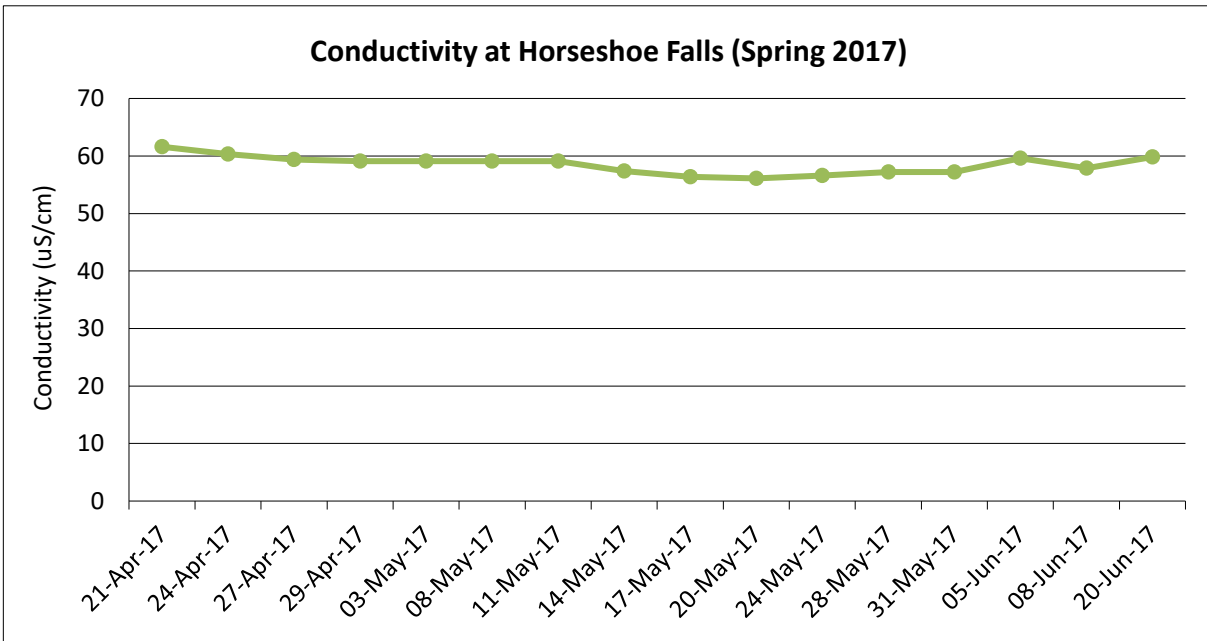
Figure 7. Conductivity measurements (uS/cm) taken at Horseshoe Falls in spring 2017

Conductivity was recorded between April 21 and June 20 at Horseshoe Falls (Figure 7). Conductivity was fairly consistent throughout the study period, fluctuating between a low of 56.1 uS/cm on May 20 and a high of 61.6 uS/cm on April 21.

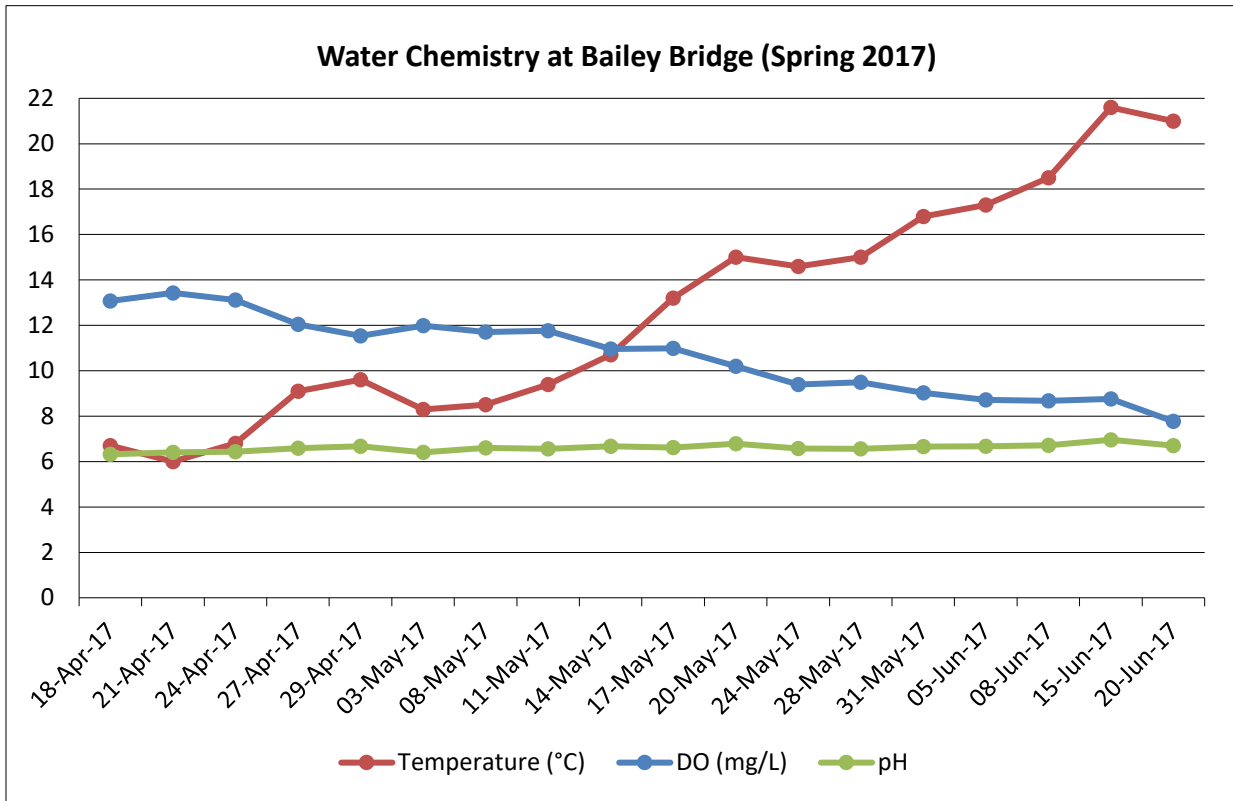
Figure 8. Water temperature (°C), dissolved oxygen (mg/L), and pH measurements taken at Bailey Bridge in spring 2017

Water temperature at Bailey Bridge increased from 6.7°C on April 18 to 21.0°C on June 20 (Figure 8). Small drops in temperature were observed several times throughout the spawning period with the largest drop recorded between April 29 (9.6°C) and May 3 (8.3°C). Dissolved oxygen levels dropped fairly consistently throughout the study period. The highest level was recorded on April 21 (13.43 mg/L) and the lowest level of 7.77 mg/L was recorded on June 20. All pH levels recorded at Bailey Bridge were above 6.0 ranging from 6.32 to 6.96. The pH readings are mildly acidic and typical for Canadian Shield watersheds.

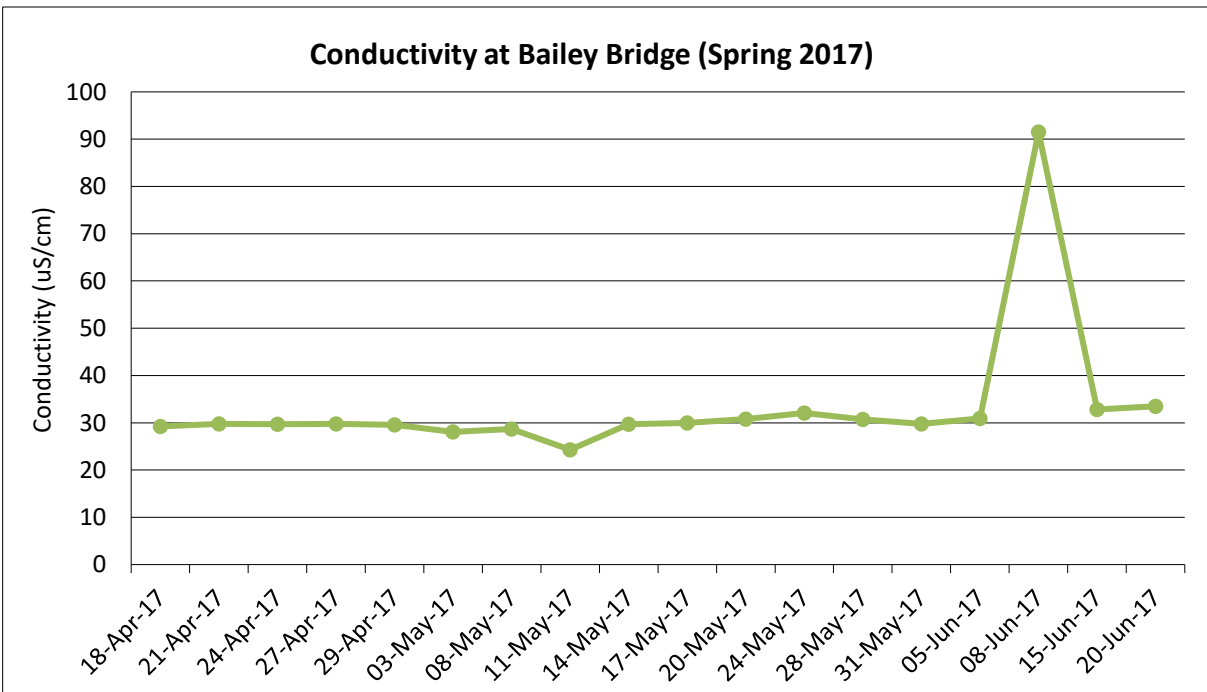
Figure 9. Conductivity measurements (uS/cm) taken at Bailey Bridge in spring 2017

Conductivity was recorded between April 18 and June 20. Conductivity held fairly steady throughout the study period with the exception of a significant spike up to 91.5 uS/cm on June 8 (Figure 9). All other conductivity measurements were below 34.0 uS/cm.

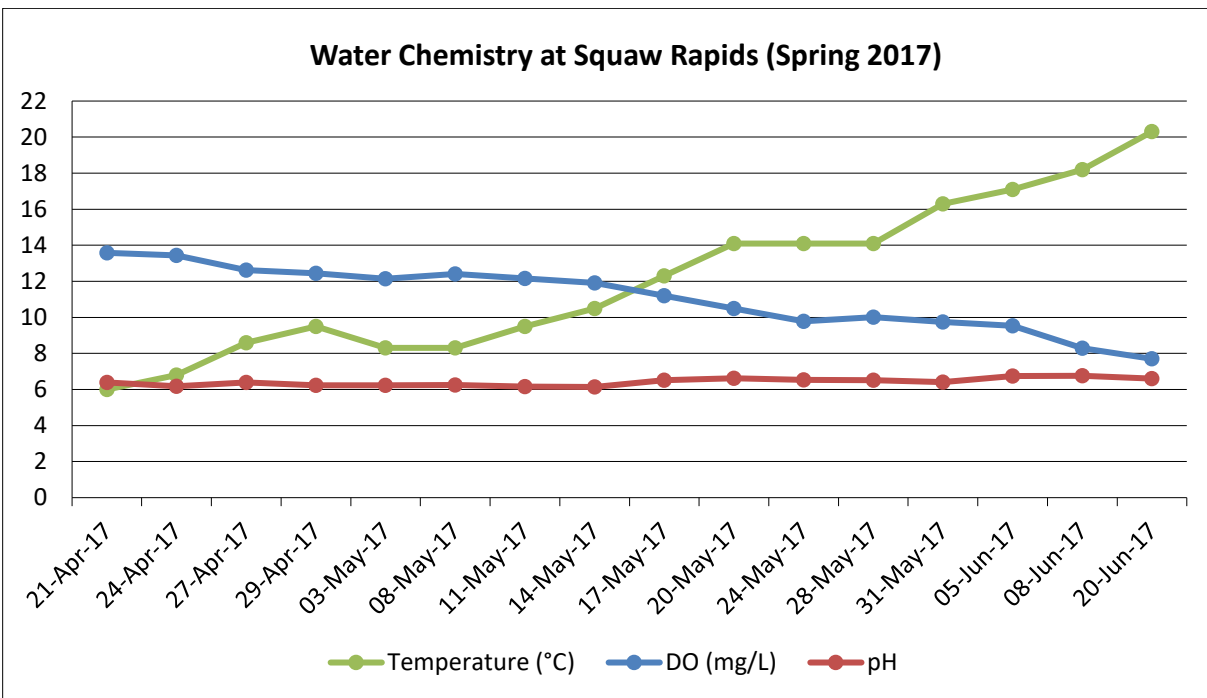
Figure 10. Water temperature (°C), dissolved oxygen (mg/L), and pH measurements taken at Squaw Rapids in spring 2017

Water temperature at Squaw Rapids increased fairly consistently from 6.0°C on April 21 to 20.3°C on June 20 (Figure 10). Similar to Trestle Gully and Horseshoe Falls, only one small drop in temperature was observed from April 29 (9.5°C) to May 3 (8.3°C). Dissolved oxygen levels dropped consistently throughout the study period. The highest level was recorded on April 21 (13.58 mg/L) and the lowest level of 7.70 mg/L was recorded on June 20. All pH levels recorded at Squaw Rapids were above 6.0. The highest pH level was 6.76 on June 8 and the lowest pH recorded was 6.14 on May 14. The pH readings are mildly acidic and typical for Canadian Shield watersheds.

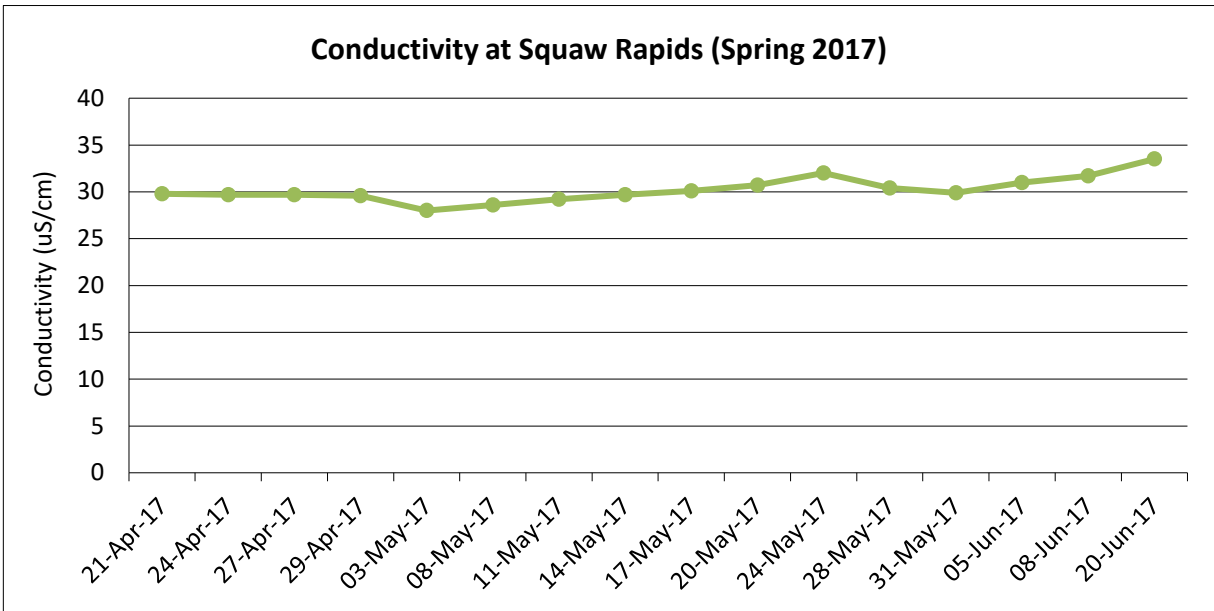
Figure 11. Conductivity measurements (uS/cm) taken at Squaw Rapids in spring 2017

Conductivity was recorded between April 21 and June 20. Conductivity was fairly consistent throughout the study period, fluctuating within a fairly narrow range of 28.0 uS/cm (May 3) to 33.5 uS/cm (June 20) (Figure 11).

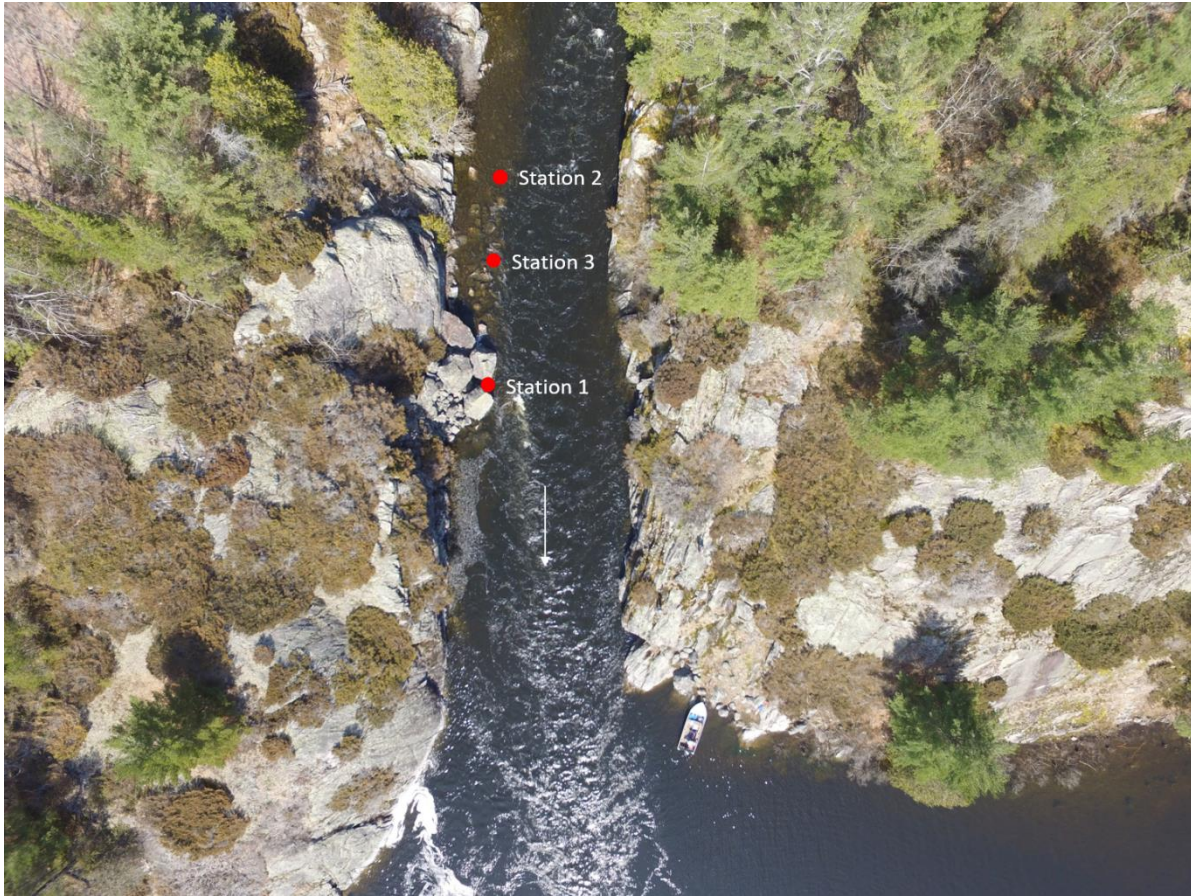
Figure 12. Water velocity (2 and 3) and depth stations (1) at Trestle Gully

Three stations were established at Trestle Gully to collect information on water velocity and water level fluctuations from April 18 to June 20 (Figure 12).

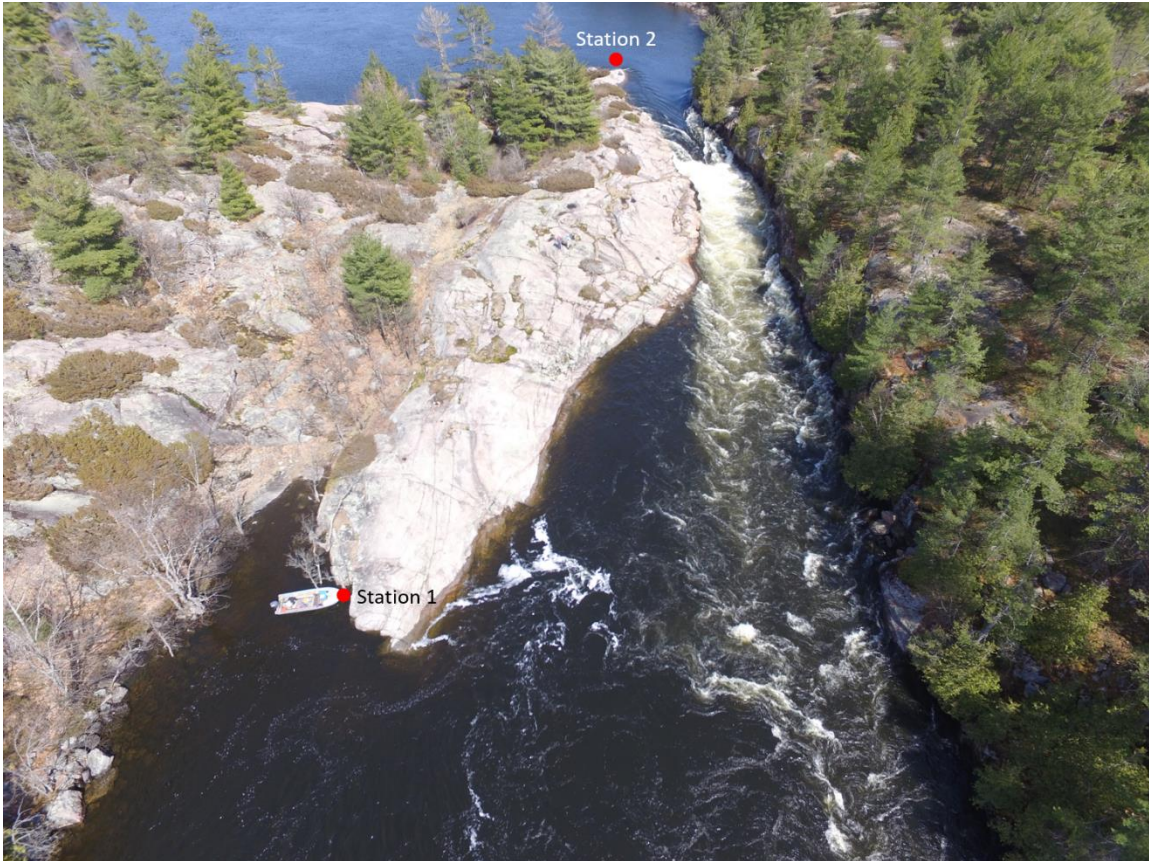
Figure 13. Water velocity (2) and depth stations (1) at Horseshoe Falls

Two stations were established at Horseshoe Falls to collect information on water velocity and water level fluctuations from April 21 to June 20 (Figure 13). Velocity measurements recorded at station 2 are displayed in Figure 14.

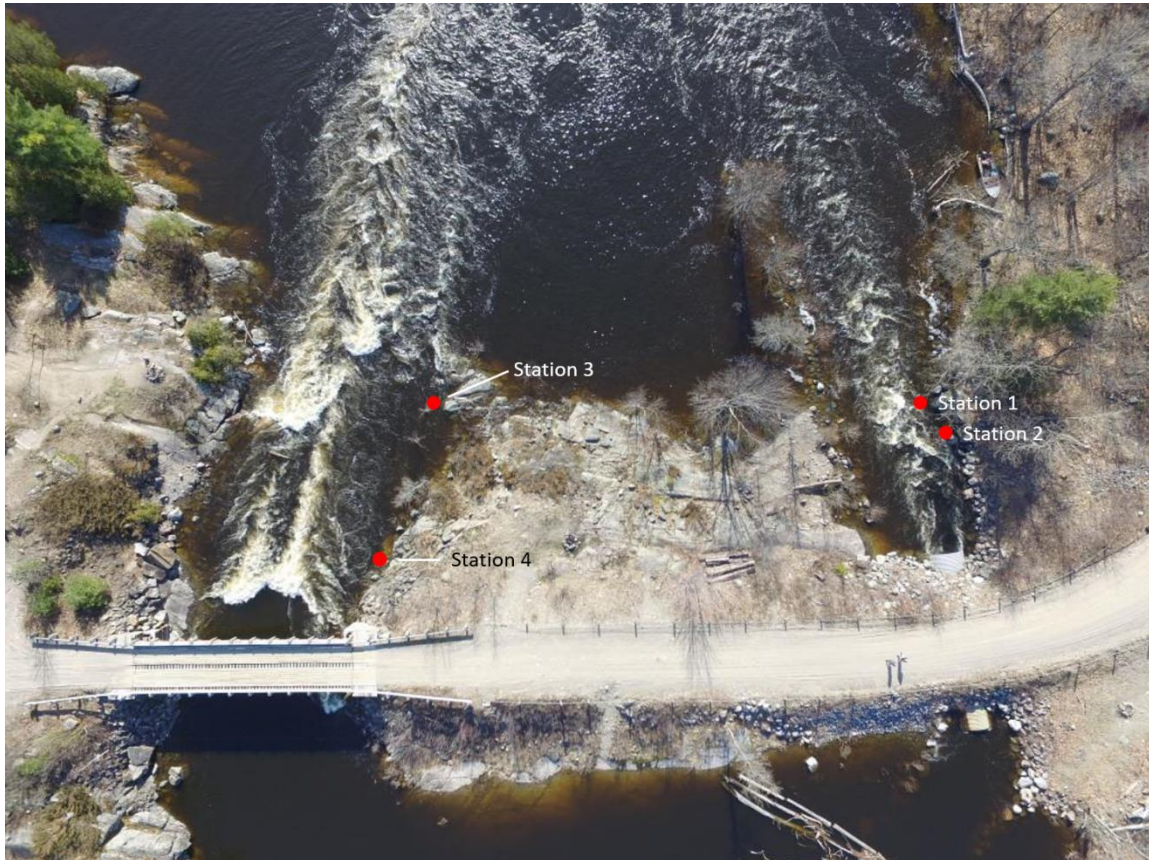
Figure 15. Water velocity (1 and 3) and depth stations (2 and 4) at Bailey Bridge

Four stations were established at Bailey Bridge to collect information on water velocity and water level fluctuations from April 18 to June 20 (Figure 15). Velocity measurements recorded at both stations are displayed in Figure 16.

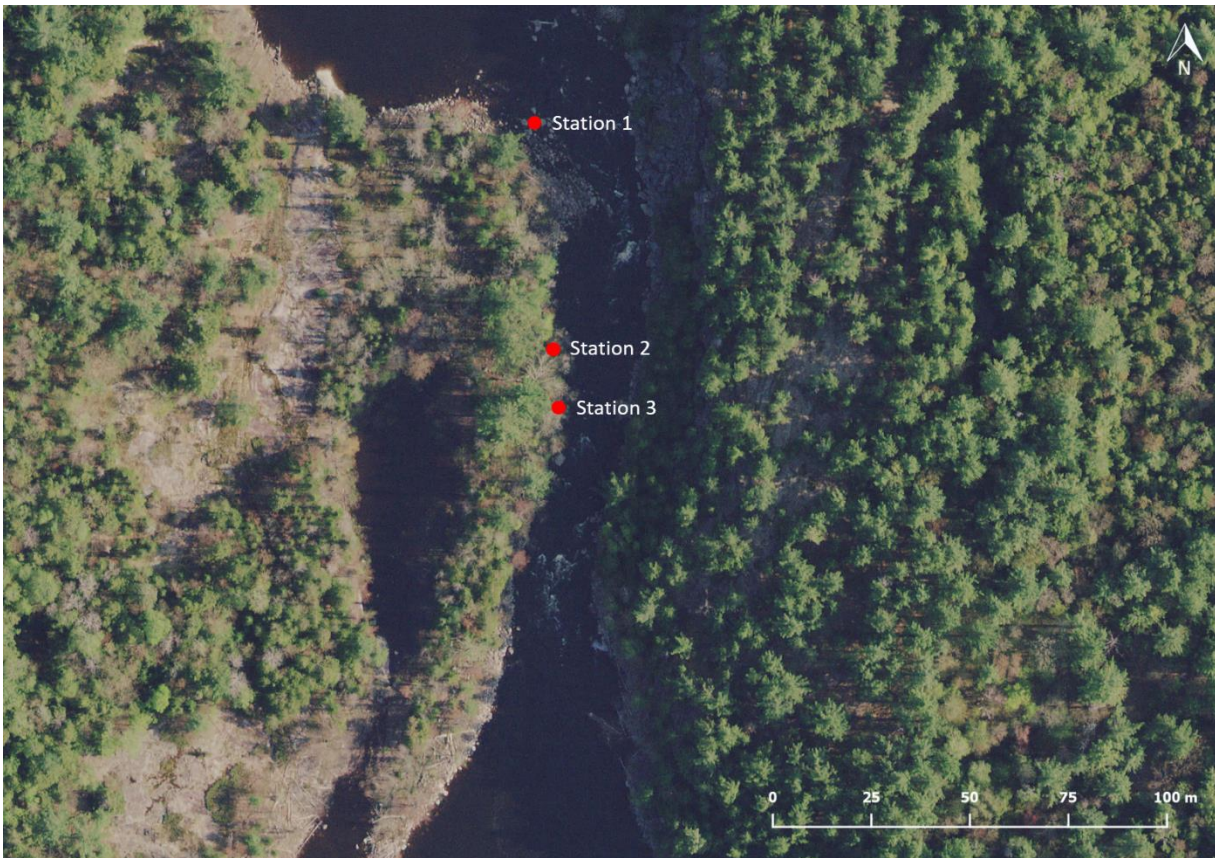
Figure 17. Water velocity (1 and 3) and depth stations (2) at Squaw Rapids. Stations 1a and 1b were located further instream of station 1 as water levels diminished. Stations 3a-3c were located further instream of station 3 as water levels diminished.

Three stations were established at Squaw Rapids to collect information on water velocity and water level fluctuations from April 21 to June 20 (Figure 17). Velocity measurements recorded at all stations are displayed in Figure 18.

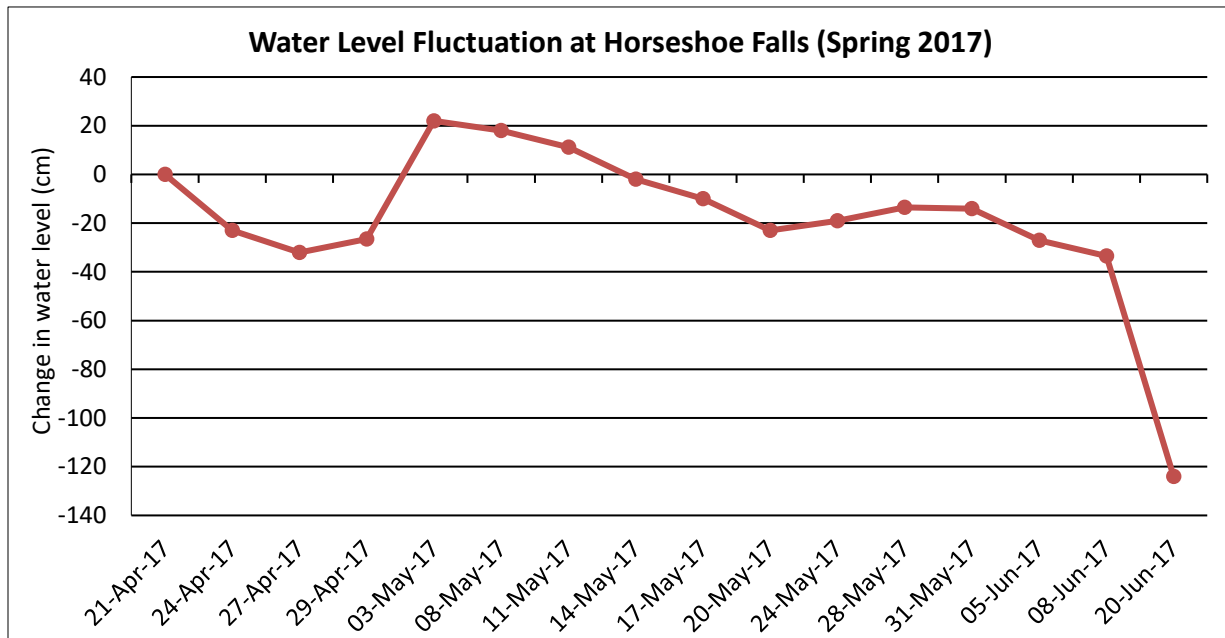
Figure 20. Water level fluctuations at Horseshoe Falls. Measurements on the first site visit served as the benchmark against which future measurements were compared (i.e., water level up or down compared to the first site visit).

At Horseshoe Falls, water level decreased after the first site visit, rose from April 29 to May 3, and then decreased again for the most part until June 20. Figure 20 illustrates the changes in water level from April 21 to June 20.

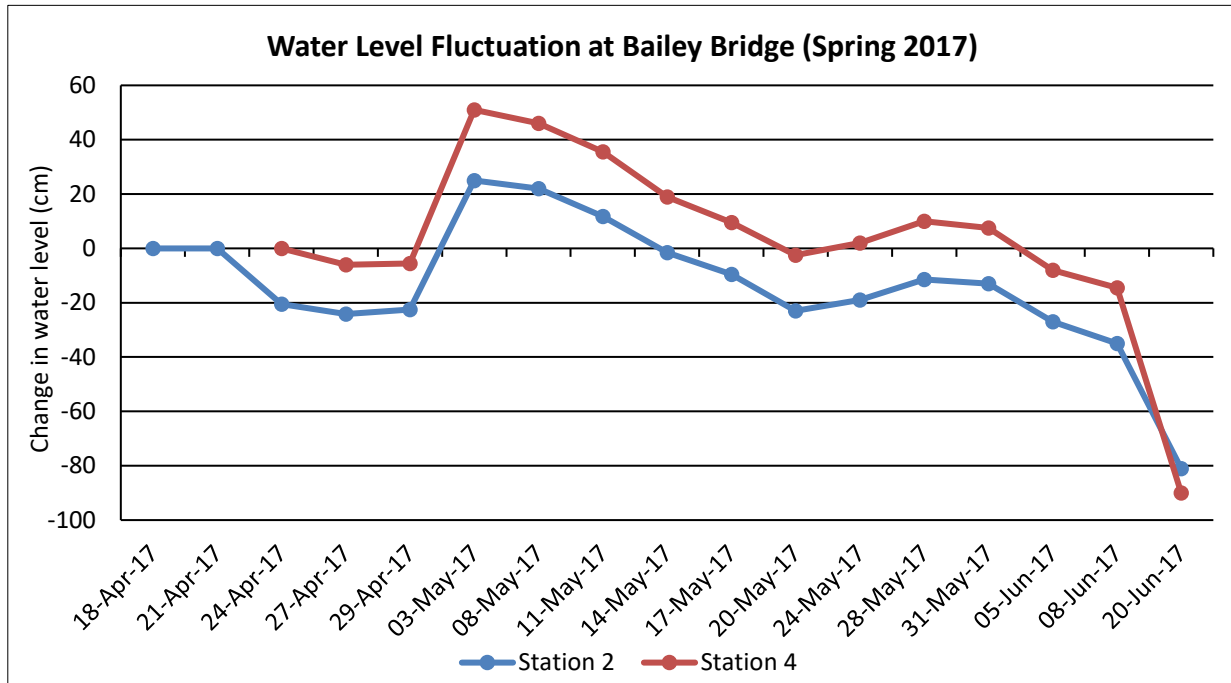
Figure 21. Water level fluctuations at Bailey Bridge measured at stations 2 and 4. Measurements on the first site visit served as the benchmark against which future measurements were compared (i.e., water level up or down compared to the first site visit).

Stations 2 and 4 at Bailey Bridge followed a similar pattern of water level fluctuation. Additionally, this pattern was very similar to that of Horseshoe Falls. Figure 21 illustrates the changes in water level from April 18 to June 20 (measurements began at station 4 on April 24).

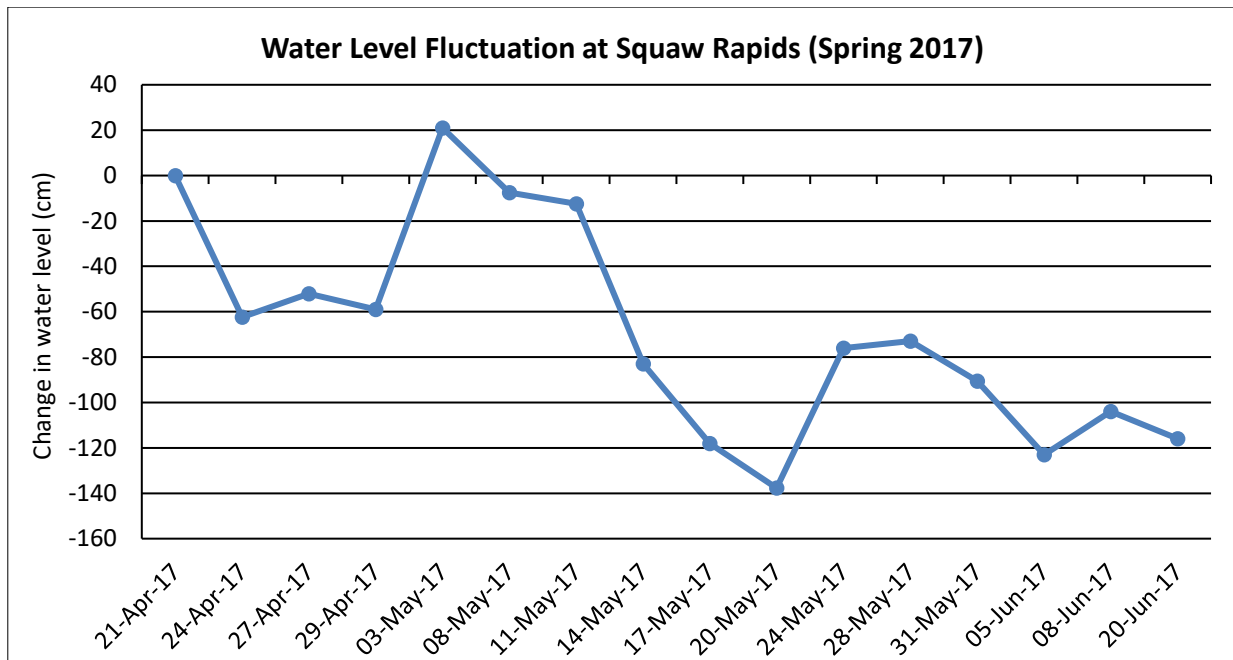
Figure 22. Water level fluctuations at Squaw Rapids. Measurements on the first site visit served as the benchmark against which future measurements were compared (i.e., water level up or down compared to the first site visit).

Water level at Squaw Rapids fluctuated greatly over the spawning and egg incubation periods. This was apparent based on the need to relocate water velocity stations on several occasions. Figure 22 illustrates the changes in water level from April 21 to June 20.

All of the spawning beds experienced considerable water level fluctuations throughout the spawning and egg incubation periods. Fluctuations appeared to be most dramatic at Squaw Rapids and Bailey Bridge with egg mats found out of water or partially out of water on more than one occasion. Bailey Bridge and Squaw rapids are fed by the Pickerel River with a dam upstream of Squaw Rapids at the outlet of Dollars Lake. Trestle Gully and Horseshoe Falls are fed by the French River. Water fluctuations did not appear to impact the spawning beds at Trestle Gully or Horseshoe Falls. Despite more pronounced fluctuations at Bailey Bridge and Squaw Rapids, no eggs were observed stranded.

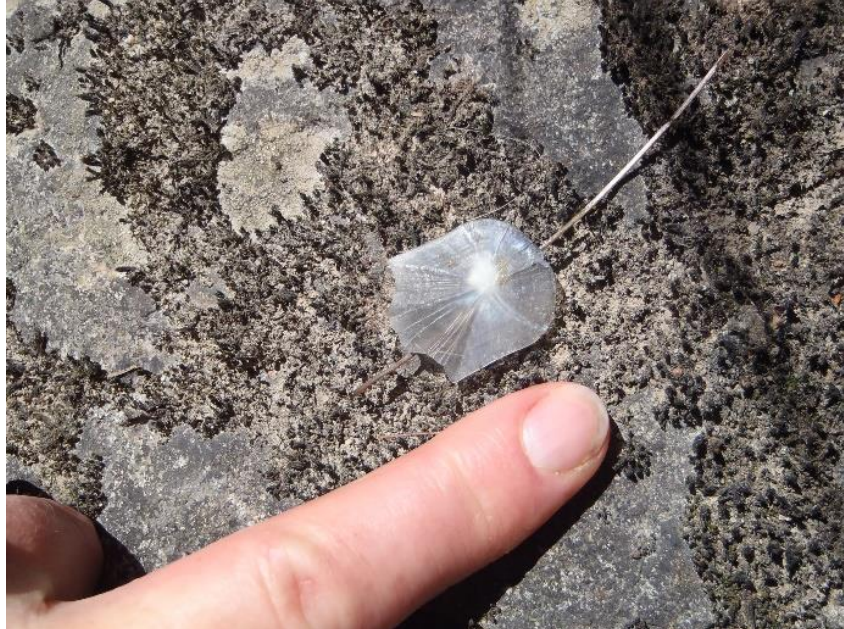
No fish were observed during regular daytime site visits at Trestle Gully, Horseshoe Falls, or Bailey Bridge. At Squaw Rapids, Redhorse Sucker scales were seen on the left bank amongst the boulders on May 24 (Figure 23). Also at Squaw Rapids, a dead Walleye was found at the upstream end of the rapids on the left bank. No night surveys were conducted on the Pickerel River in 2017.

Figure 23. Redhorse Sucker scales found at Squaw Rapids on May 24, 2017

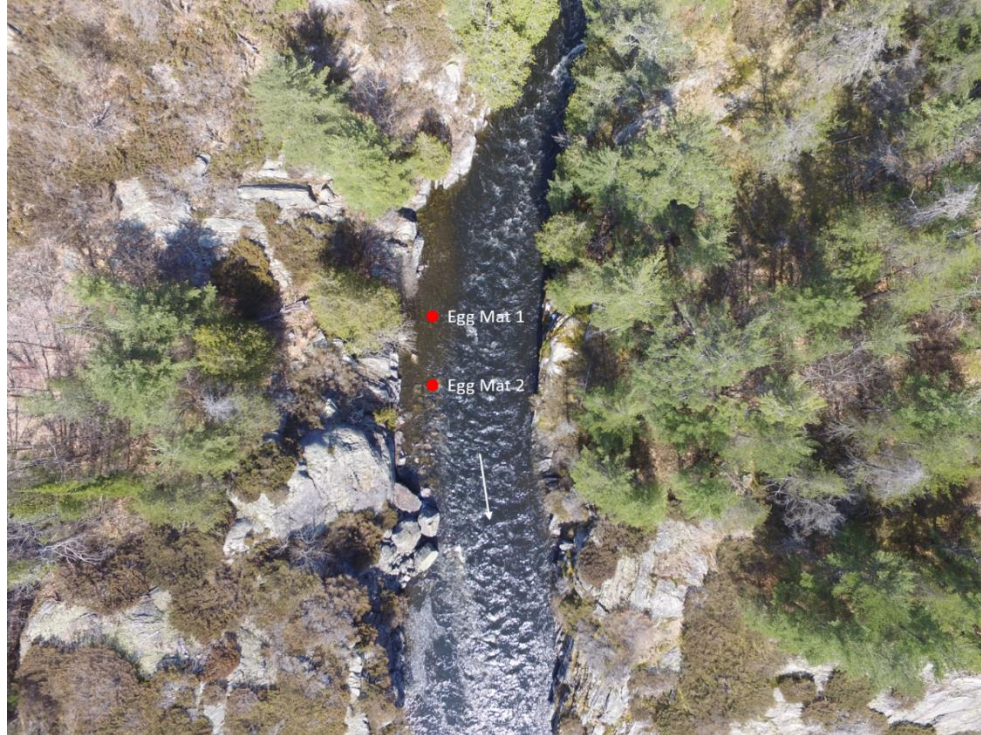
Figure 24. Location of egg mats installed at Trestle Gully in 2017

The egg mats were installed on April 27 and reset on April 29. After being reset on April 29, the egg mats were not safely accessible again until June 20 (see [Appendix C](#) for more detail). Egg deposition on the mats was very low. A total of eighty-six (86) Walleye eggs were counted (sixty-six (66) on egg mat 1, twenty (20) on egg mat 2) and no Sucker eggs were observed.

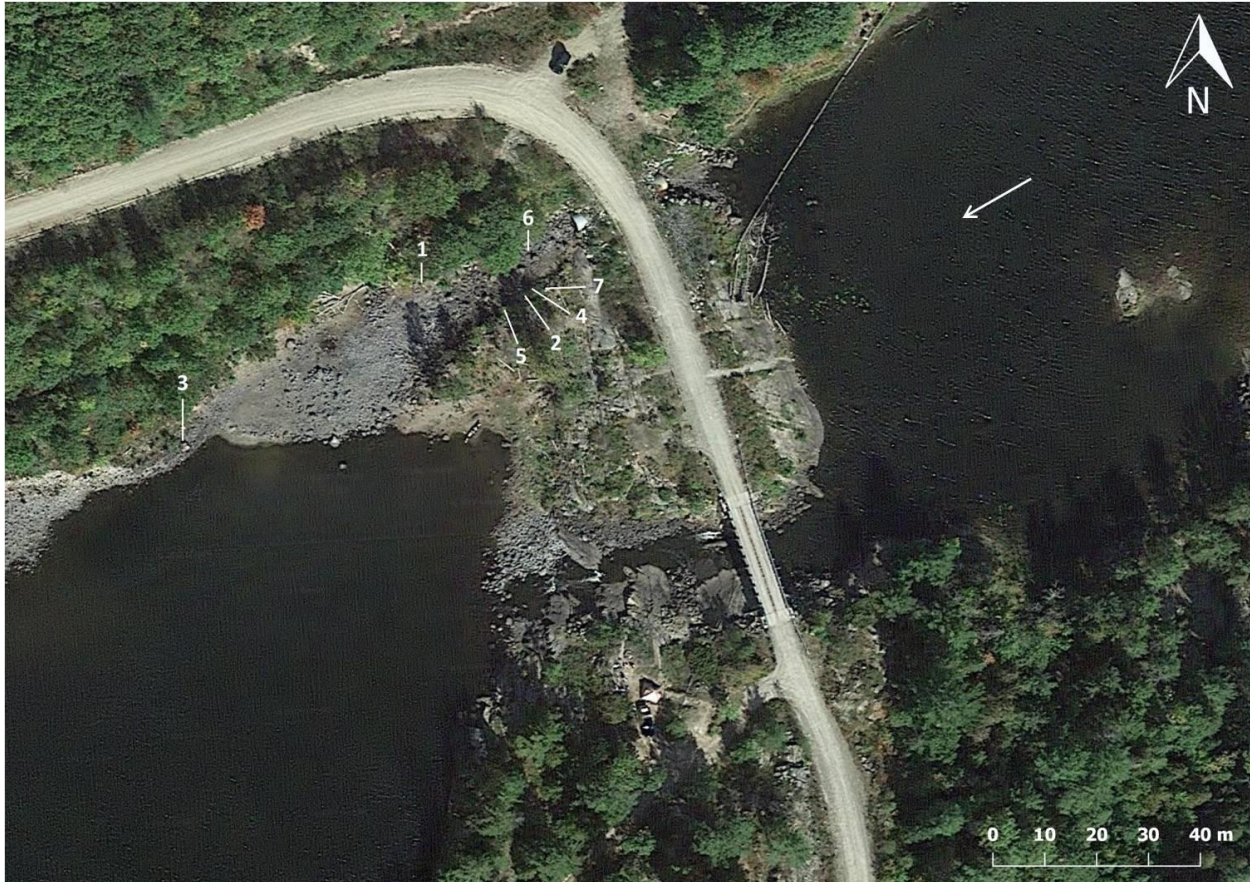
Figure 25. Location of egg mats installed at Bailey Bridge in 2017

Seven egg mats were set at Bailey Bridge at different times throughout the study period to help assess the amount, type, and location of egg deposition (Figure 25). Egg mats were only placed on a small, accessible portion of the spawning bed, and therefore, only represent a small portion of the entire spawning area. Based on size, eggs could be differentiated between Walleye and Sucker species, but it was not possible to identify the Sucker eggs to species level. Had Lake Sturgeon eggs been deposited, they would have also been distinguishable by size and colour.

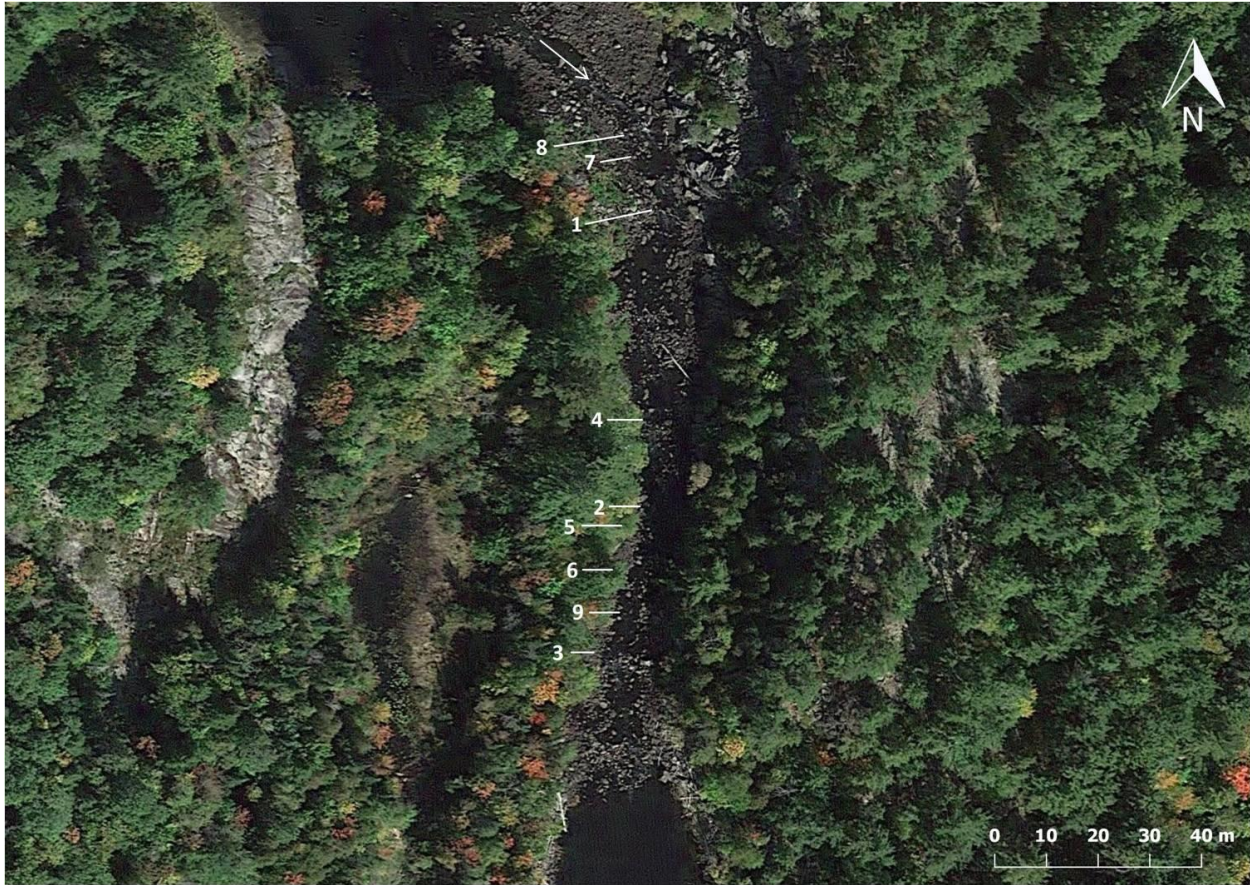
Figure 26. Location of egg mats installed at Squaw Rapids in 2017

Nine egg mats were set at Squaw Rapids at different times throughout the study period to help assess the amount, type, and location of egg deposition (Figure 26). Egg mats were only placed on a small, accessible portion of the spawning bed, and therefore, only represent a small portion of the entire spawning area. Based on size, eggs could be differentiated between Walleye and Sucker species, but it was not possible to identify the Sucker eggs to species level. Had Lake Sturgeon eggs been deposited, they would have also been distinguishable by size and colour.

The egg mats were installed at various times throughout the study period. Egg deposition on the mats was higher than at Trestle Gully, but much lower than at Bailey Bridge. From April 21 to June 20, a total of 667 Walleye eggs were counted. No Sucker eggs were seen on any of the egg mats. Egg mat 1 had the greatest total number of Walleye eggs (379). In addition to eggs counted on the egg mats, a small number of Walleye eggs were observed in the substrate on the left bank on May 20.

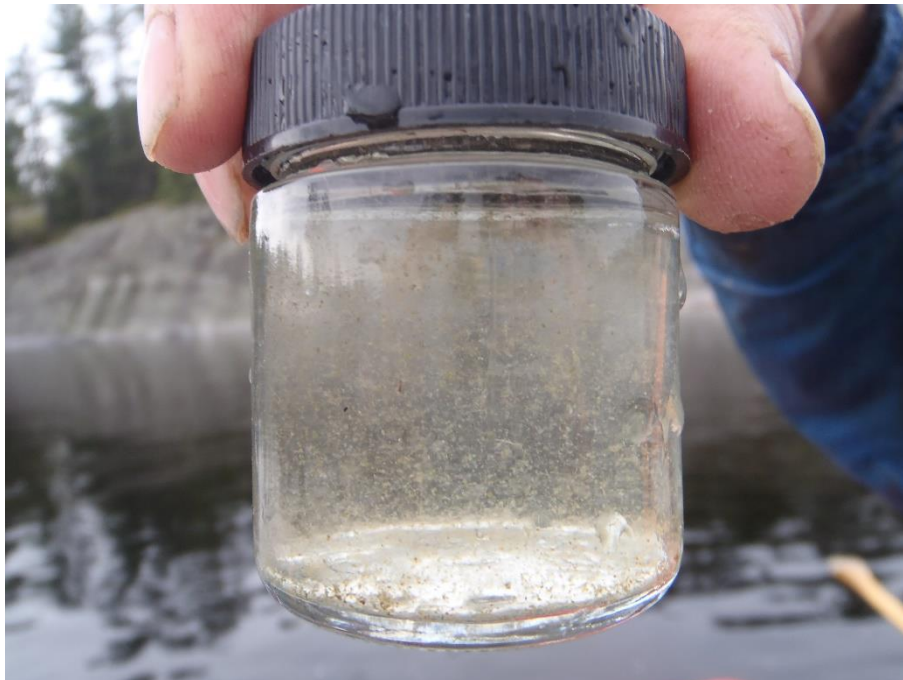
Three samples were taken downstream of Trestle Gully on May 24 and June 8. Each time, the three samples were combined to create one composite sample (Figures 27 and 28). Based on the composite samples, the waters downstream of Trestle Gully can be described as having good plankton production. In fact, downstream of Trestle Gully appeared to have the best plankton production of the four areas sampled on the Pickerel River.

Figure 27. Trestle Gully composite plankton sample (May 24, 2017)

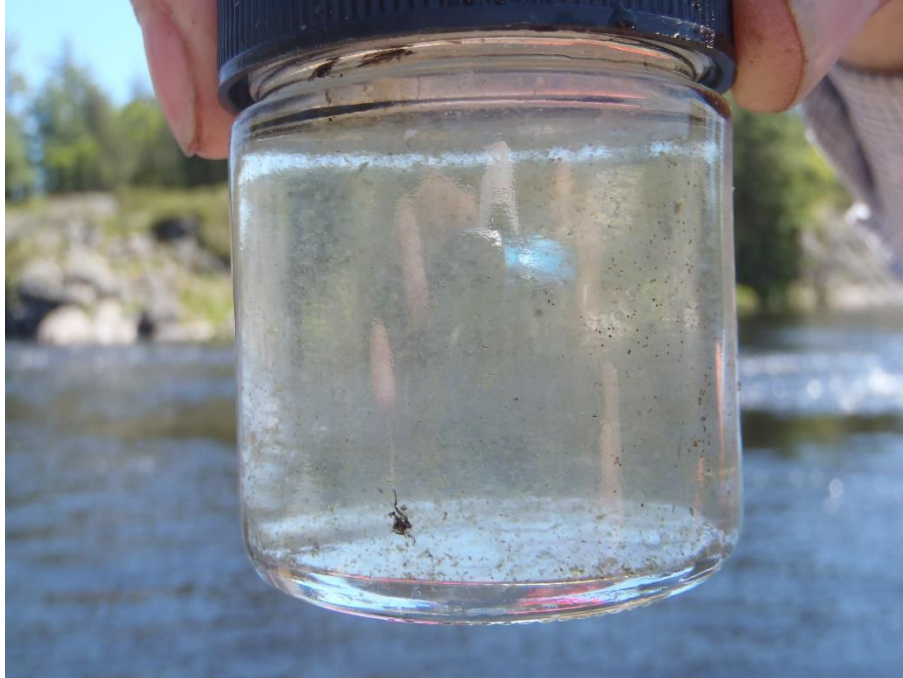
Figure 28. Trestle Gully composite plankton sample (June 8, 2017)

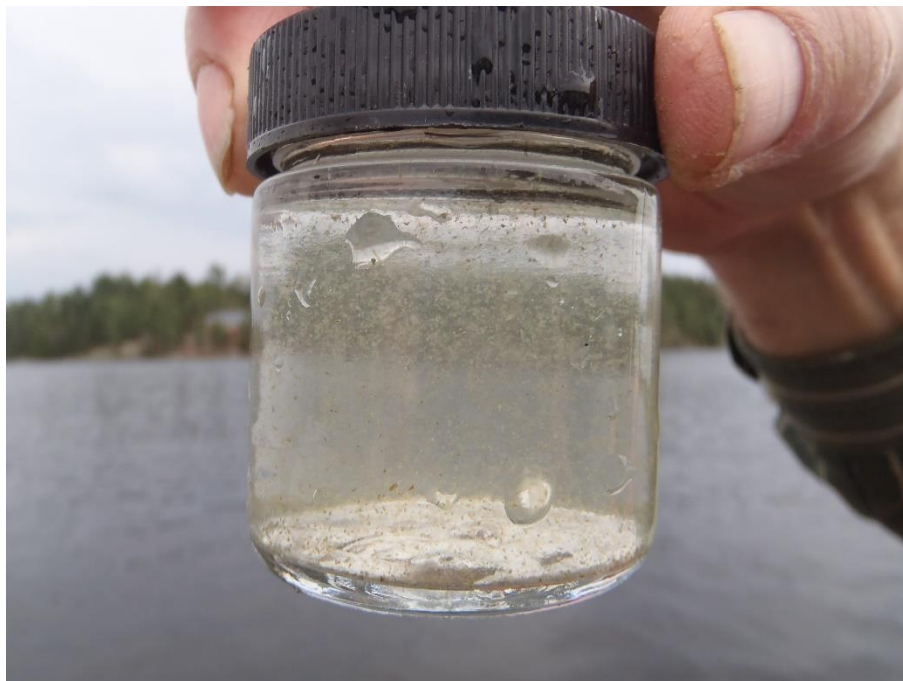
As with Trestle Gully, three samples were taken downstream of Horseshoe Falls on May 24 and June 8. Each time, the three samples were combined to create one composite sample (Figures 29 and 30). The waters downstream of Horseshoe Falls can be described as having good plankton production.

Figure 29. Horseshoe Falls composite plankton sample (May 24, 2017)

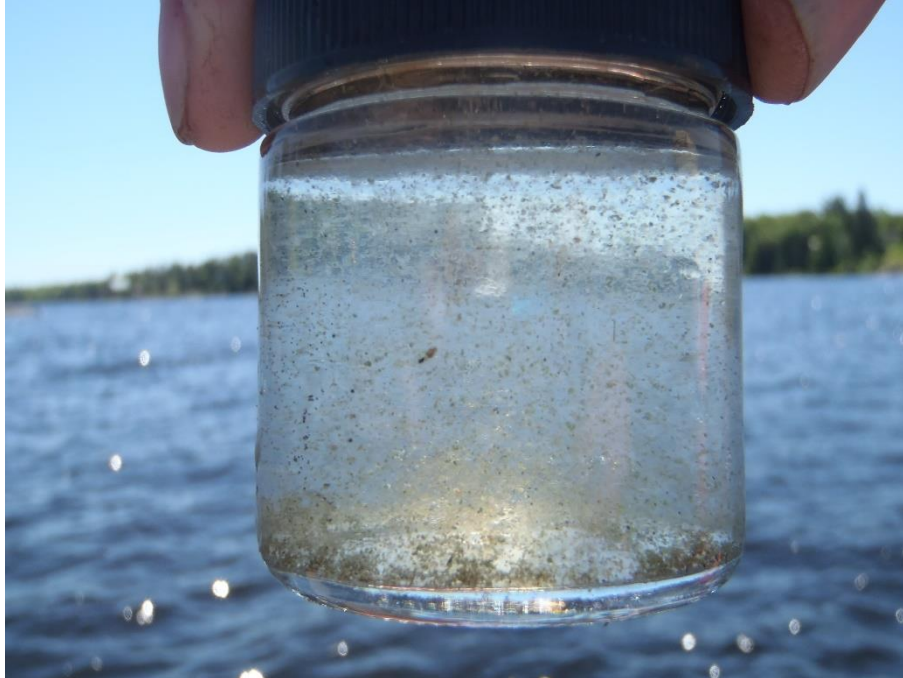
Figure 30. Horseshoe Falls composite plankton sample (June 8, 2017)
