Pickerel River Fish Habitat Assessment

Executive Summary

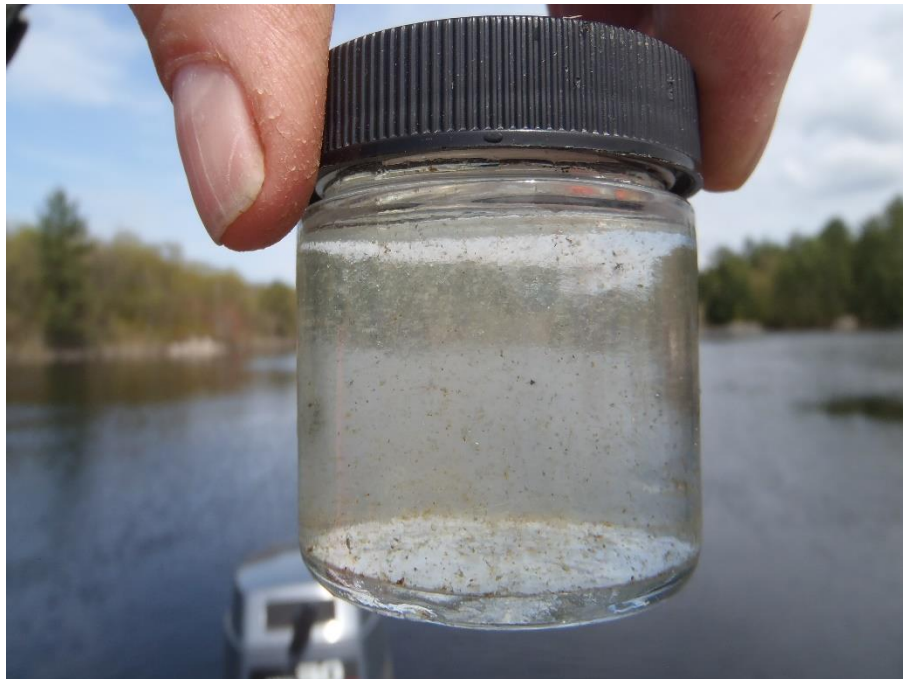
Downstream of Bailey Bridge, three plankton samples were taken on May 24 and June 8. Each time, the three samples were combined to create one composite sample (Figures 31 and 32). Based on the composite samples, the waters downstream of Bailey Bridge can be described as having good plankton production.

Figure 31. Bailey Bridge composite plankton sample (May 24, 2017)

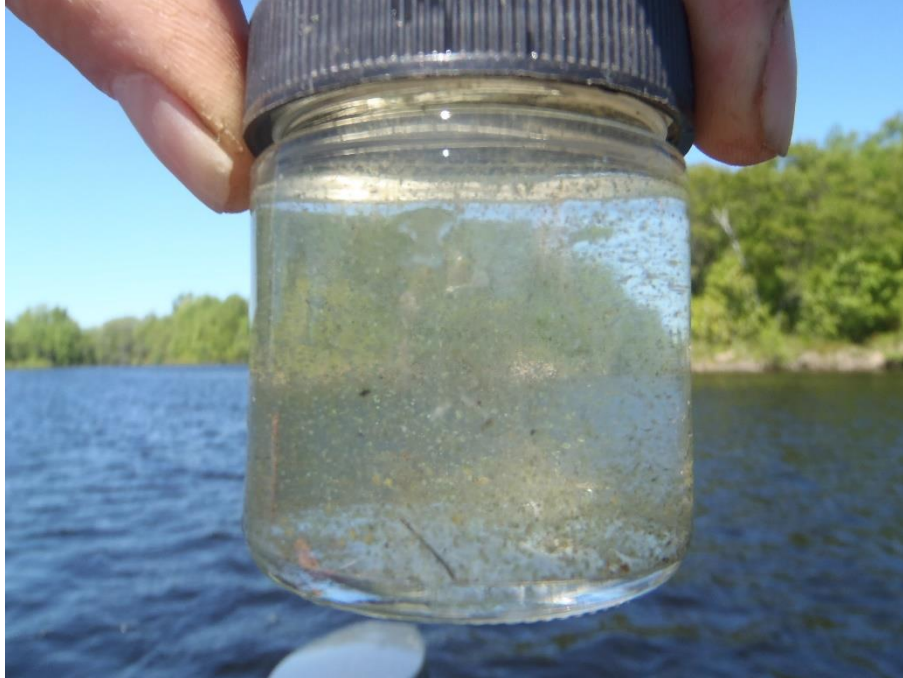
Figure 32. Bailey Bridge composite plankton sample (June 8, 2017)

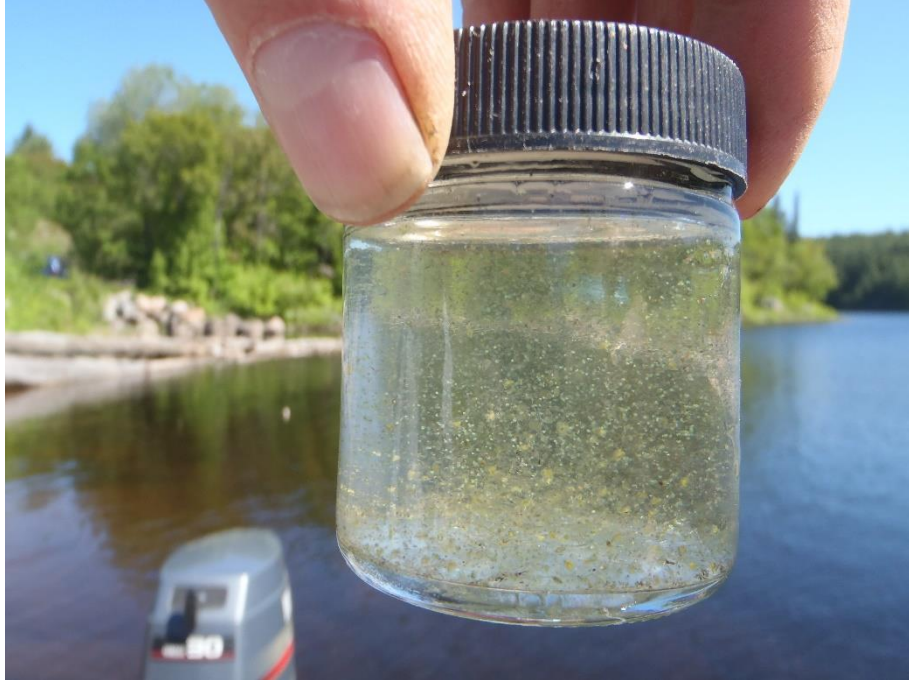
As with the other three sites, three plankton samples were taken downstream of Squaw Rapids on May 24 and June 8. A composite sample was created both times by combining the three samples into one (Figures 33 and 34). Based on the composite samples, the waters downstream of Squaw Rapids can be considered to have good plankton production.

Figure 34. Squaw Rapids composite plankton sample (June 8, 2017)

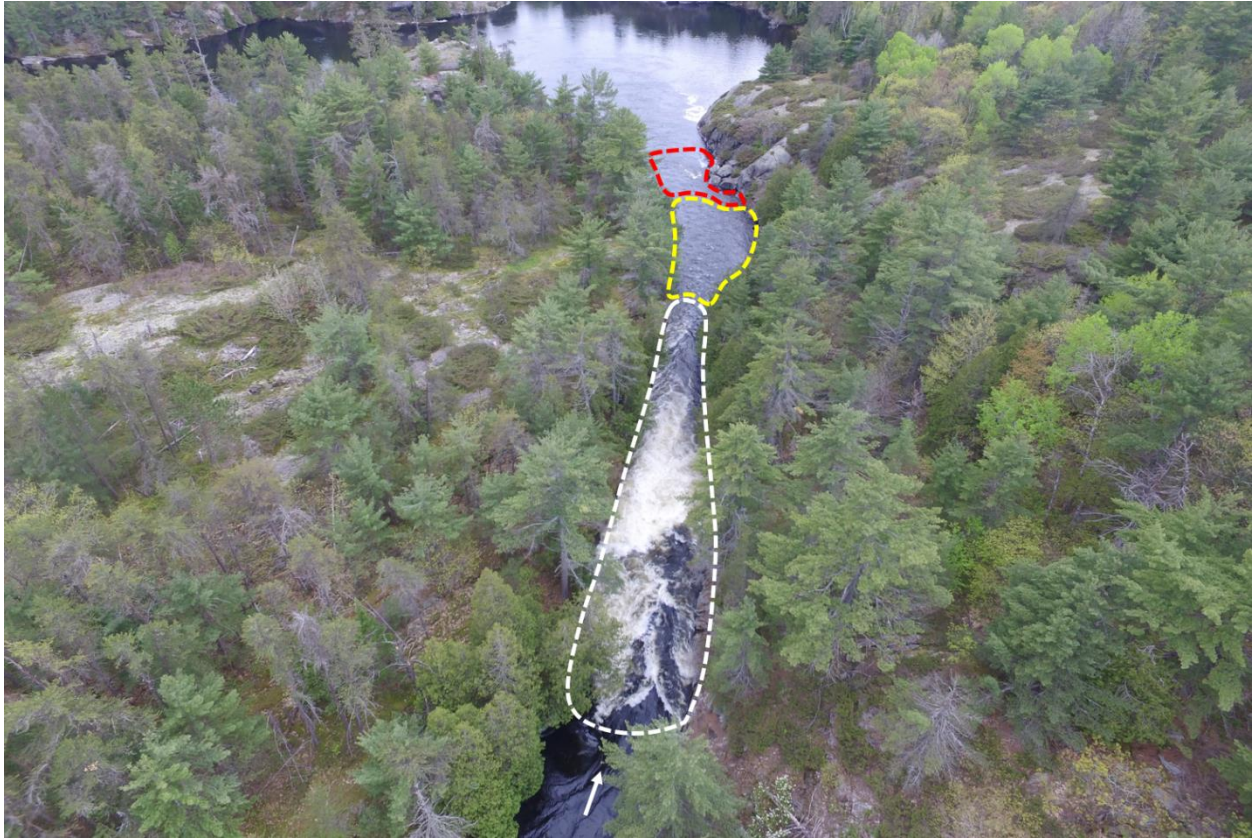
Figure 35. Spawning bed at Trestle Gully. Dashed white line indicates area of primarily bedrock and large boulder substrate. Dashed yellow line shows an area of primarily cobble and small boulders. Red dashed line highlights an area of primarily small and large boulders.

As water levels diminished over the summer and into the fall, more substrate at Trestle Gully became visible. Figure 35 outlines the substrate observed in three sections of Trestle Gully. The most upstream area, the main section of rapids, is predominantly made up of bedrock and large boulders (dashed white line). Below the main section of rapids, the yellow dashed line delineates an area with cobble and small boulders as the dominant substrate. Finally, the area outlined by the red dashed line has small and large boulders as the predominant substrate. Figure 36 exemplifies this transition from mainly cobble and small boulders to small and large boulders as the dominant substrate. Limited substrate suitable for Sucker was observed at Trestle Gully.

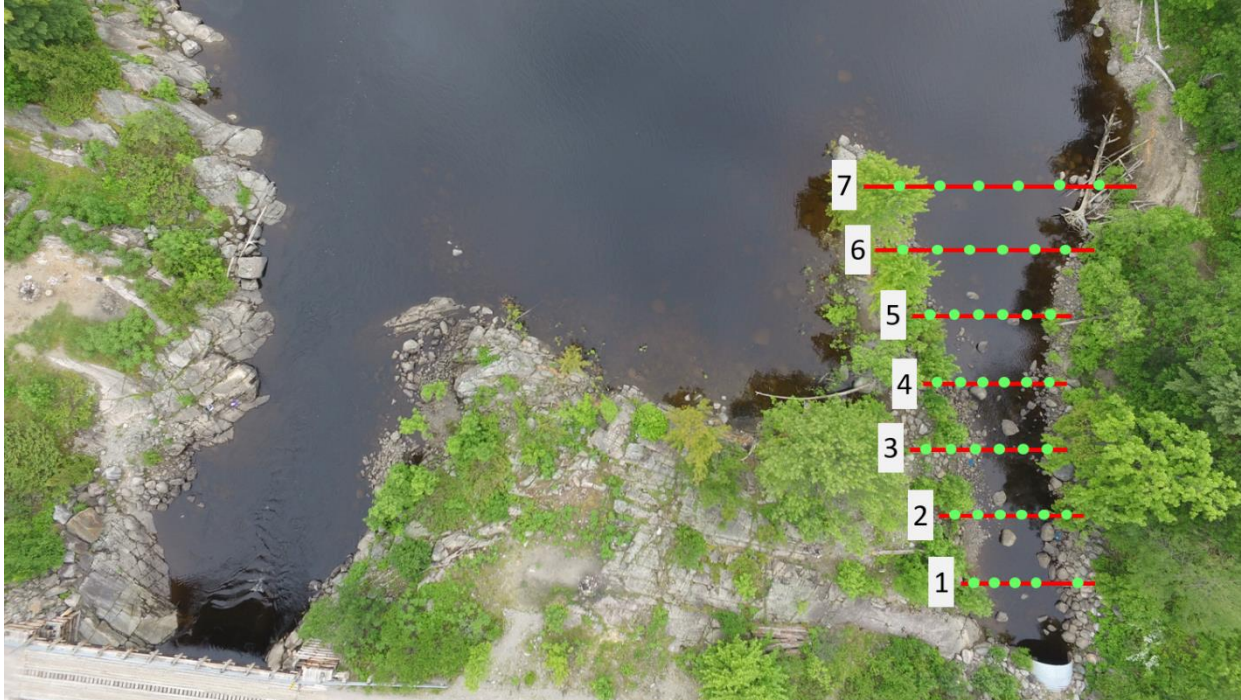
Figure 37. Spawning bed measurement transects at Bailey Bridge. Green dots indicate points with ideal depth and at least some ideal substrate for Walleye, Lake Sturgeon, and/or Sucker spawning.

This evaluation was based on identifying ideal spawning habitat only. It does not indicate the actual amount of spawning, as fish will spawn in areas without ideal substrate. In addition, the ideal habitat has only been measured at certain points along the transect lines, and therefore does not represent the entire spawning bed. The measurements are a sample of the spawning bed and serve as an indicator of potential site limitations. Complete transect data is provided in [Appendix D](#).

In the fall of 2017, transects were measured across the Bailey Bridge spawning bed with the intent of identifying areas “ideal” for spawning for Walleye, Lake Sturgeon, and Sucker species. EGBSC used some of the methods from the Ontario Stream Assessment Protocol (developed by MNRF) to complete the transects. Along each transect, six points were measured for depth and substrate type, based on the width (taken at bankfull) of each transect. In addition to depth and substrate, any aquatic vegetation was noted at each point, and shoreline vegetation was recorded at each transect. Depth was recorded with a metre stick and substrate was estimated with the aid of a grid marked at 10 cm increments. Transects were completed later in the season, when it was safe to wade across the spawning bed; because of this, only depth and substrate information was collected. Any velocity data collected would not have been the same as during the spawning season. Therefore, the analysis of ideal spawning habitat is based on depth and substrate only.

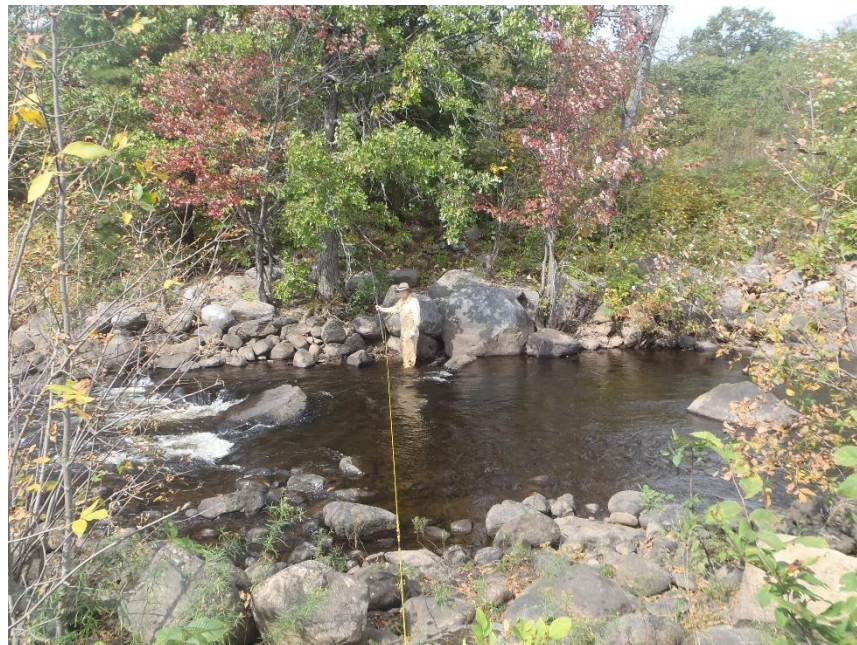
EGBSC completed seven transects across the spawning bed, spaced roughly 6 m apart (Figures 37 and 38). In total, across the seven transects, forty-two (42) points were measured for depth and substrate. For Walleye, 90% of the points met the optimal depth and 93% of the points had at least some of the optimal substrate type. Overall, 88% of the points measured (37 of the 42) had both the ideal depth and the ideal substrate size. For Lake Sturgeon, 100% of the points measured fell into the optimal depth range, and 95% of the points had at least some substrate in the optimal substrate range. Overall, 95% of the points measured met both depth and optimal substrate for Lake Sturgeon. For White Sucker, EGBSC was unable to find the ideal depth for spawning in any of the literature searched. As a result, habitat for White Sucker was only based on ideal substrate type and size. Very few of the points measured at Bailey Bridge were ideal for White Sucker. Only 19% of the points measured had the ideal substrate (8 of the 42 points). White Sucker substrate was found at three points on transects 1 and 2, and one point on transects 3 and 4.

Figure 38. Measuring bankfull width and depths along transect 3

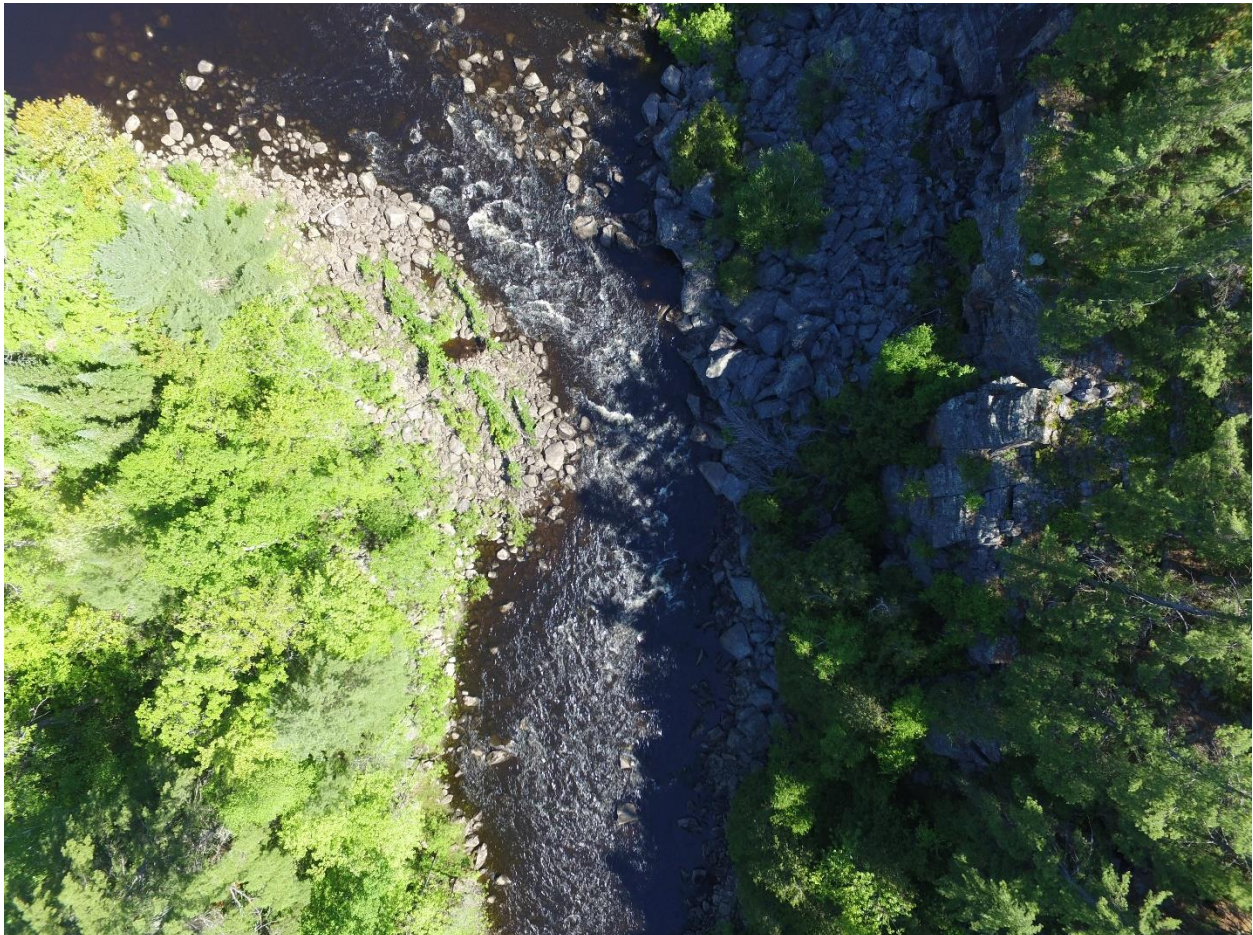
Figure 39. Example of large and small boulders dominating the substrate at the upper end of Squaw Rapids

As water levels diminished over the summer and into the fall, more substrate at Squaw Rapids became visible. Substrate visible from the left bank was recorded. Overall, large boulders were the dominant substrate at Squaw Rapids with cobble and small boulders being the next dominant substrate types. Large and small boulders make up the overwhelming majority of the substrate at the upper end of the rapids (Figures 39 and 40). More cobble and a small amount of gravel appears further down the rapids; however, small and large boulders are still present in these areas as well. Limited substrate suitable for Sucker was observed at Squaw Rapids.

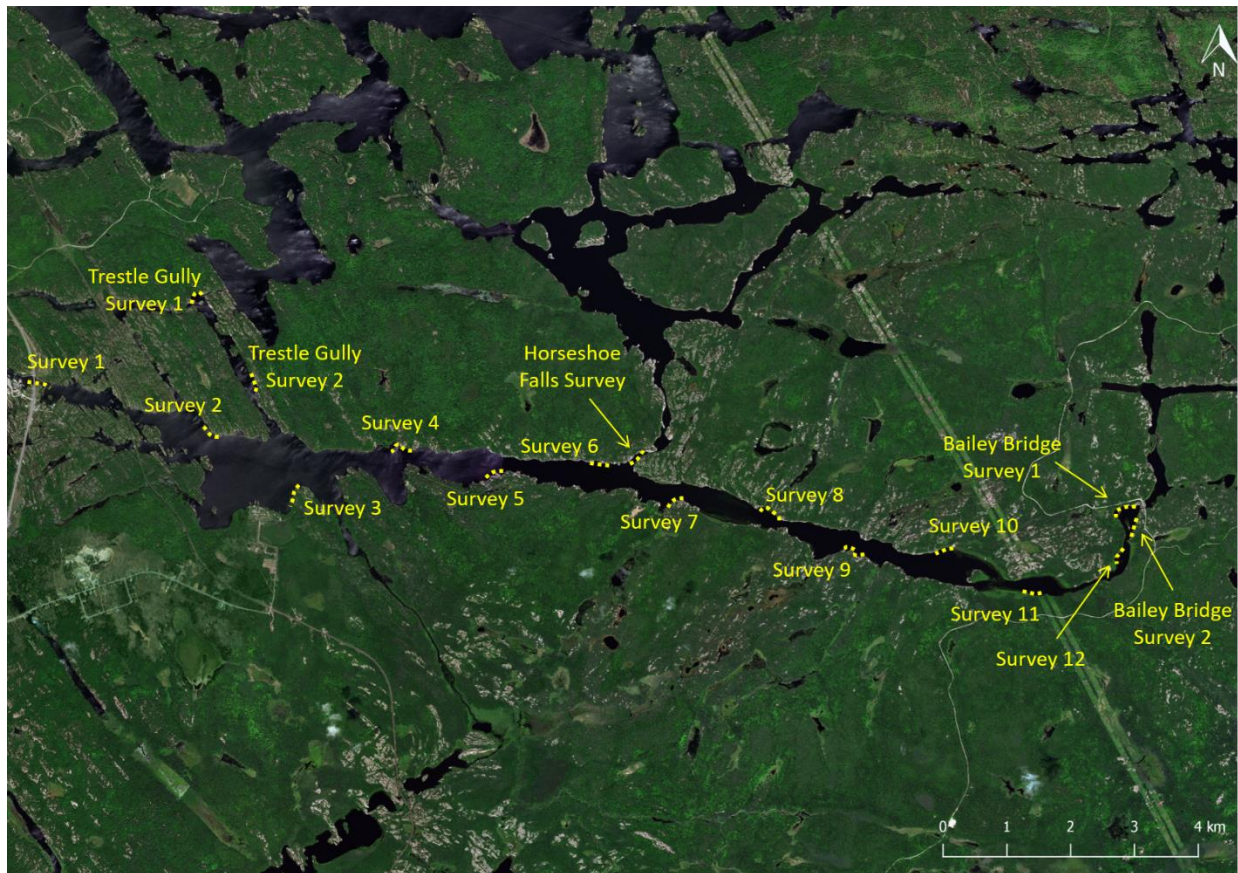
Figure 41. Underwater survey locations downstream of Bailey Bridge, Horseshoe Falls, and Trestle Gully

Underwater videos were taken by snorkelling for 100 m approximately every 1 km, using a GoPro camera. In total, EGBSC carried out seventeen (17) underwater surveys between Bailey Bridge and Highway 69. Each survey location has been identified in Figure 41. Bathymetry maps are presented in [Appendix E](#).

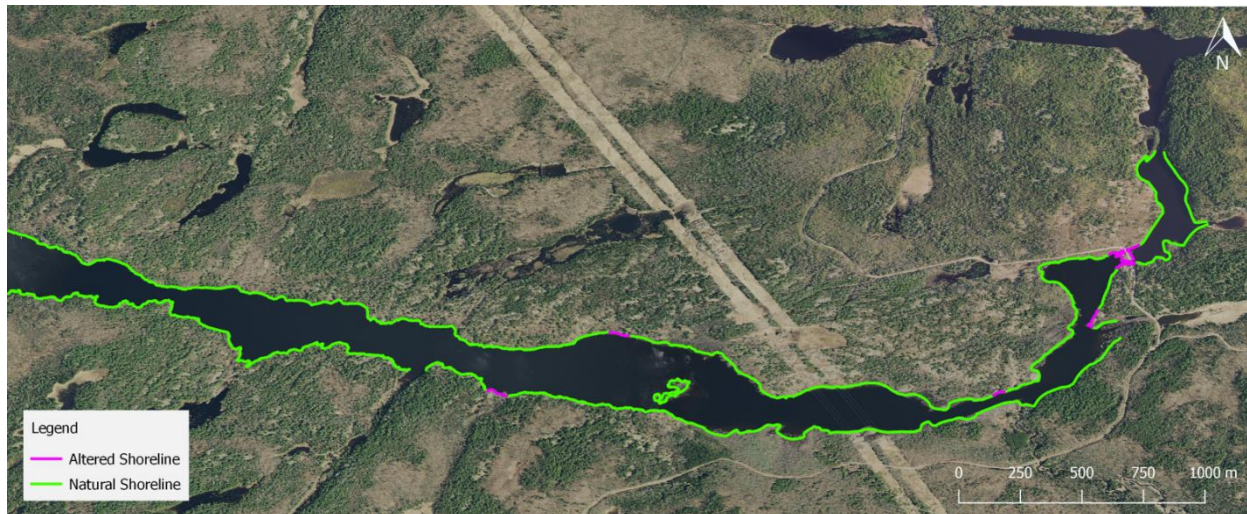
Figure 42. Natural and altered shoreline downstream of Squaw Rapids and Bailey Bridge

Along each of the underwater surveys, shoreline characteristics were also recorded and photographed. The Pickerel River, downstream of Squaw Rapids to Highway 69, has a predominantly natural shoreline (86% natural, 14% altered) (Figures 42-44). Observed alterations included train and highway bridges, mown grass close to the shoreline, docks, compacted soil and disturbed vegetation at Crown land campsites, and boat launches. The natural shoreline along the surveys consisted mainly of bedrock with forest set back, low lying forest, pockets of wetland, and flooded alders. Photos of the shoreline from each survey can be found in [Appendix F](#). It is important to note that surveys did not cover the entire length of the shoreline, therefore, they do not represent all possible alterations or types of natural shoreline.

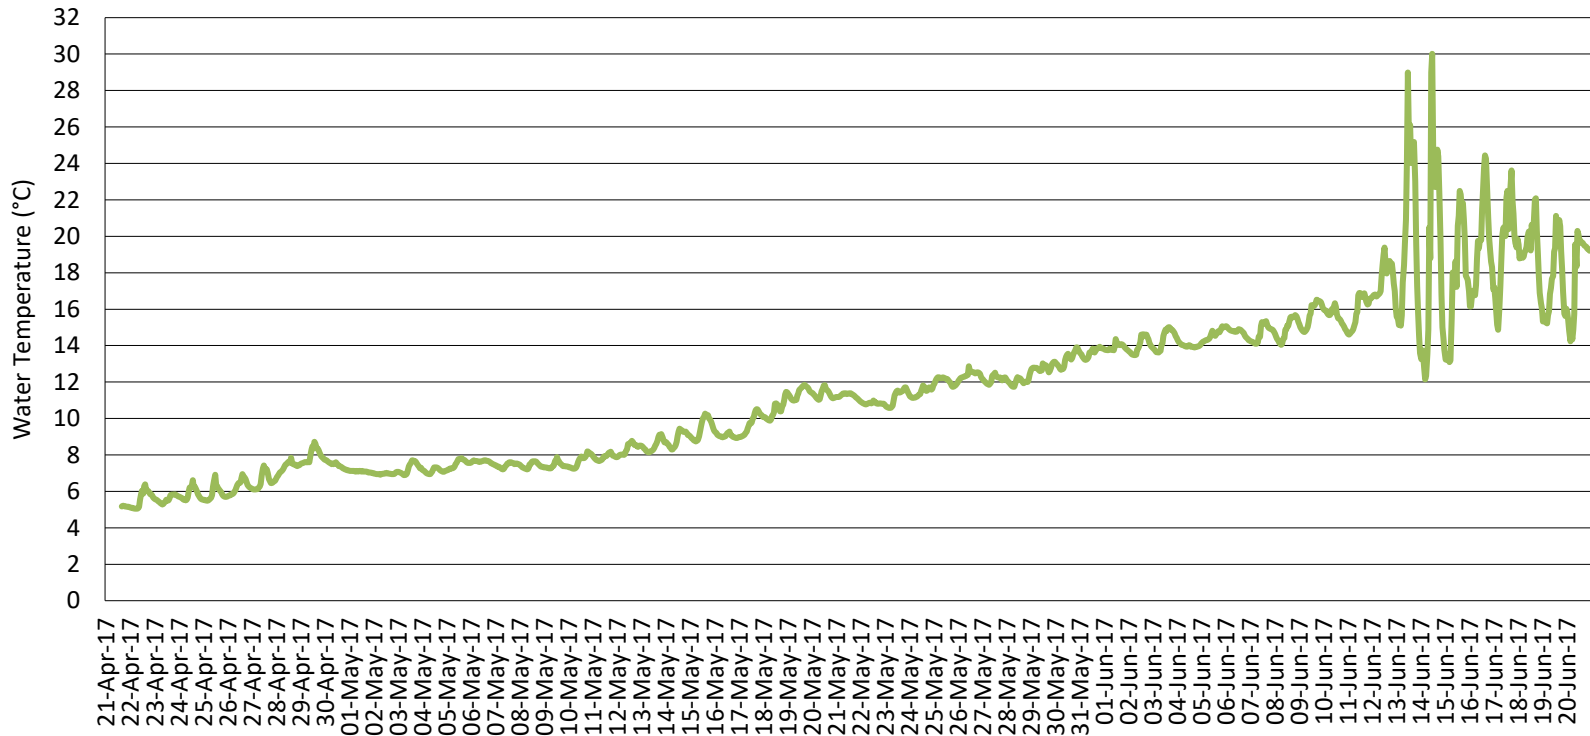
Pickrel River Hourly Temperature (°C) Taken at Horseshoe Falls From April 21, 2017 - June 20, 2017

Note: Temperature logger found out of water on June 20. The drastic temperature fluctuations that begin around June 13 may be the result of the temperature logger being out of water and recording air temperature rather than water temperature.
