# Seguin River Fish Habitat Assessment

# Executive Summary

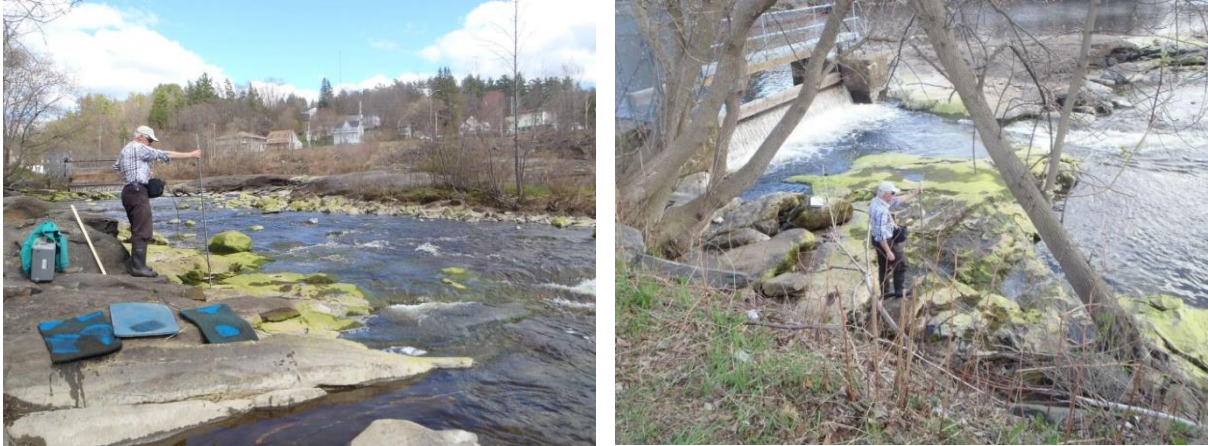
As previously stated, water velocity could not be measured consistently at two of the three original stations (1a and 3a, see Figure 9). Velocity measurements were complicated by dam manipulation on two occasions. Sometime between May 2 and May 5, the insertion of stop-logs into the north dam (immediately above the spawning bed) resulted in a water level drop of 28.5 cm. On May 13, a half log was inserted in the south dam, adjacent to the CPR trestle (D. Albrook, personal communication, 2016), thereby directing more water into the spawning bed below the north dam. A subsequent major rainfall event on May 14 caused water levels to increase further. As a result, it was difficult to track changes in water velocity between April 23 and June 8; however, there were no velocity measurements recorded that would have excluded fish from accessing areas of the spawning bed. Station 3b had the highest velocity reading on May 24, at 1.51 m/s. Station 3b was located at the base of the dam in a narrow channel and would naturally have a faster flow due to its proximity to the dam. Because of the increase in water level and velocity after the dam manipulation on May 13 and a rain event on May 14, EGBSC could not safely access station 3b on the May 19 site visit (Figure 10). It is likely that velocity readings would have increased between May 16 and May 19, due to the fact that the site became inaccessible for measuring. Photographs taken between May 16 and May 19 capture an increase in water level. Velocities at this location would not have prevented fish from accessing the spawning bed, as the majority of the spawning bed is situated below station 3a and 3b. There were no velocities recorded at station 2 that would have prevented fish from accessing the spawning area.

**Figure 9.** Dry water velocity stations 1a (left) and 3a (right) at the Seguin River spawning bed in 2016

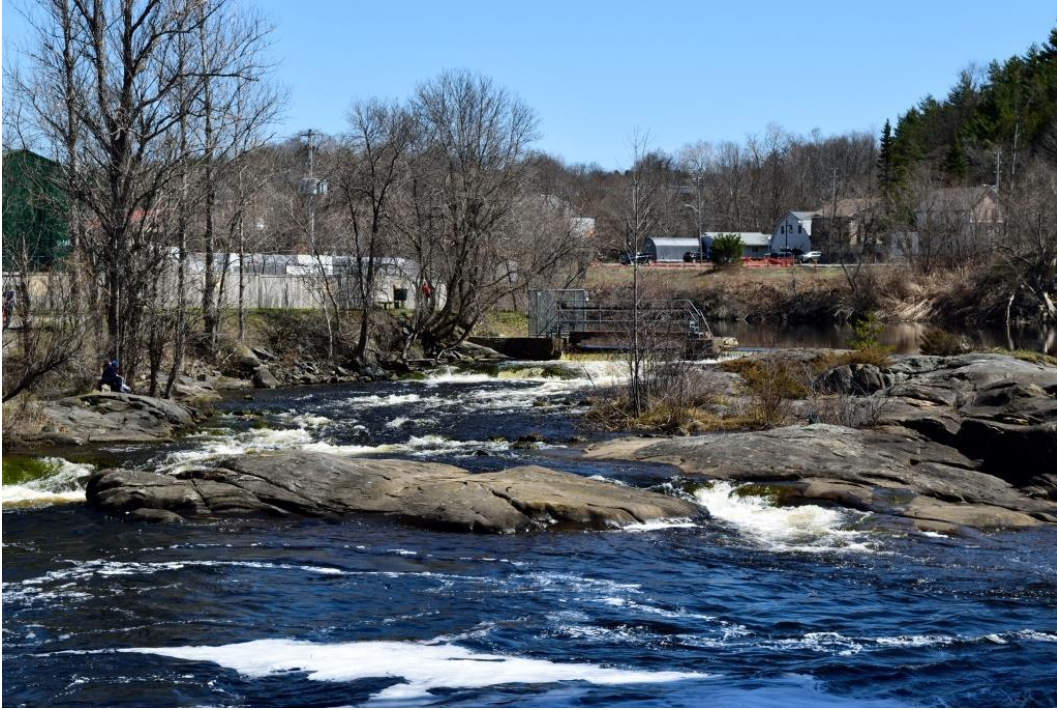
**Figure 12.** Seguin River spawning bed April 30, 2016

An important component of the spawning bed assessments was taking a series of drone photographs during the spawning and egg incubation period to help evaluate how the spawning area changed throughout the spring freshet. However, EGBSC was unable to fly the drone at the Seguin River spawning bed due to the fact that it is located within airspace, making it illegal to fly a drone in the area. Instead, EGBSC took site photos from the same location each visit. Figures 12 and 13 provide an example of the change in water level between April 30 and May 5 site visits. Walleye did not begin to spawn until after May 5, and there were no observations of eggs being stranded out of water. However, the change in water level did reduce the overall area of spawning habitat available, which is discussed further in the [Discussion and Recommendations](#) section.

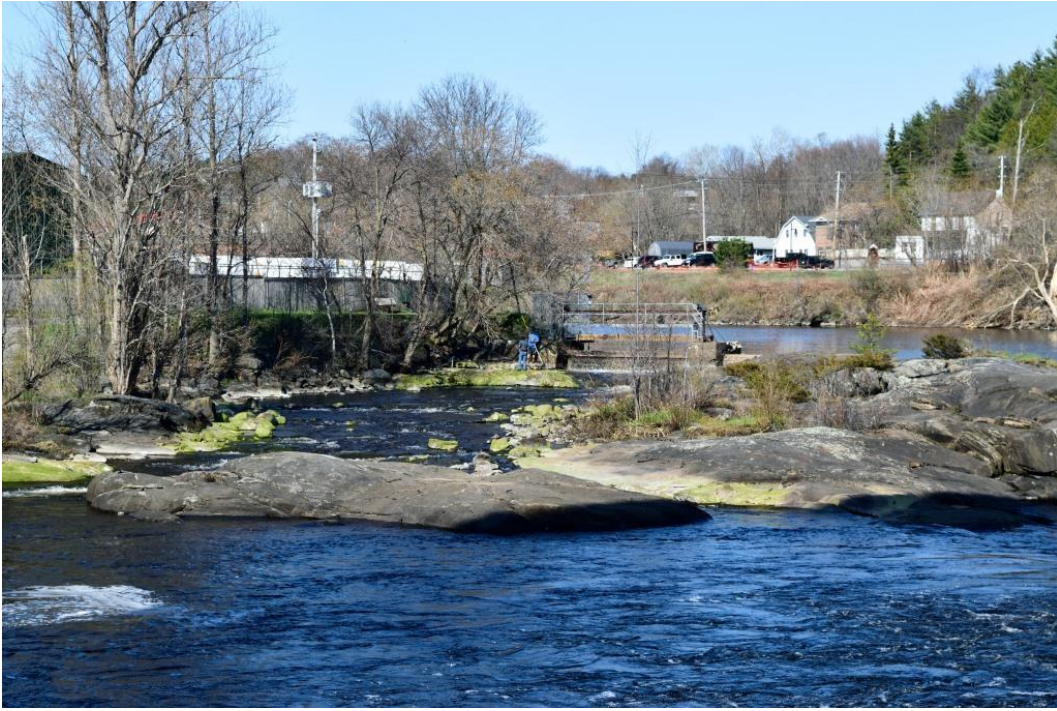
**Figure 13.** Seguin River spawning bed May 5, 2016

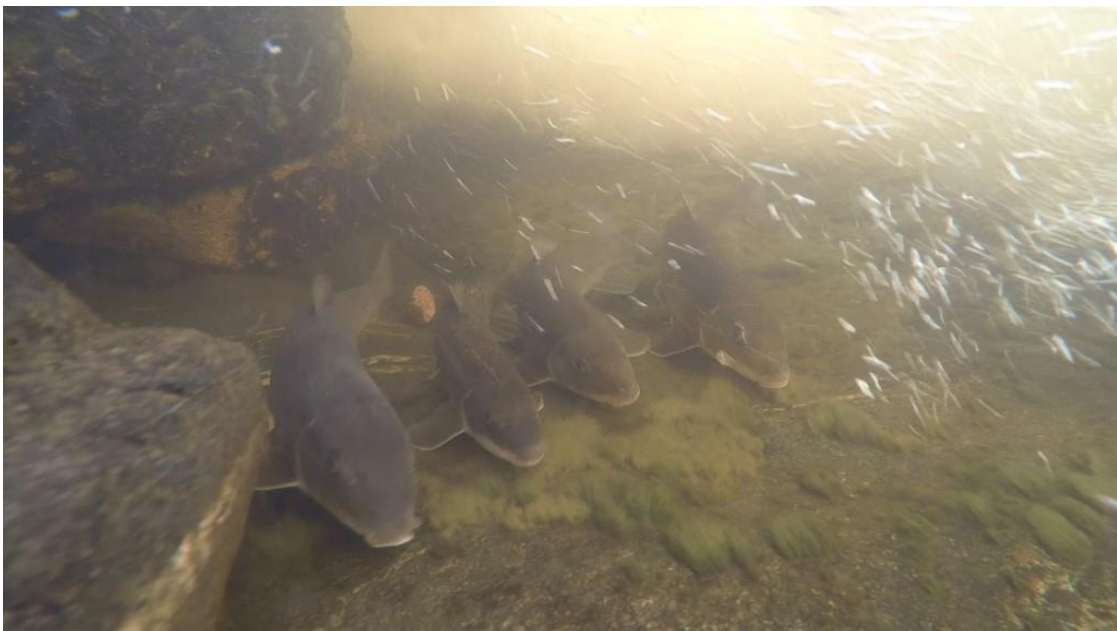
**Figure 14.** White Sucker congregating below the north dam

EGBSC carried out visual observations (night and day) at the spawning bed to help ascertain fish movement and spawning activity. White Sucker were first observed during day surveys on May 10. The fish were seen congregating in a calm area downstream of the chute below the dam. White Sucker were also observed and recorded on GoPro video in a pool directly below the dam (Figure 14). White Sucker were last observed at the spawning bed on May 19.

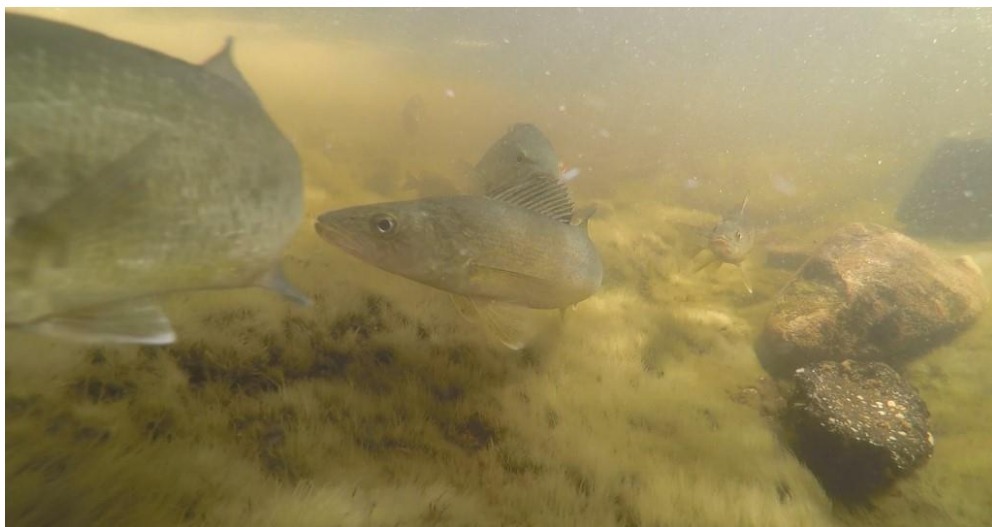
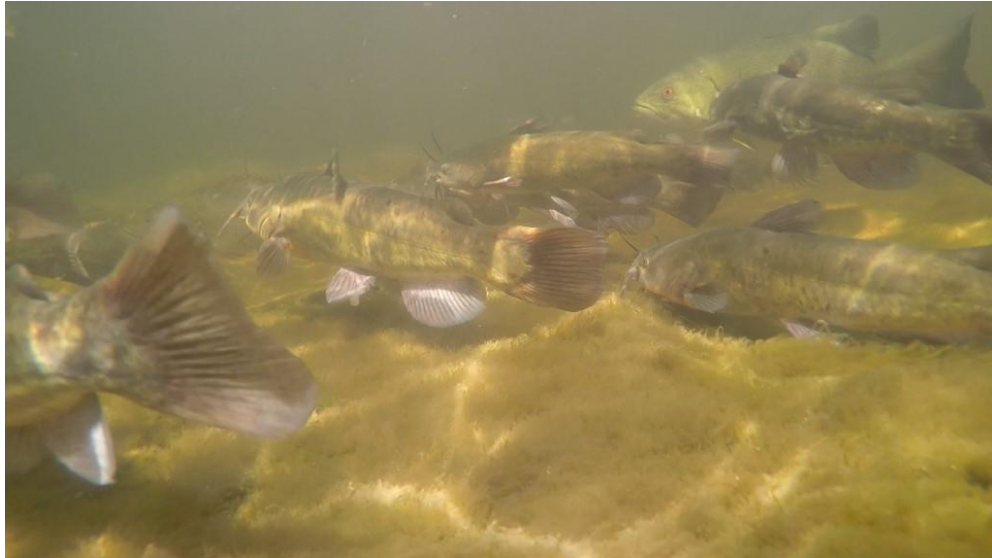
**Figure 15.** Fish observed at the Seguin River spawning bed on May 30, 2016

Snorkeling at the site on May 30 revealed seven Walleye, at least fifteen (15) Brown Bullhead, at least ten (10) Smallmouth Bass, and a few Rock Bass (Figures 15 and 16). No Redhorse Sucker species or Lake Sturgeon were seen.

Between day and night visual observations, there were very few Walleye observed, aside from three observed on May 5 and seven observed on May 30 during a snorkel survey of the spawning bed. White Sucker were observed at the spawning bed beginning on May 10 and up until May 19; however, a maximum of only fifteen (15) were observed during a single visit. A low number of Walleye eggs (144) and Sucker eggs (185) were counted on the three egg mats placed along the north shore of the spawning bed. A small accumulation of Walleye eggs was observed adjacent to the north shore on May 10 and in a pocket at the last ledge of the spawning bed on May 12. While the egg counts were low, they were higher than anticipated given how few Sucker and Walleye were seen at the site.

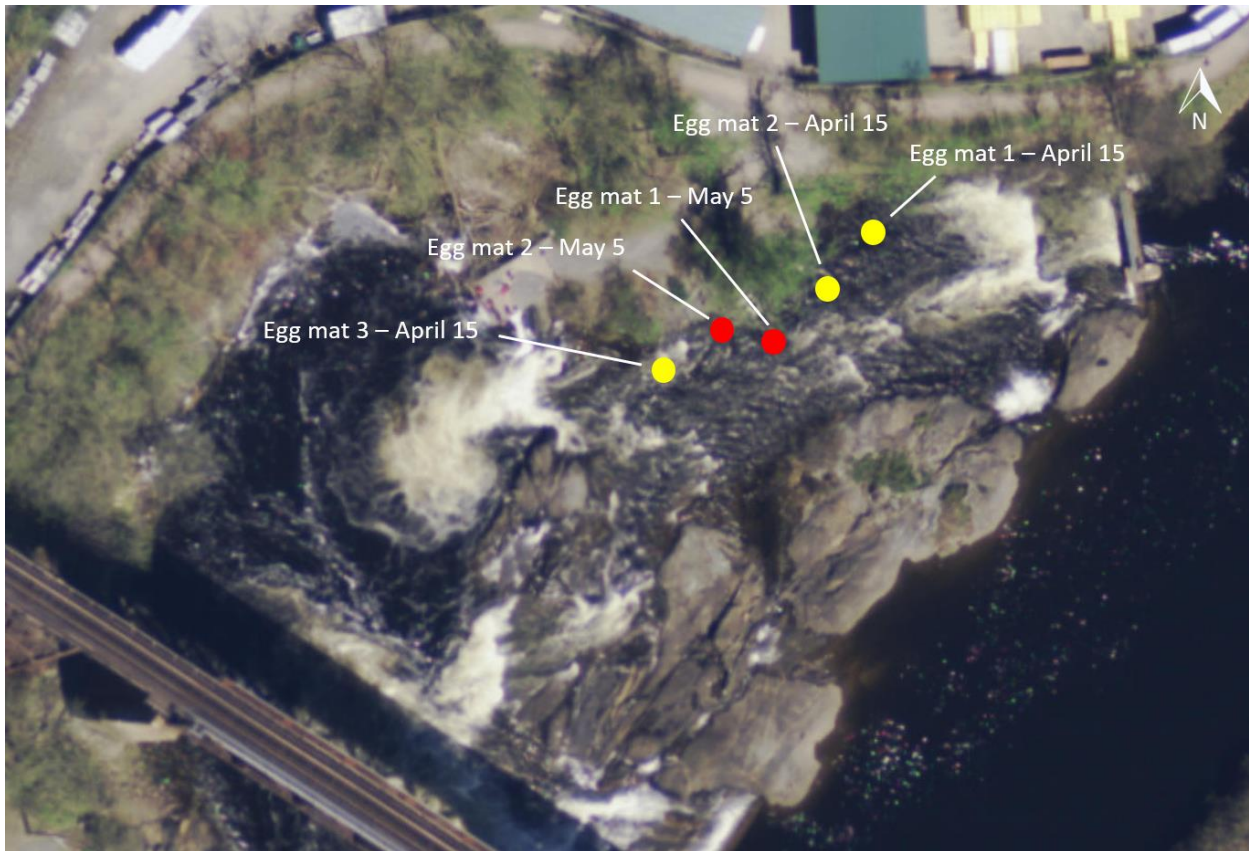
EGBSC initially set three egg mats at the Seguin River spawning bed on April 15 to help assess the amount and location of egg deposition (Figure 17). All egg mats were removed on May 5, when water levels dropped. One mat was found completely out of water. No eggs were present on any of the mats.

Two egg mats were re-set in slightly different locations on May 5 and counted on May 12. Walleye and Sucker eggs were present on both mats. A total of sixty-eight (68) Sucker eggs and 143 Walleye eggs were counted on May 12. The two mats were re-set in the same locations and counted again on May 24. Only one Walleye egg and 117 Sucker eggs were counted. In total, egg mat 1 had forty (40) Walleye eggs and 122 Sucker eggs. Egg mat 2 had a total of 104 Walleye eggs and sixty-three (63) Sucker eggs. Overall total egg counts were 144 Walleye eggs and 185 Sucker eggs. Egg mats were only placed on a small portion of the spawning bed, and therefore, only represent a small portion of the entire spawning area.

**Figure 17.** Location of egg mats installed at the Seguin River spawning bed in 2016

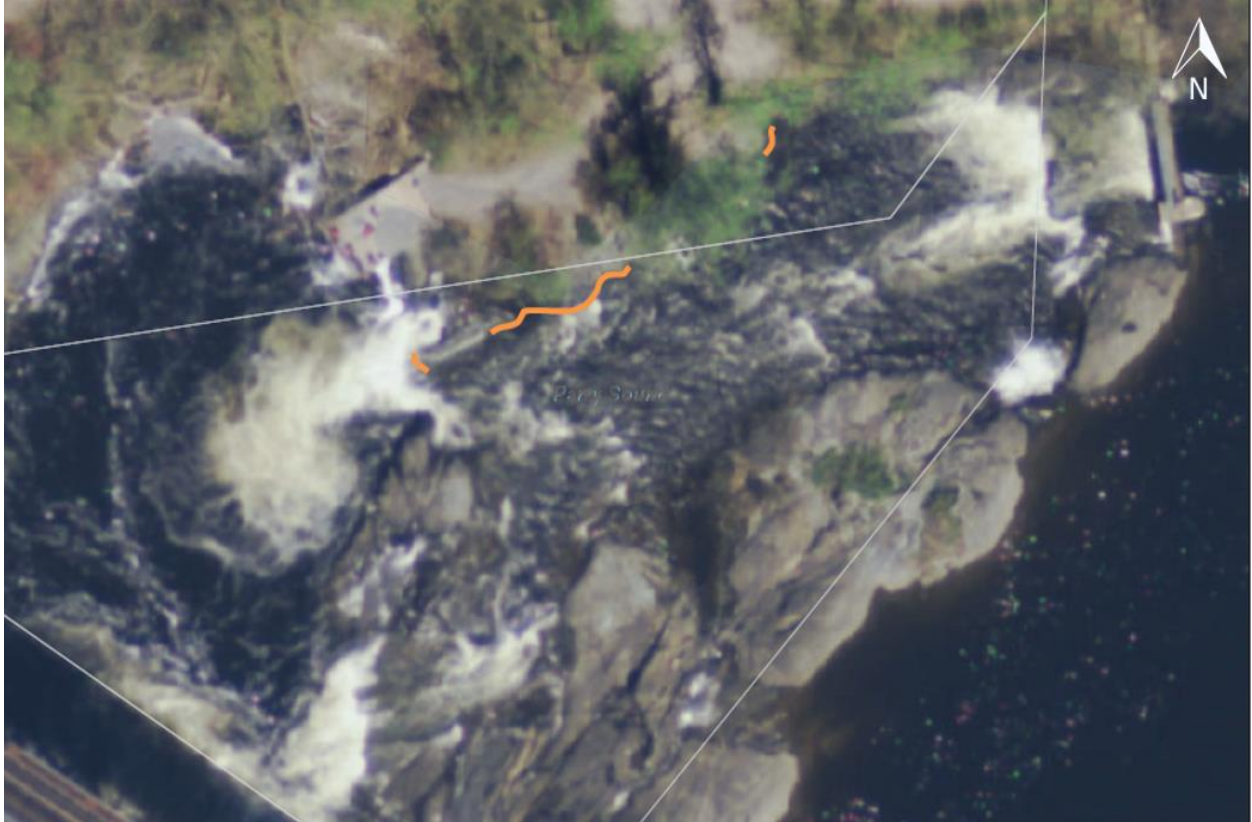
On May 10 and 12, EGBSC discovered other areas of Walleye egg deposition. Eggs were found deposited in cobble and also in cracks along a bedrock ledge near the bottom end of the rapids. Although the eggs were observed in shallow pockets, those areas remained underwater. The amount of Walleye egg deposition in these areas was sparse, with over fifty (50) counted on May 10 and only a few counted on May 12. Figure 18 shows the shoreline areas where eggs were observed. Figures 19 and 20 show a closeup of the egg deposition. As shown, the eggs collected in very shallow areas making them prone to stranding.

**Figure 18.** Areas of egg deposition at the Seguin River spawning bed highlighted in orange

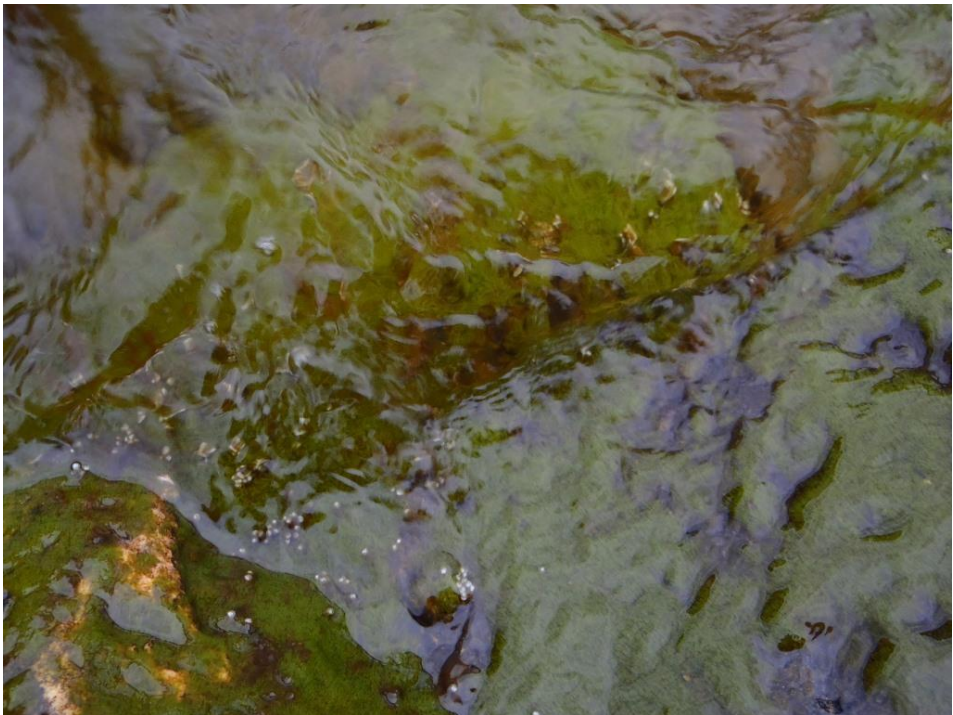
**Figure 19.** Walleye eggs observed at the Seguin River spawning bed. Eggs are white indicating that they are dead, live Walleye eggs are translucent.

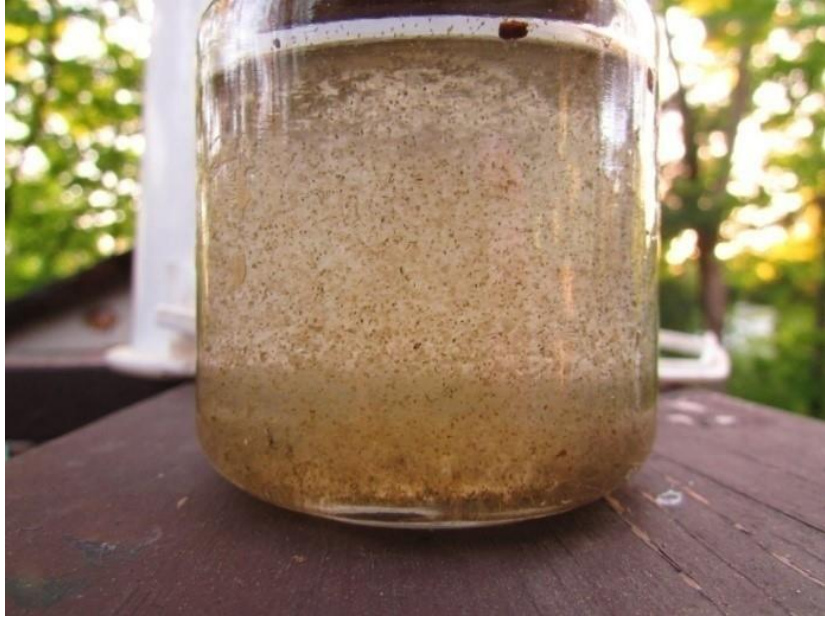
**Figure 21.** Plankton sample from the Seguin River in 2016

EGBSC did not identify and count the zooplankton in the samples. Only a visual observation of the samples could be made and compared with the four other rivers sampled in 2016. An example of a sample taken at the Seguin River is shown in Figure 21. Relative to the samples from the other four rivers sampled in 2016, the Seguin River had moderate plankton density (less than Shawanaga River, more than Magnetawan River, and similar to Shebeshekong River and Sucker Creek).

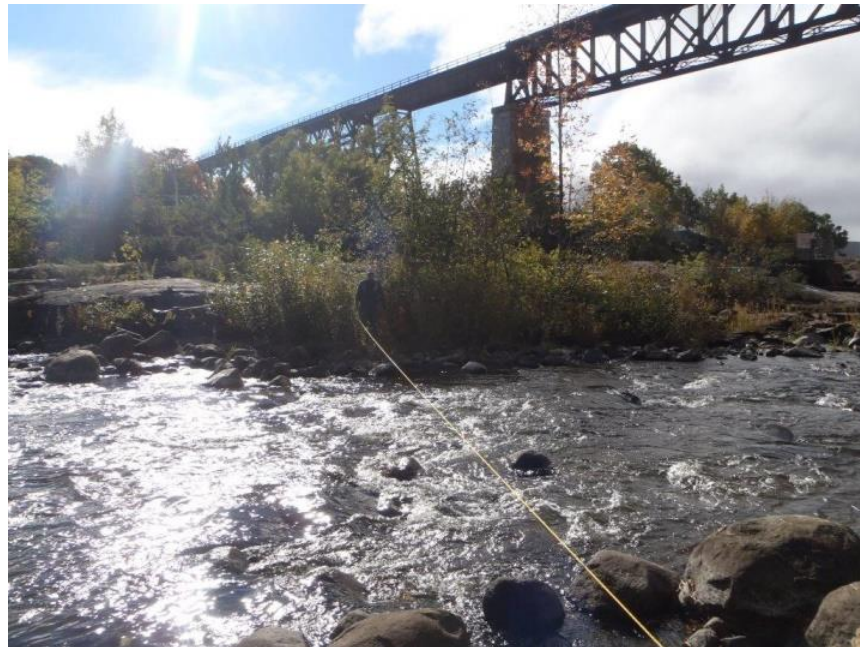
**Figure 23.** Measuring bankfull width at transect 7

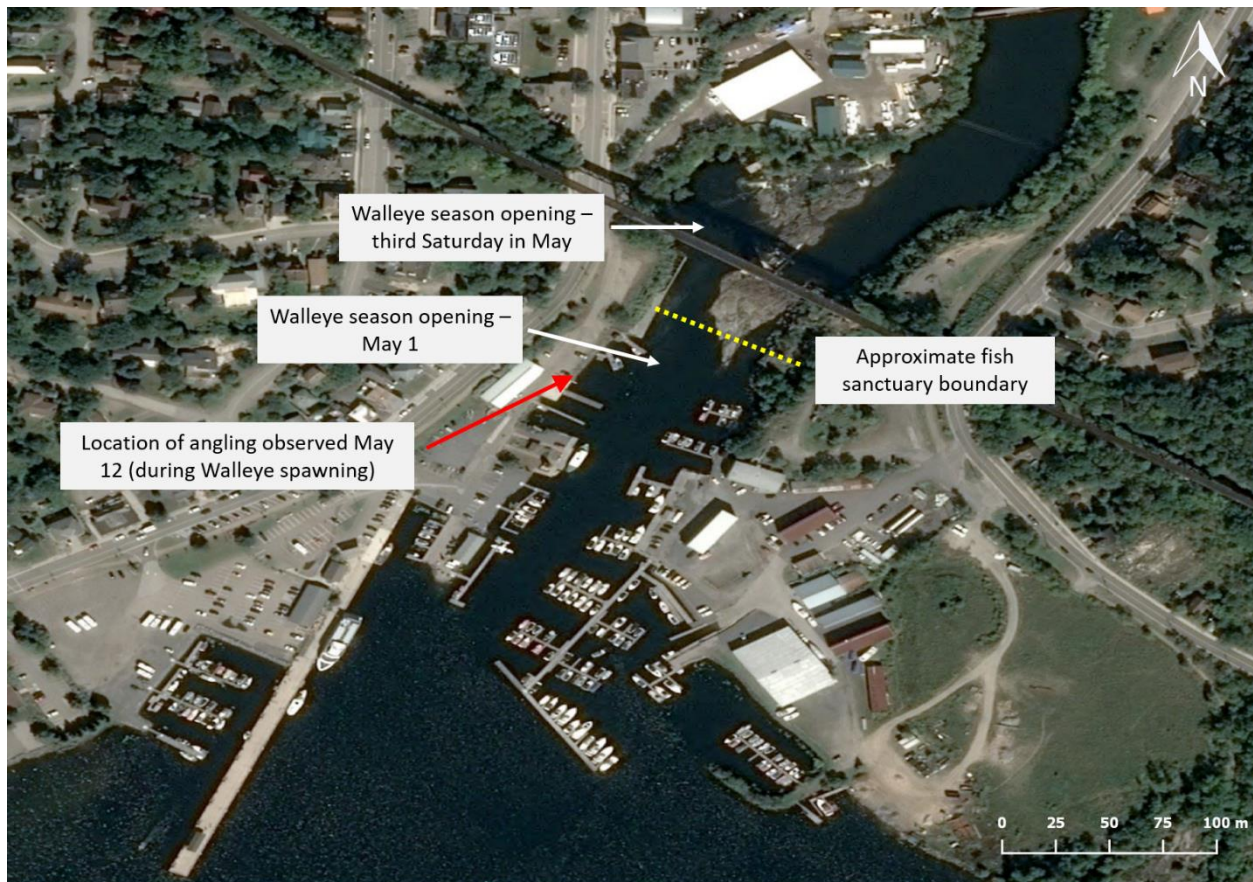
Another issue identified in the 2016 spawning season was related to the May 1 opening of the Walleye angling season (Fisheries Management Zone 14). While the Seguin River spawning bed is considered a fish sanctuary, and fishing within this area is restricted until the third Saturday in May, the fish sanctuary boundary is located in such a location that anglers are able to fish legally while directly targeting Walleye moving in to spawn (Figure 26).

**Figure 26.** Approximate location of the Seguin River spawning bed fish sanctuary boundary

Based on the 2016 observations, egg deposition, and anecdotal information, Walleye spawn later at the Seguin River, and the season opening of May 1 is too early to protect spawning Walleye. In 2016, anglers were observed along the wharf directly downstream of the fish sanctuary boundary starting on May 12 (Figure 26). To improve the efficacy of the fish sanctuary regulations, the boundary should be moved farther downstream, or the opening season date should be delayed further.

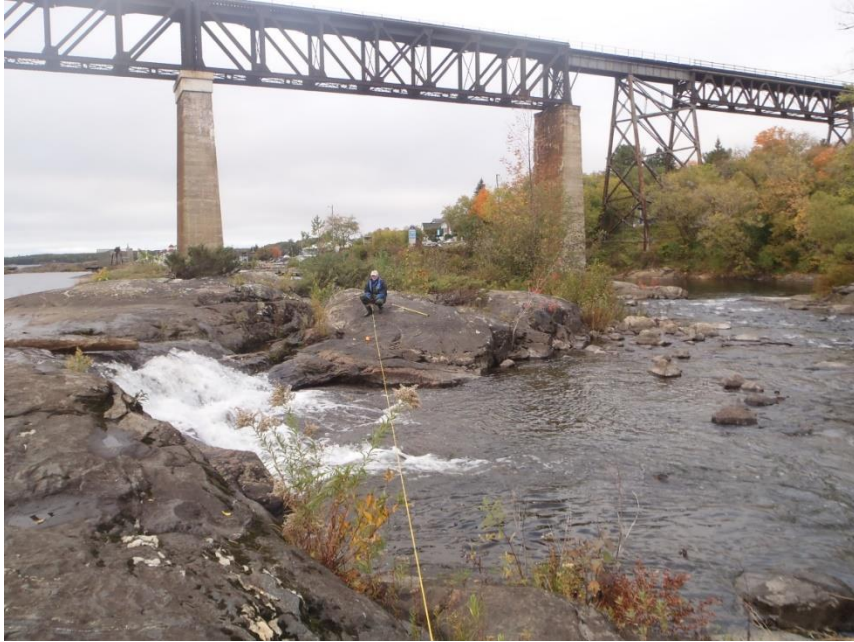
### Transect 3

Point	Depth (m)		Particle sizes	Aquatic vegetation present
	Bankfull	Present		
(1) 2.28	0.9	0	100% bedrock	none
(2) 6.83	1.15	0.29	70% cobble, 30% sand	none
(3) 11.38	1.47	0.67	50% sm boulder, 50% cobble	none
(4) 15.93	0.96	0.12	100% bedrock	none
(5) 20.48	1.07	0.15	80% lg boulder, 20% bedrock	none
(6) 25.03	0.12	0	100% bedrock	none

Point 1	Point 2	Point 3	Point 4	Point 5	Point 6
<b>Walleye</b>							
Optimal depth (m)	0.3 - 1.0						
Optimal substrate (cm)	0.2 - 25			*			
<b>Lake Sturgeon</b>							
Optimal depth (m)	0.1 - 2.0						
Optimal substrate (cm)	10 - 60		*				
<b>Sucker species</b>							
Optimal depth (m)							
Optimal substrate (cm)	0.2 - 1.6		*

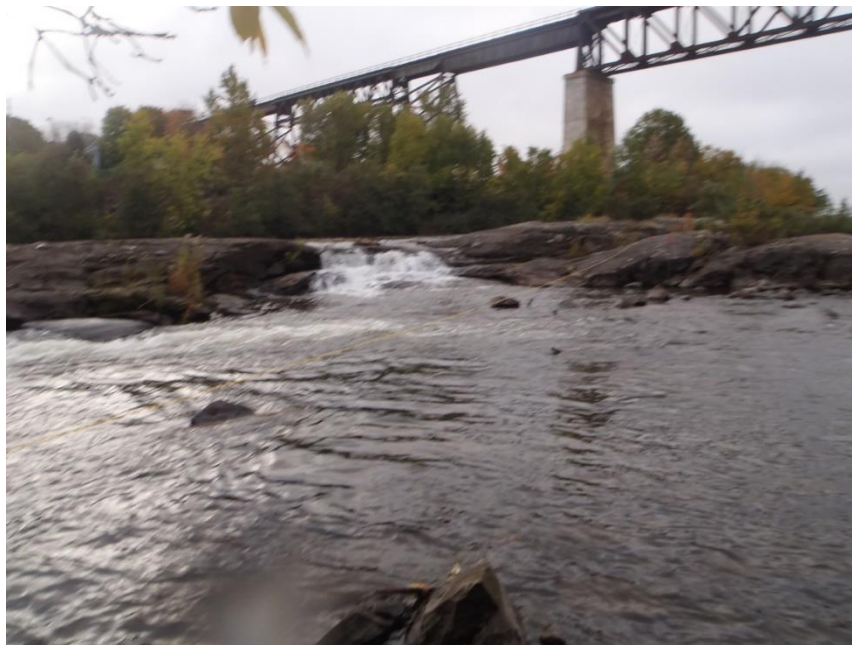
**Transect 4**

Point	Depth (m)		Particle sizes	Aquatic vegetation present
	Bankfull	Present		
(1) 1.83	0.86	0.22	75% lg boulder, 15% lg stone, 10% cobble	none
(2) 5.50	1.06	0.39	100% cobble	none
(3) 9.17	1.24	0.54	25% lg boulder, 25% sm boulder, 50% cobble	none

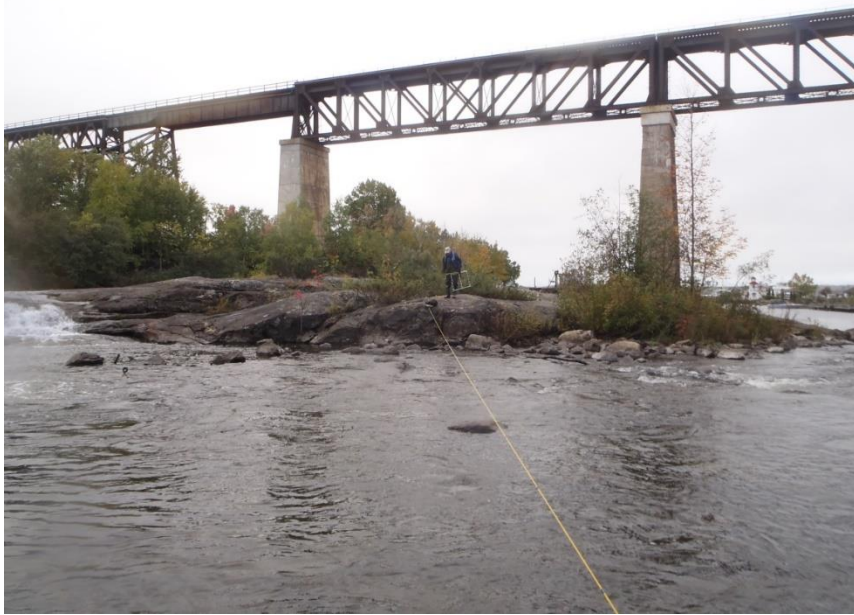
**Transect 5**

Point	Depth (m)		Particle sizes	Aquatic vegetation present
	Bankfull	Present		
(1) 1.79	0.97	0.26	20% bedrock, 40% cobble, 20% sm boulder, 20% sand	none
(2) 5.37	1.12	0.43	10% lg boulder, 60% cobble, 20% sm boulder, 10% lg stone	none
(3) 8.95	1.08	0.37	70% cobble, 20% sand, 10% lg stone	none
(4) 12.53	0.9	0.12	100% bedrock	none
(5) 16.11	0.94	0.11	50% lg boulder, 20% cobble, 30% sm boulder	none
(6) 19.69	1.09	0.17	60% lg boulder, 30% cobble, 10% lg stone	none

Point 1	Point 2	Point 3	Point 4	Point 5	Point 6
<b>Walleye</b>							
Optimal depth (m)	0.3 - 1.0						
Optimal substrate (cm)	0.2 - 25	*	*			*	*
<b>Lake Sturgeon</b>							
Optimal depth (m)	0.1 - 2.0						
Optimal substrate (cm)	10 - 60	*	*	*		*	*
<b>Sucker species</b>							
Optimal depth (m)							
Optimal substrate (cm)	0.2 - 1.6	*		*

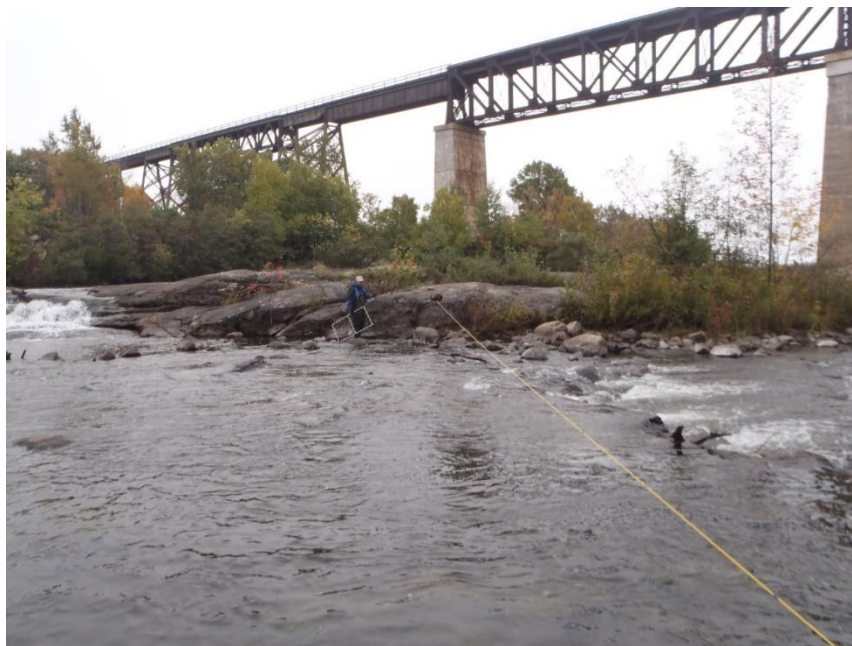
**Transect 6**

Point	Depth (m)		Particle sizes	Aquatic vegetation present
	Bankfull	Present		
(1) 1.46	0.26	0	80% lg boulder, 20% cobble	none
(2) 4.38	1.11	0.35	100% cobble	none
(3) 7.30	1.2	0.43	25% lg boulder, 25% bedrock, 50% cobble	none
(4) 10.22	1.09	0.29	60% bedrock, 40% cobble	none
(5) 13.14	1.04	0.19	100% lg boulder	none
(6) 16.06	0.79	0.02	90% lg boulder, 10% sm boulder	none

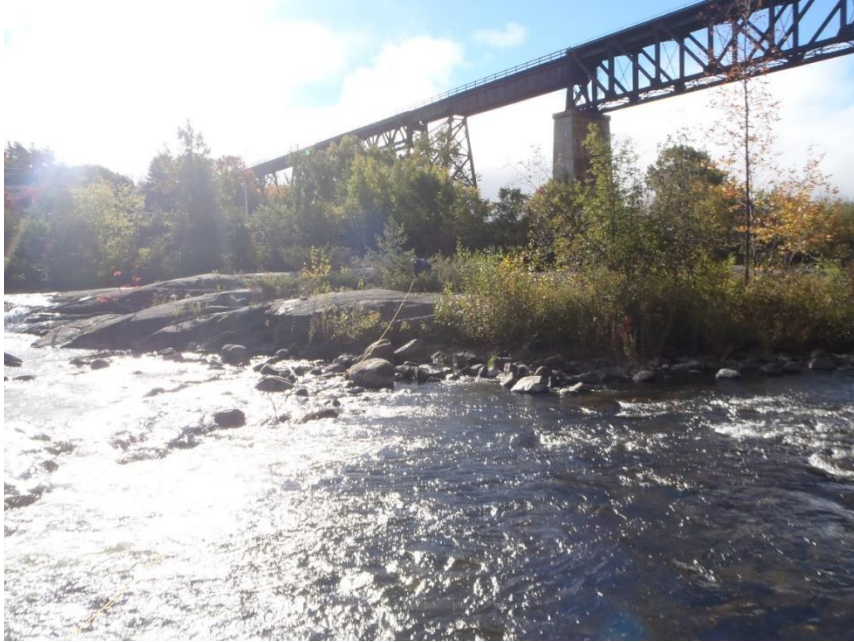
**Transect 7**

Point	Depth (m)		Particle sizes	Aquatic vegetation present
	Bankfull	Present		
(1) 1.33	0.76	0	20% lg boulder, 20% lg stone, 30% cobble, 30% sand	none
(2) 4.0	0.97	0.21	50% sm boulder, 50% cobble	none
(3) 6.67	0.95	0.25	100% lg boulder, GP 1540	none
(4) 9.34	0.94	0.28	50% bedrock, 25% lg boulder, 25% sm boulder	none
(5) 12.01	0.86	0.18	10% sm boulder, 90% cobble	none
(6) 14.68	0.53	0	80% cobble, 10% sm boulder, 10% lg stone	none

Point 1	Point 2	Point 3	Point 4	Point 5	Point 6
<b>Walleye</b>							
Optimal depth (m)	0.3 - 1.0						
Optimal substrate (cm)	0.2 - 25	*	*			*	*
<b>Lake Sturgeon</b>							
Optimal depth (m)	0.1 - 2.0						
Optimal substrate (cm)	10 - 60	*			*		*
<b>Sucker species</b>							
Optimal depth (m)							
Optimal substrate (cm)	0.2 - 1.6	*

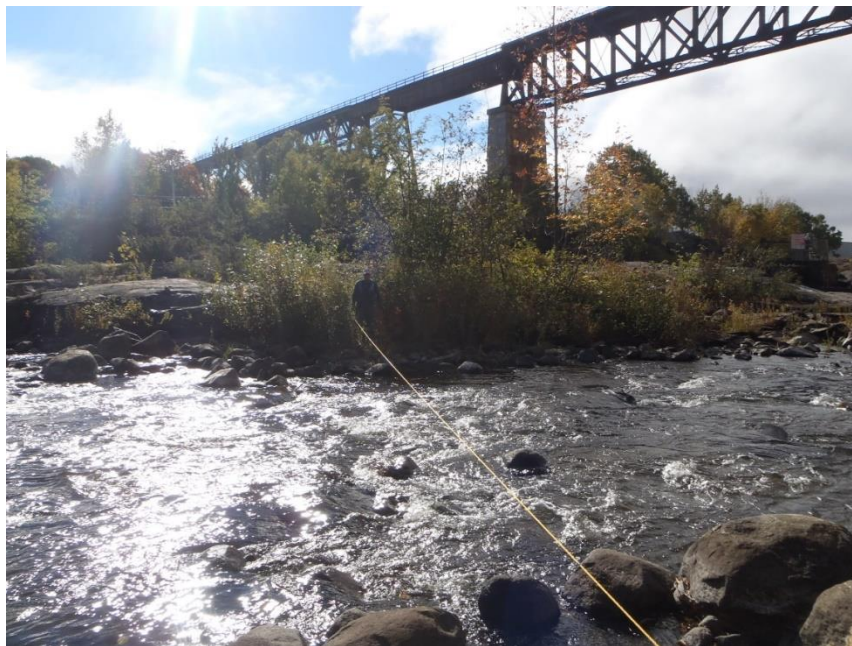
### Transect 8

Point	Depth (m)		Particle sizes	Aquatic vegetation present
	Bankfull	Present		
(1) 1.29	0.26	0	100% bedrock	none
(2) 3.87	0.39	0	60% bedrock, 20% sm boulder, 20% cobble	none

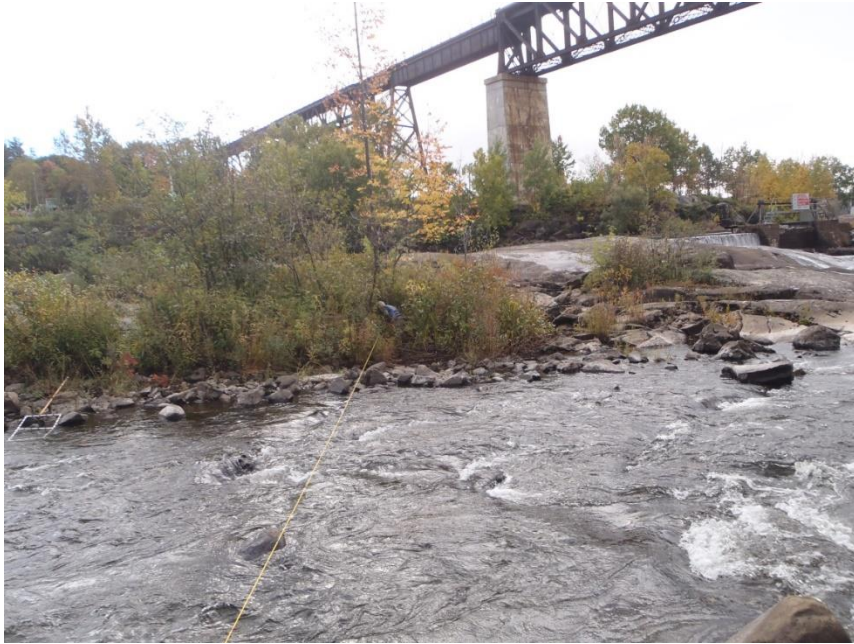
**Transect 9**

Point	Depth (m)		Particle sizes	Aquatic vegetation present
	Bankfull	Present		
(1) 1.96	0.8	0	100% bedrock	none
(2) 5.88	1.14	0.35	100% bedrock	none
(3) 9.80	1.15	0.41	100% bedrock	none
(4) 13.72	0.17	0	100% lg boulder	none
(5) 17.64	0.24	0	100% bedrock	none
(6) 21.56	0.51	0	100% bedrock	none

Point 1	Point 2	Point 3	Point 4	Point 5	Point 6
<b>Walleye</b>							
Optimal depth (m)	0.3 - 1.0						
Optimal substrate (cm)	0.2 - 25						
<b>Lake Sturgeon</b>							
Optimal depth (m)	0.1 - 2.0						
Optimal substrate (cm)	10 - 60						
<b>Sucker species</b>							
Optimal depth (m)							
Optimal substrate (cm)	0.2 - 1.6

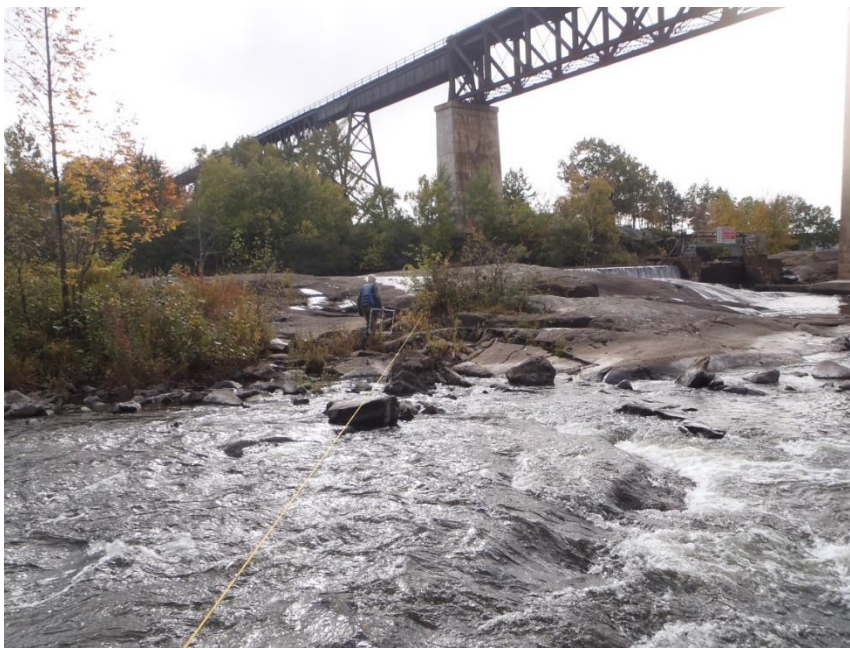
**Transect 10**

Point	Depth (m)		Particle sizes	Aquatic vegetation present
	Bankfull	Present		
(1) 1.08	0.26	0	40% bedrock, 30% lg stone, 30% sm stone	none
(2) 3.25	0.31	0	100% bedrock	none
(3) 5.42	1.02	0.39	100% bedrock	none
(4) 7.59	too dangerous to take measurements at this point			
(5) 9.76	0.81	0.14	100% bedrock	none

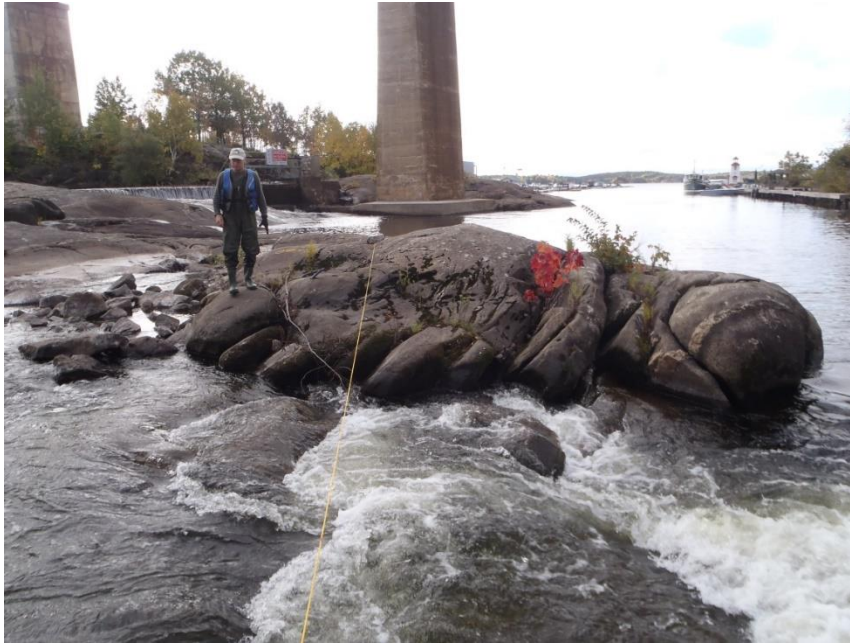
**Transect 11**

Point	Depth (m)		Particle sizes	Aquatic vegetation present
	Bankfull	Present		
(1) 0.92	0.13	0	100% bedrock	none
(2) 2.75	0.37	0	100% bedrock	none
(3) 4.58	0.66	0.03	100% lg boulder	none
(4) 6.41	0.62	0.06	75% lg boulder, 10% cobble, 10% sm boulder, 5% lg stone	none
(5) 8.24	0.86	0.29	20% lg boulder, 60% cobble, 10% sm boulder, 10% lg stone	none
(6) 10.07	0.36	0	100% bedrock	none

Point 1	Point 2	Point 3	Point 4	Point 5	Point 6
<b>Walleye</b>							
Optimal depth (m)	0.3 - 1.0						
Optimal substrate (cm)	0.2 - 25				*	*	
<b>Lake Sturgeon</b>							
Optimal depth (m)	0.1 - 2.0						
Optimal substrate (cm)	10 - 60				*	*	
<b>Sucker species</b>							
Optimal depth (m)							
Optimal substrate (cm)	0.2 - 1.6

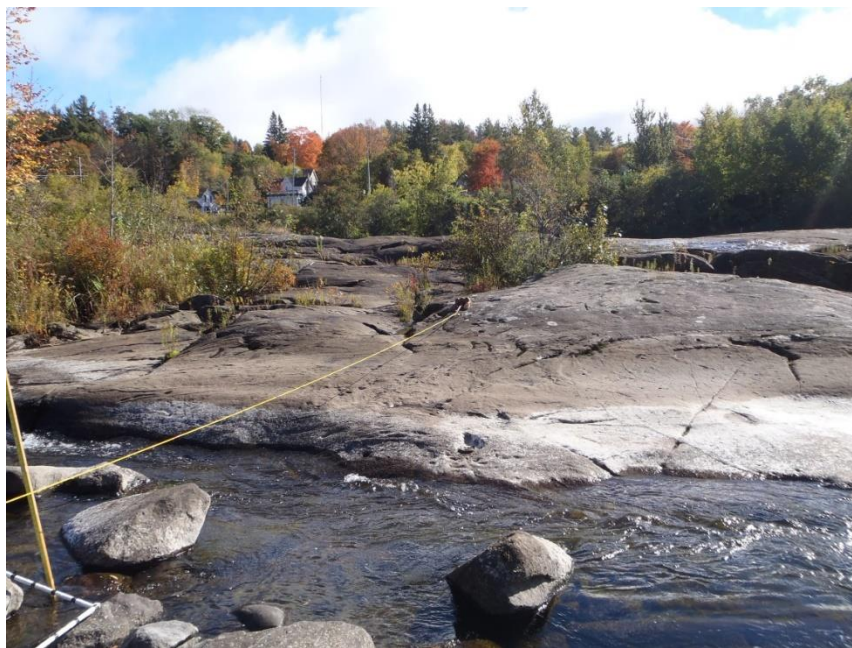
**Transect 12**

Point	Depth (m)		Particle sizes	Aquatic vegetation present
	Bankfull	Present		
(1) 0.83	0.19	0	100% bedrock	none
(2) 2.50	0.52	0	100% bedrock	none
(3) 4.17	0.79	0	100% bedrock	none
(4) 5.84	0.42	0	100% bedrock	none
(5) 7.51	0.18	0	100% bedrock	none
(6) 9.18	0.04	0	100% bedrock	none
