Shebeshekong River Fish Habitat Assessment

Executive Summary

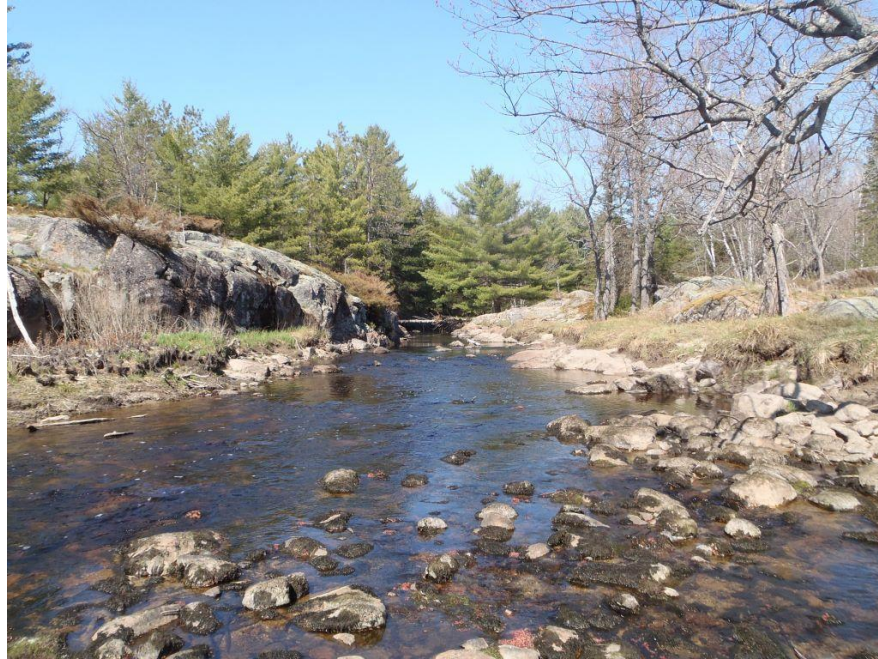
Figure 4. Historical spawning area referred to as Lockett Lake Rapids

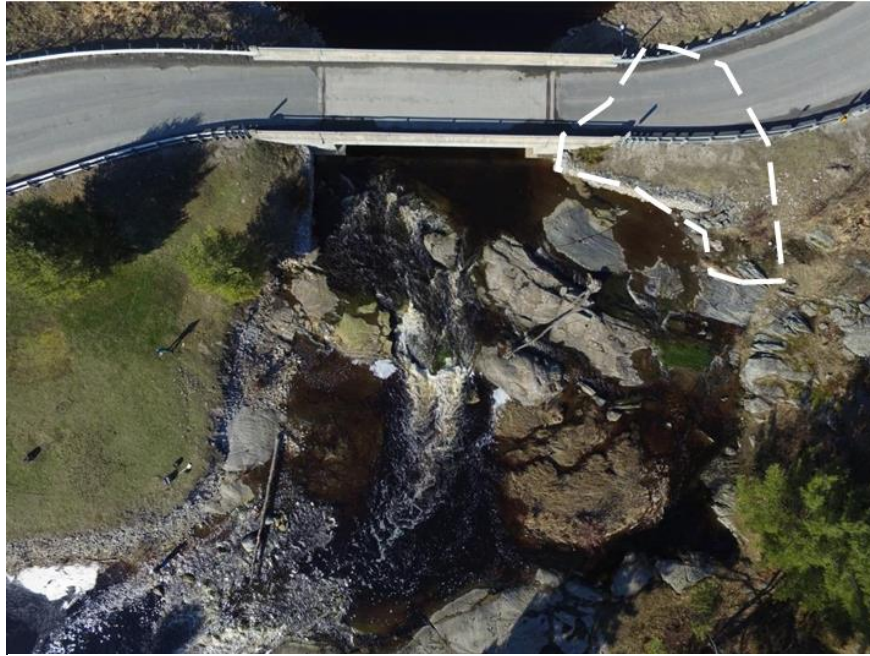
Historical changes from the logging industry (prior to 1920) to both Young's and Dillon Rapids have made it difficult for Walleye to navigate and swim past each site. At Dillon Rapids, an area of bedrock on the west side of the rapids was blasted and removed to help facilitate driving logs downstream. In more recent history, when the old iron bridge that used to cross Dillon Rapids was replaced, the new bridge cut off a portion of the rapids on the east side, which is the side fish used to use to swim up Dillon Rapids (Figure 5). Both modifications have greatly reduced the size of the rapids and have changed the hydrology at the site, resulting in more flow being directed on the west side of the rapids, where there is a steeper gradient for fish to attempt to navigate. The east side is now much shallower and depth is not always sufficient for passage.

Figure 5. Dashed white line indicates the area of Dillon Rapids filled in from road development

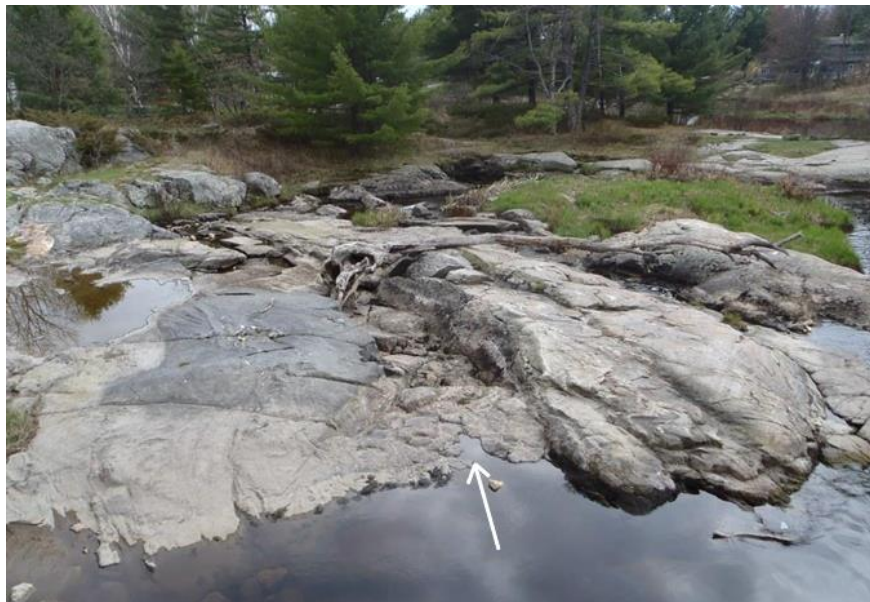
There is no written documentation on the project, but EGBSC was informed that the MNR attempted to create a channel within Dillon Rapids to help get Walleye upstream. They used a substance called Dexpan which is a non-explosive demolition agent which cracks the bedrock slowly. Due to the drilling pattern used, the bedrock at the top and bottom of the channel did not fracture and was not able to be removed (Figure 6).

Figure 6. White arrow indicates a channel created with Dexpan at Dillon Rapids

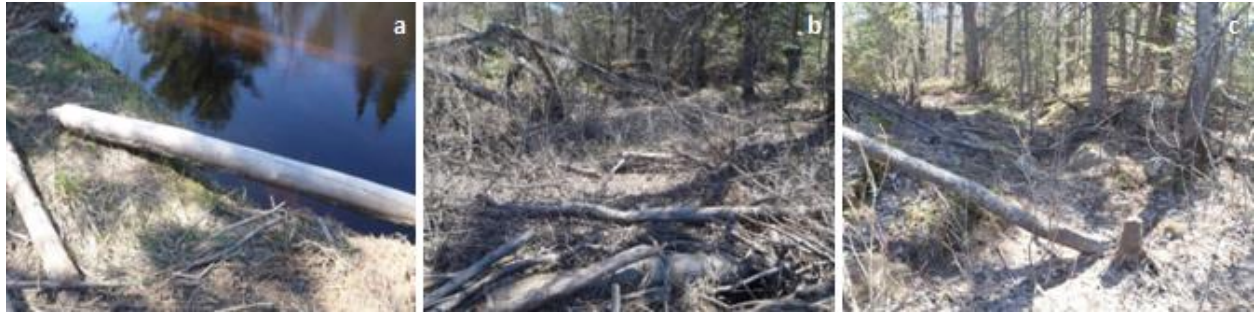
sediment have since filled in the top portion of the bypass channel. Remnants of the old channel were still visible and pooling was observed in the channel during the spring freshet in 2017 (Figures 7 and 8).

Figure 7. Young's Rapids bypass channel: (a) top of the channel that has filled in over many years; (b) looking down the bypass channel from the top at the material that has filled in over time; (c) immediately below the blocked area where the channel is still somewhat defined.

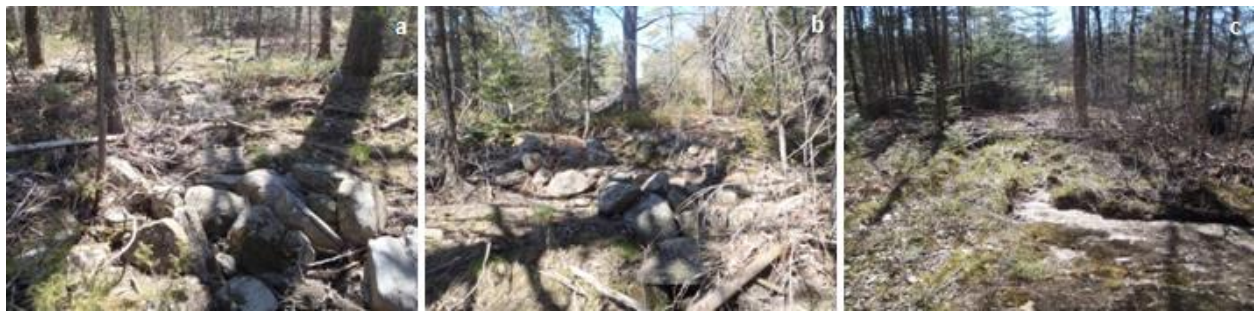
Figure 8. Young's Rapids bypass channel: (a) and (b) rocky portion of the channel; (c) bottom of bypass channel where sediment and grass have covered the former bedrock base of the channel.

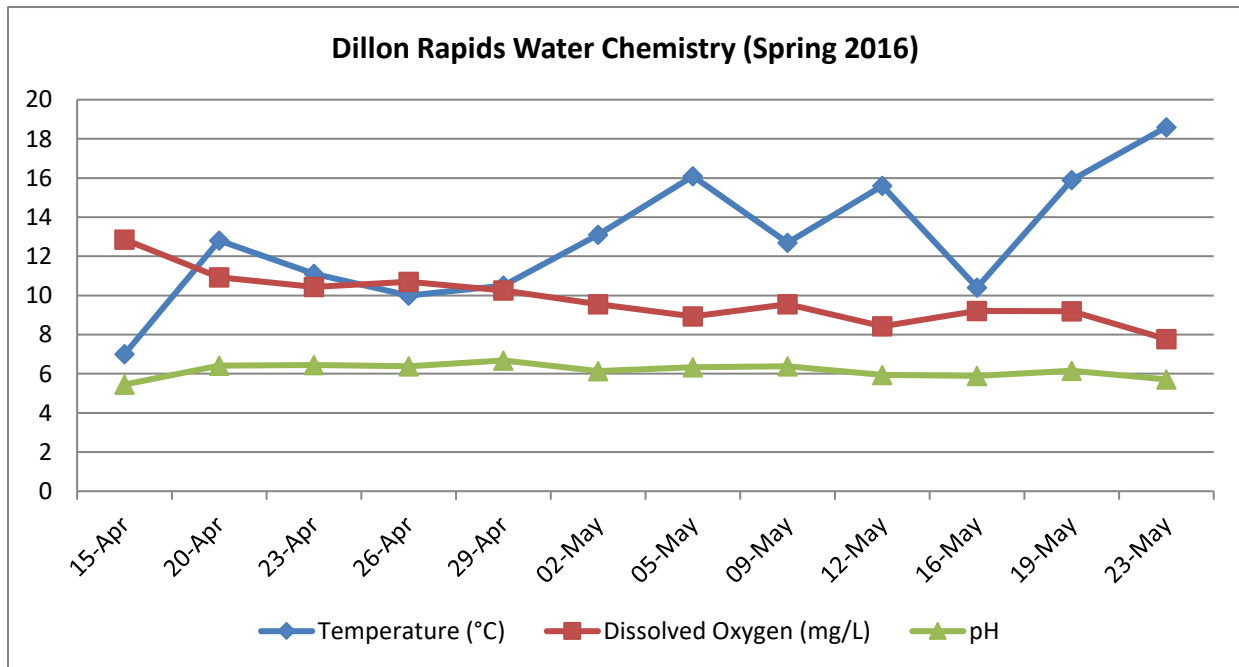
The pH of water refers to how alkaline or acidic the water is, and is ranked on a scale of 0 to 14. pH will influence how soluble and available nutrients and heavy metals are in a system. pH can also influence fish health and reproductive success. In general, Walleye do best in waterbodies with a pH ranging between 6.0 and 9.0. Reproductive success can be jeopardized at pH levels below 6.0. Four of the pH measurements recorded at the Shebeshekong River spawning bed were below 6.0 (Figure 9). The highest pH was 6.68, which was recorded on April 29. The lowest pH was recorded on April 15 (5.45). These pH readings are mildly acidic and typical for Canadian Shield watersheds.

Figure 9. Water temperature (°C), dissolved oxygen (mg/L), and pH measurements at Dillon Rapids in spring 2016

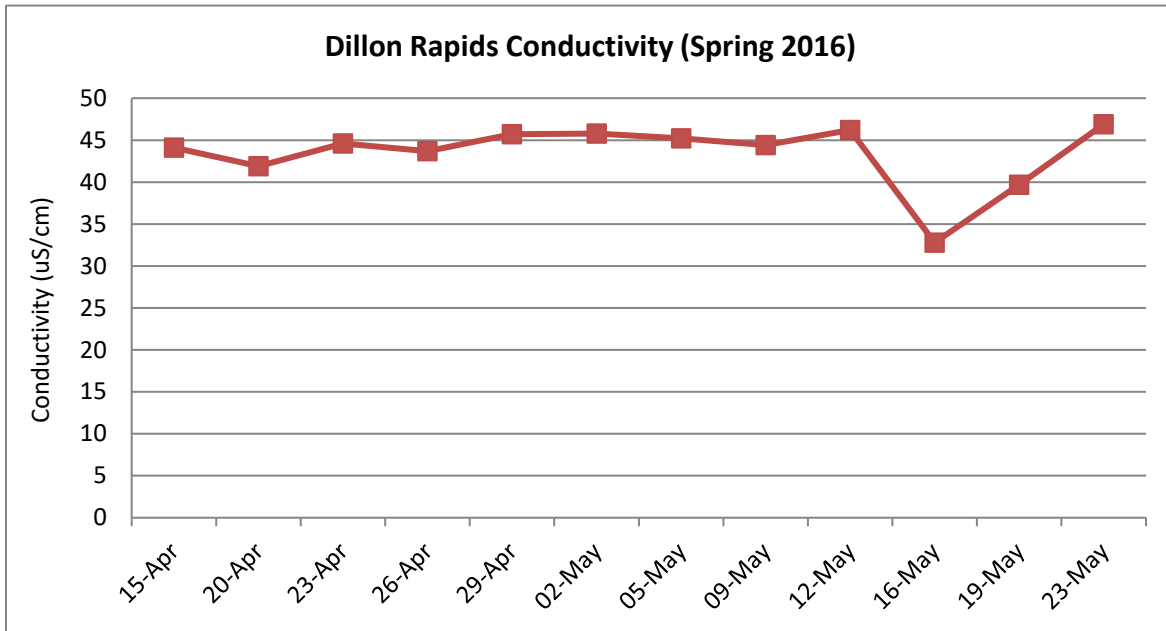
or decrease can indicate issues in a waterbody. Conductivity was recorded between April 15 and May 23. Conductivity was consistently low throughout the study period, ranging from 32.8 uS/cm on May 16 to 46.9 uS/cm on May 23 (Figure 10).

Figure 10. Conductivity measurements (uS/cm) at Dillon Rapids in spring 2016

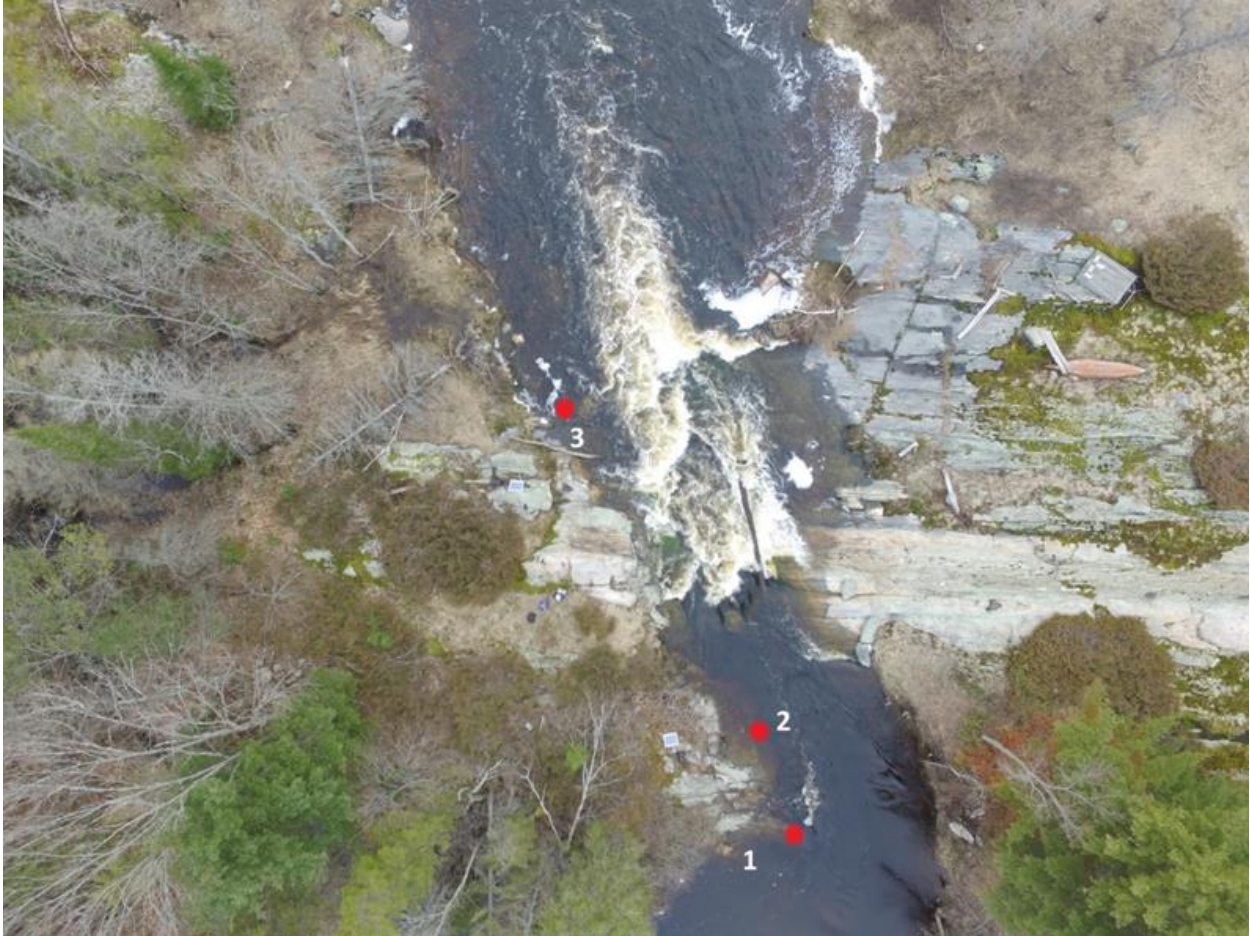
In 2017, new velocity stations were established based on 2016 fish passage observations and the location of underwater infrared cameras installed by Biotactic to help assess fish passage. Figure 15 shows the location of stations in 2017. Underwater infrared cameras were located near stations 2 and 3.

Figure 15. Water velocity stations at Young's Rapids in 2017

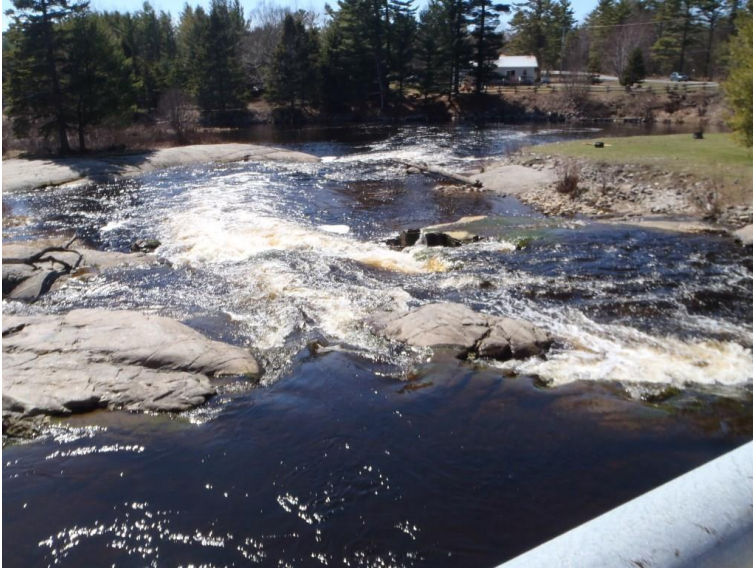
April 26, 2016

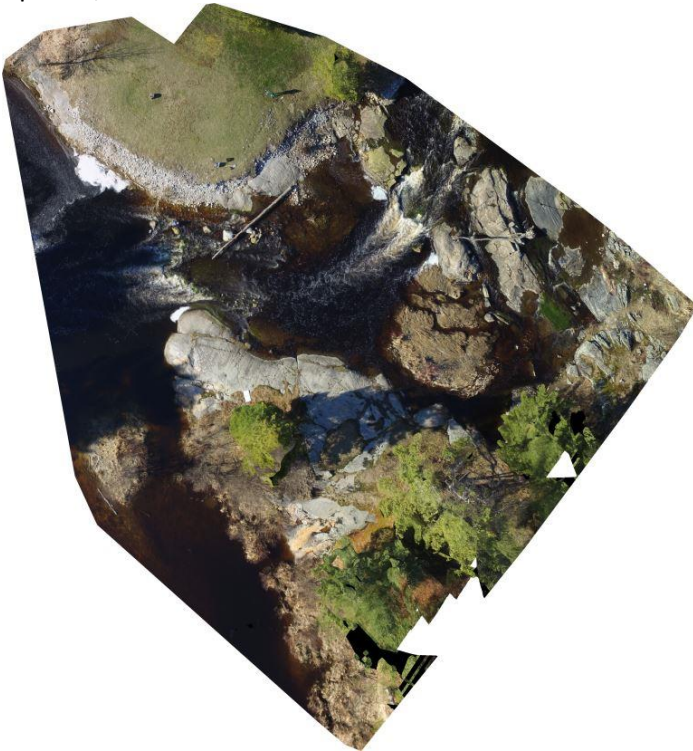
April 29, 2016 – water levels and velocities reduced on east side of rapids

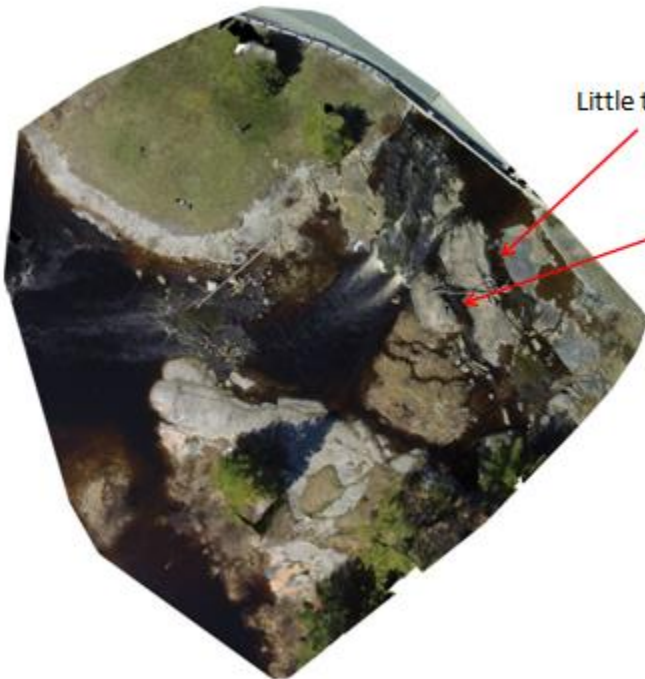
May 2, 2016 – significant change in water level and velocity throughout site; Walleye eggs observed stranded out of water

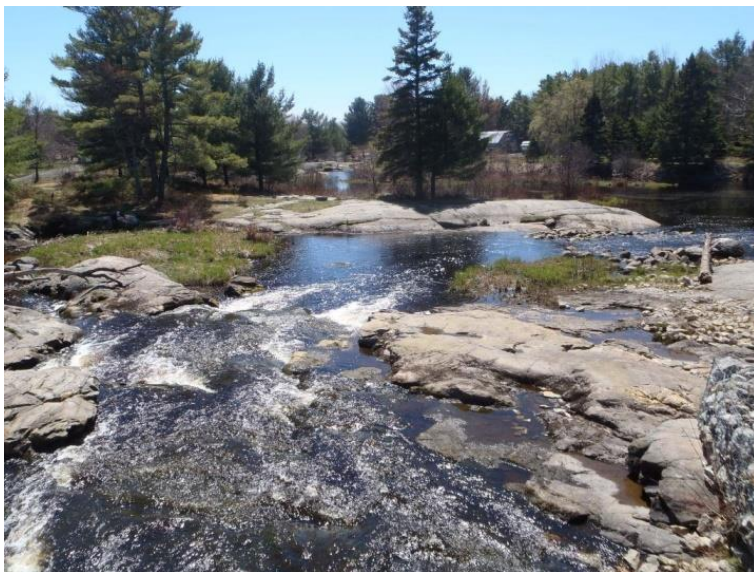
Station 3 channel beginning to dry, unable to take flow measurements

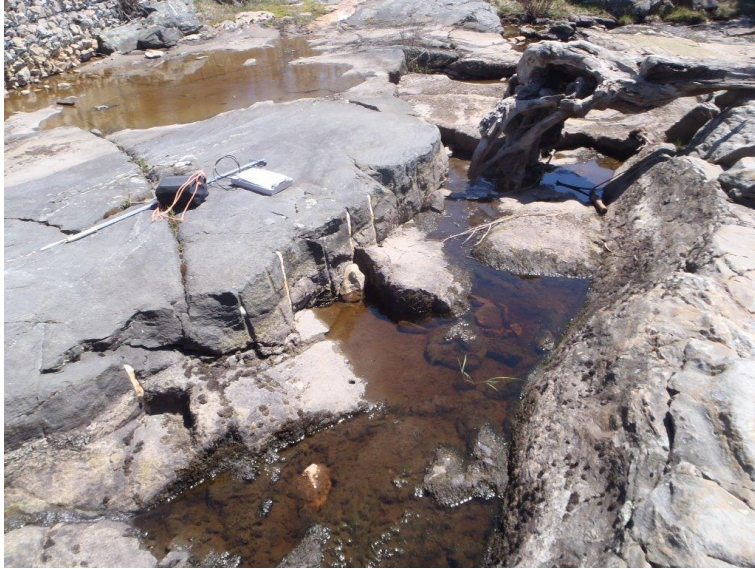
Entire east side of rapids drying up

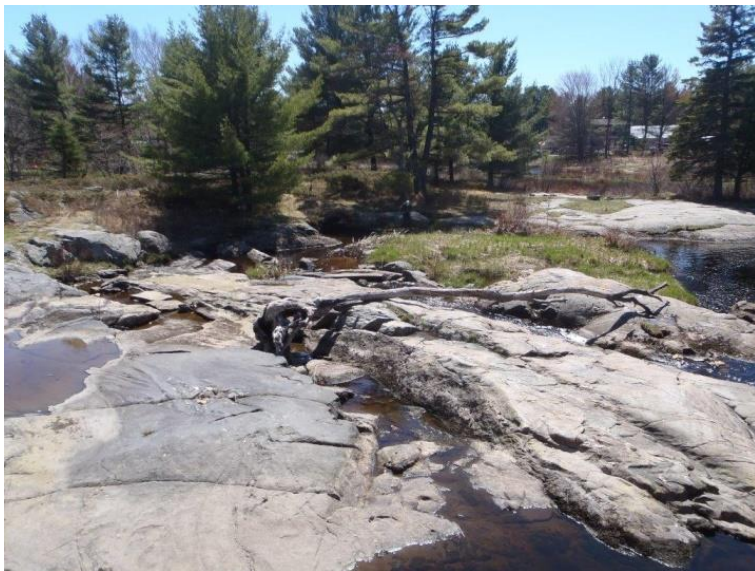
May 12, 2016 – east side of rapids almost completely dry

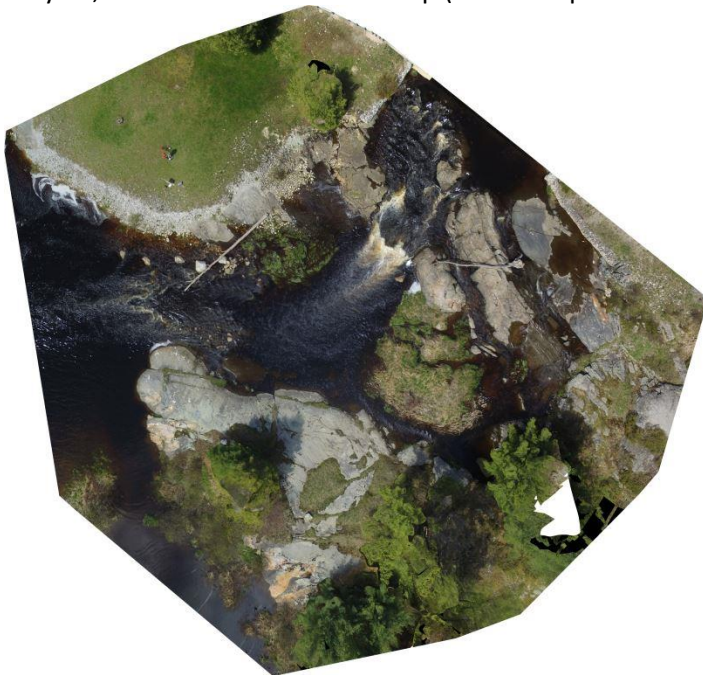
May 23, 2016 – water levels beginning to decline (similar to May 2 levels)

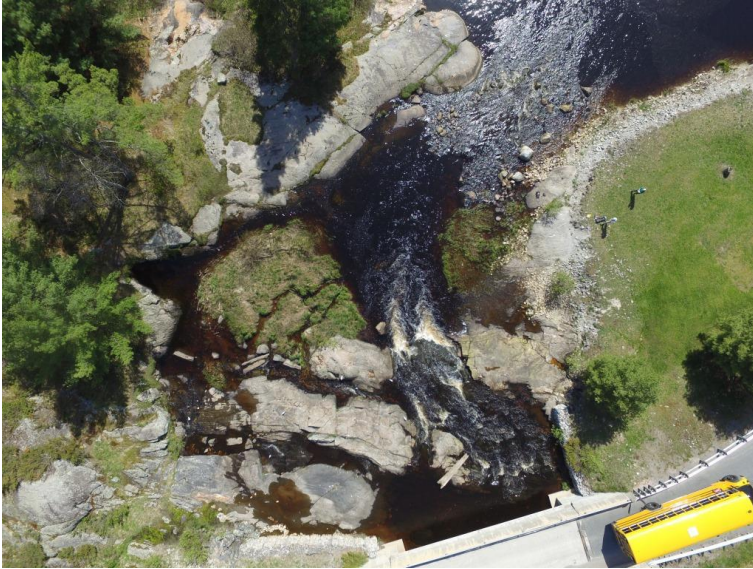
May 19, 2017 – beginning to see exposed cobble at the base of the rapids and water levels and velocity reduced on the east side of the rapids

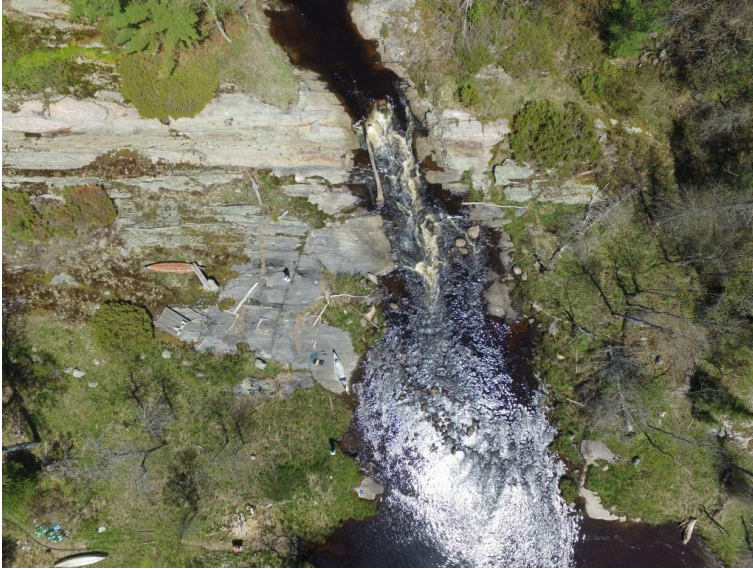
May 4, 2017 – reduction in water level at the perimeter of the rapids and some cobble visible at the base of the rapids

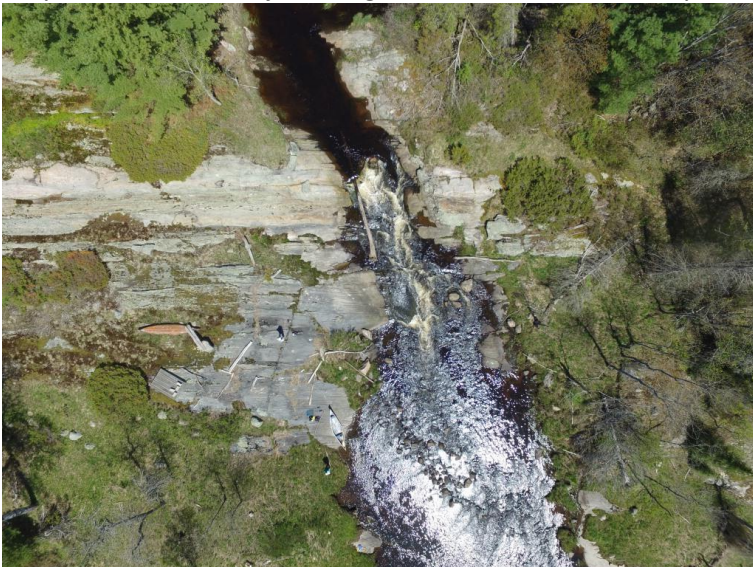
May 19, 2017 – no major change in water levels from May 4

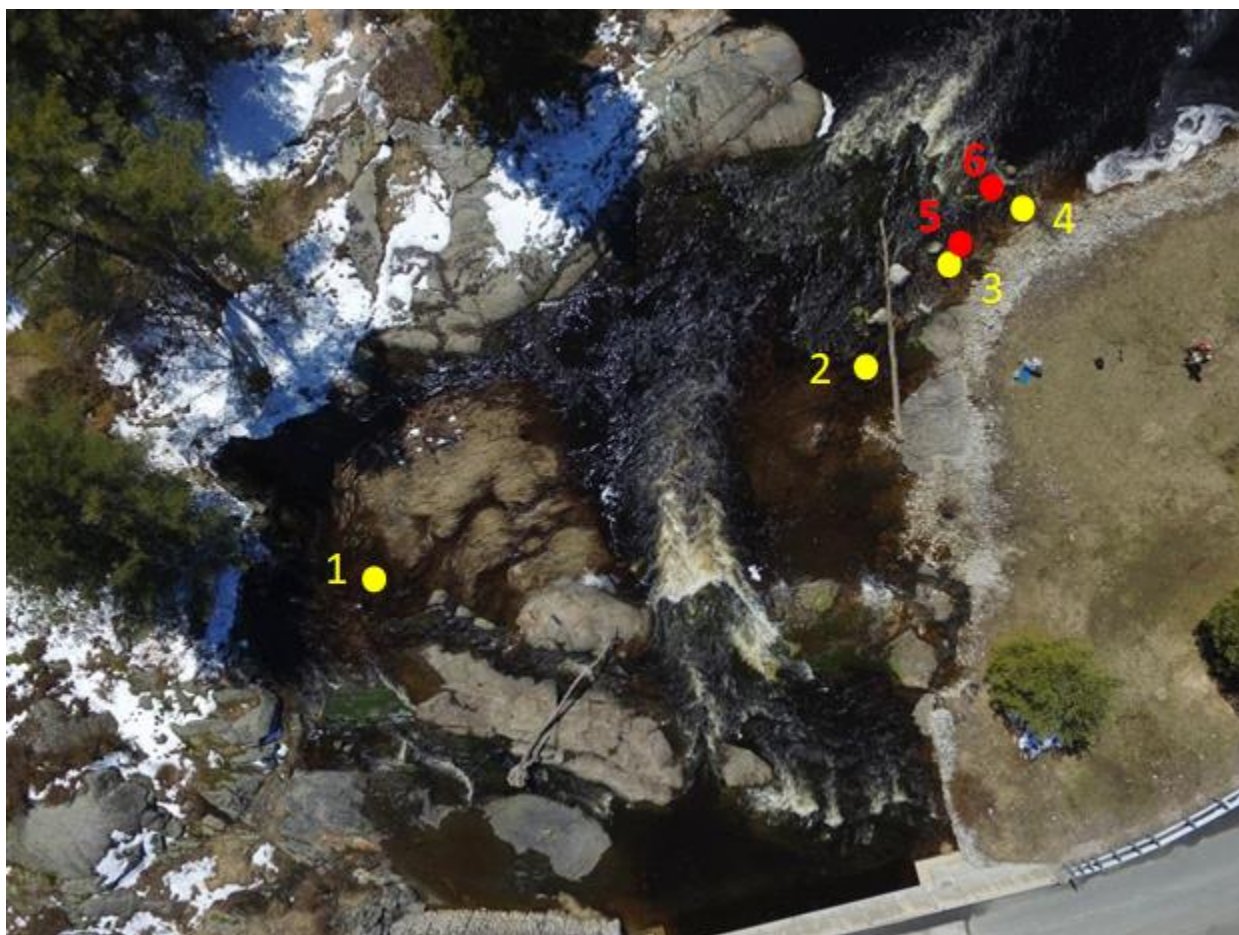
EGBSC set four egg mats at Dillon Rapids on April 15, 2016. Three of the four egg mats were removed from the water by someone other than EGBSC staff at some point after April 15. Two half mats were set on April 26. Figure 21 shows the locations of the original four eggs mats installed (1-4), and the two half mats (5 and 6). EGBSC counted twelve (12) Walleye eggs and two Sucker eggs on egg mat 5 (half mat) on April 29. On May 2, two Walleye eggs and thirty-two (32) Sucker eggs were counted on egg mat 1 (set since April 15). No eggs were found on egg mat 6. In total, EGBSC counted twenty-eight (28) Walleye eggs and thirty-four (34) Sucker eggs at Dillon Rapids in 2016. In addition to egg mats, EGBSC recorded the locations of Walleye egg deposition, both underwater and stranded out of water.

Figure 21. Location of egg mats installed at Dillon Rapids in 2016. Egg mats 1-4 were set on April 15 and egg mats 5 and 6 were set on April 26.

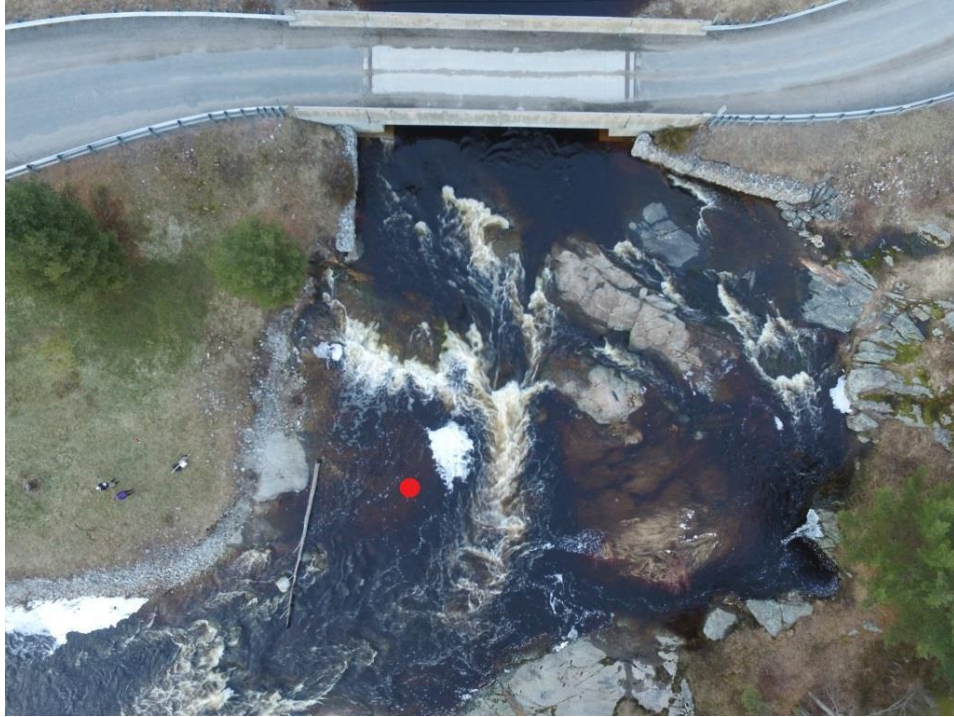
Due to high water levels and velocities in 2017, EGBSC was very limited in the timing and location of egg mat placement. At Dillon Rapids, only one spot was safely accessible for installing an egg mat within the appropriate spawning window (Figure 22). The egg mat was set on April 14 and checked throughout the spawning season. No eggs were observed on the mat at any point. The egg mat was removed on May 19.

Figure 22. Egg mat location at Dillon Rapids in 2017

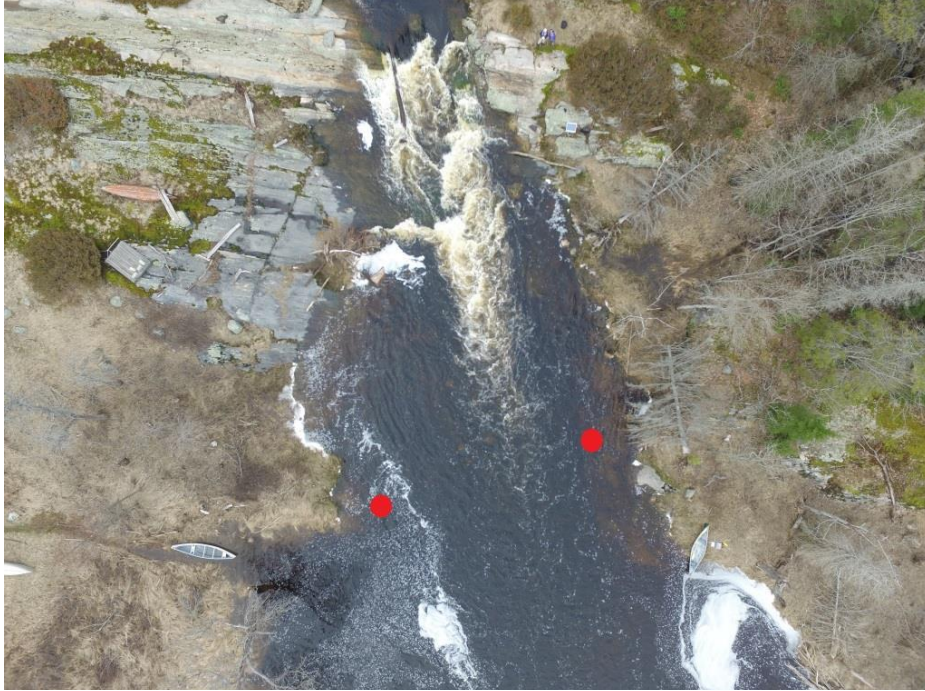
In 2017, only two locations were safely accessible for egg mat placement (Figure 23). The first opportunity EGBSC had to safely set an egg mat was April 24. No eggs were observed, and the egg mats were removed on May 19.

Figure 23. Egg mat locations at Young's Rapids in 2017

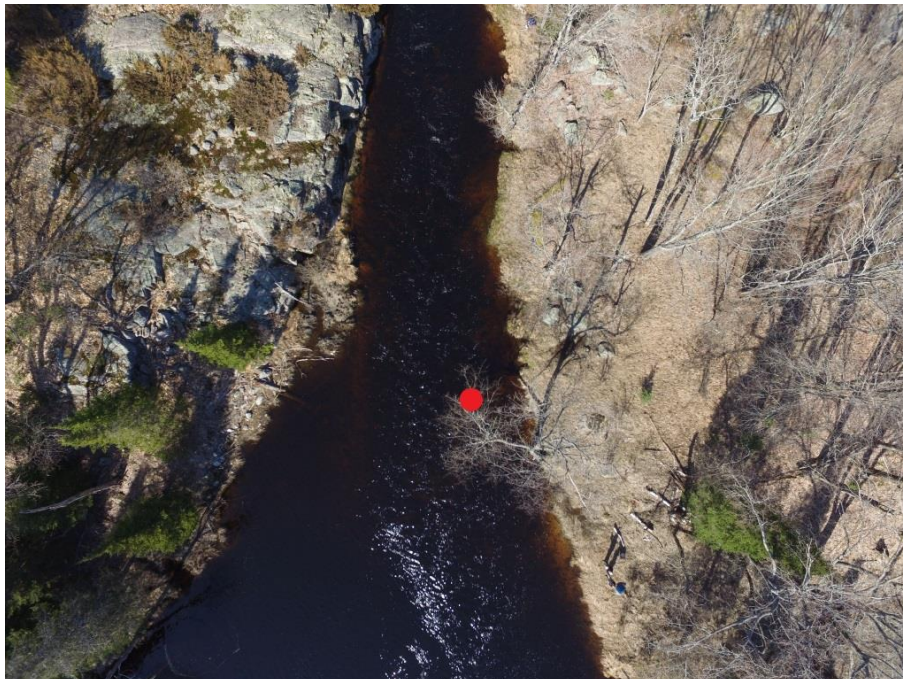
High flows in the spring of 2017 made accessing Lockett Lake Rapids by canoe unsafe for a large part of the spawning window. EGBSC was able to access the site on April 24 and install one egg mat (Figure 24). Due to water velocity and depth, no additional locations were identified as being safely accessible. The egg mat was checked periodically but no eggs were observed before the mat was removed on May 19.

Figure 24. Egg mat location at Lockett Lake Rapids in 2017

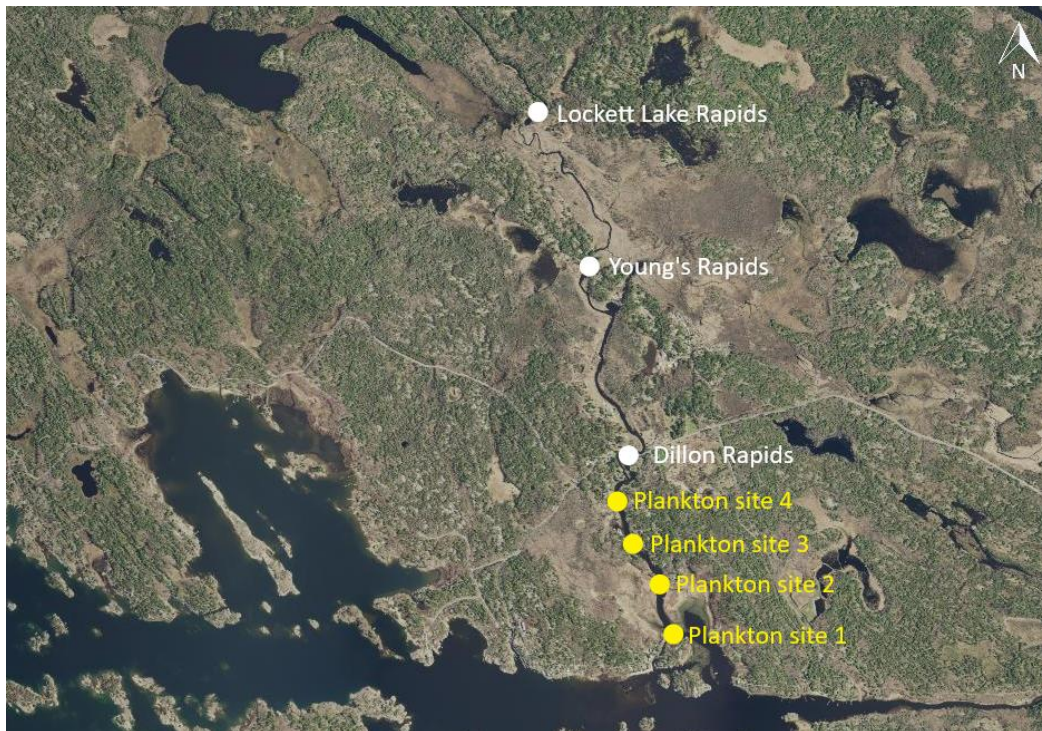
Once eggs incubate and hatch, fish enter their larval stage. Larval Walleye have limited mobility and typically move by drifting with water flow and wave action. Shortly after hatching, Walleye need to feed on zooplankton to ensure survival, growth, and development. The availability of zooplankton is a major factor in surviving this life stage. To help evaluate the amount of zooplankton downstream of Dillon Rapids, EGBSC conducted four plankton tows using a 12" diameter, 153 micron plankton net. The plankton sampling locations are illustrated in Figure 25.

Figure 25. Plankton sampling locations on the Shebeshekong River in 2016

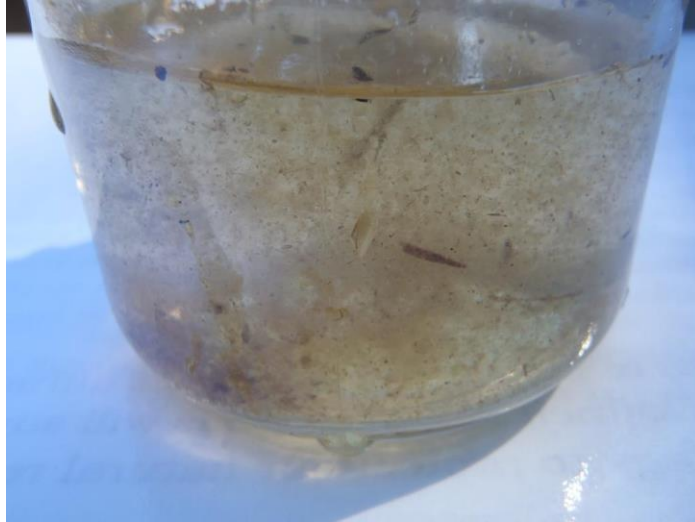
Figure 26. Plankton sample from Shebeshekong River in 2016

EGBSC did not identify and count the zooplankton in the samples. Only a visual observation of the samples could be made and compared with the four other rivers sampled in 2016. An example of a sample taken at the Shebeshekong River is shown in Figure 26. Relative to the samples from the other four rivers sampled in 2016, the Shebeshekong River had moderate plankton density (less than Shawanaga River, more than Magnetawan River).

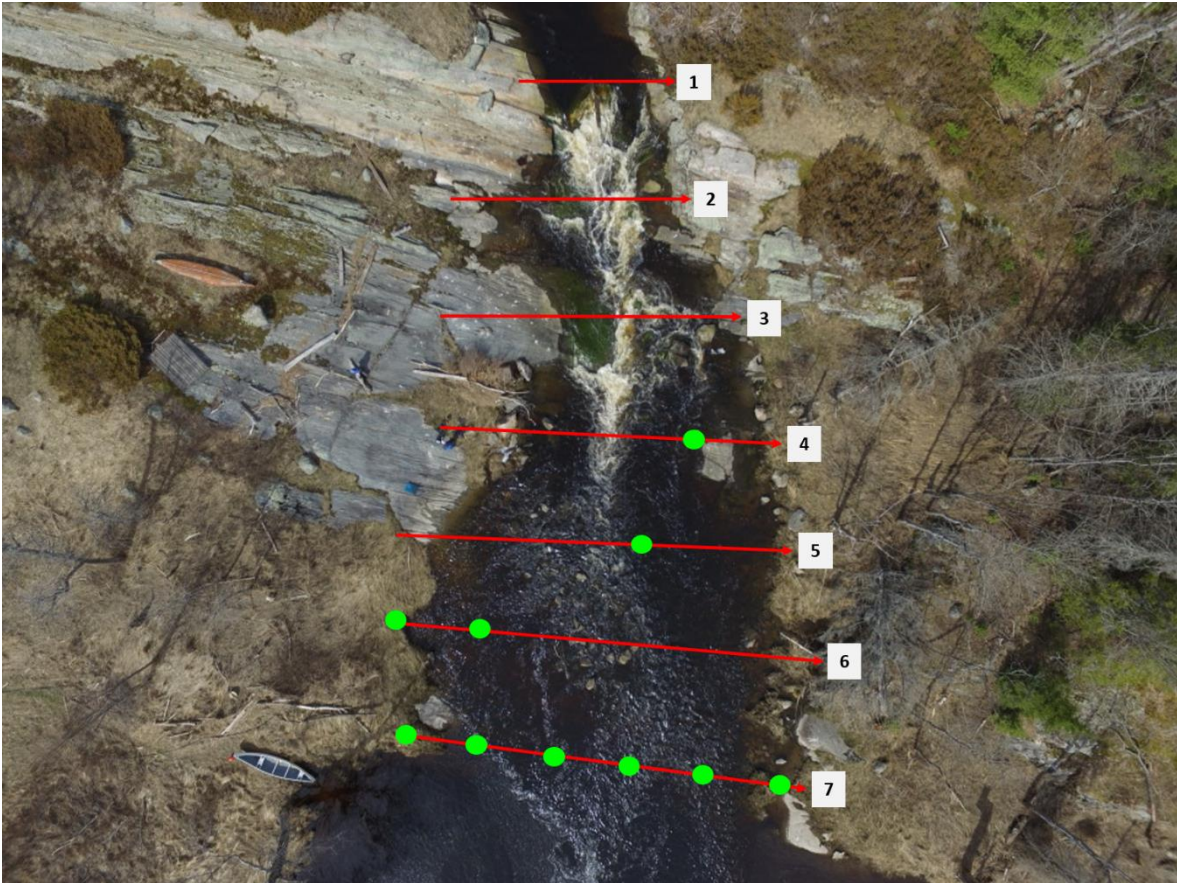
The locations of the seven transects completed at Young's Rapids are shown in Figure 28. The points measured with ideal substrate for Walleye are highlighted in green.

Figure 28. Spawning bed measurement transects at Young's Rapids. Green dots indicate ideal depth and substrate for Walleye spawning.

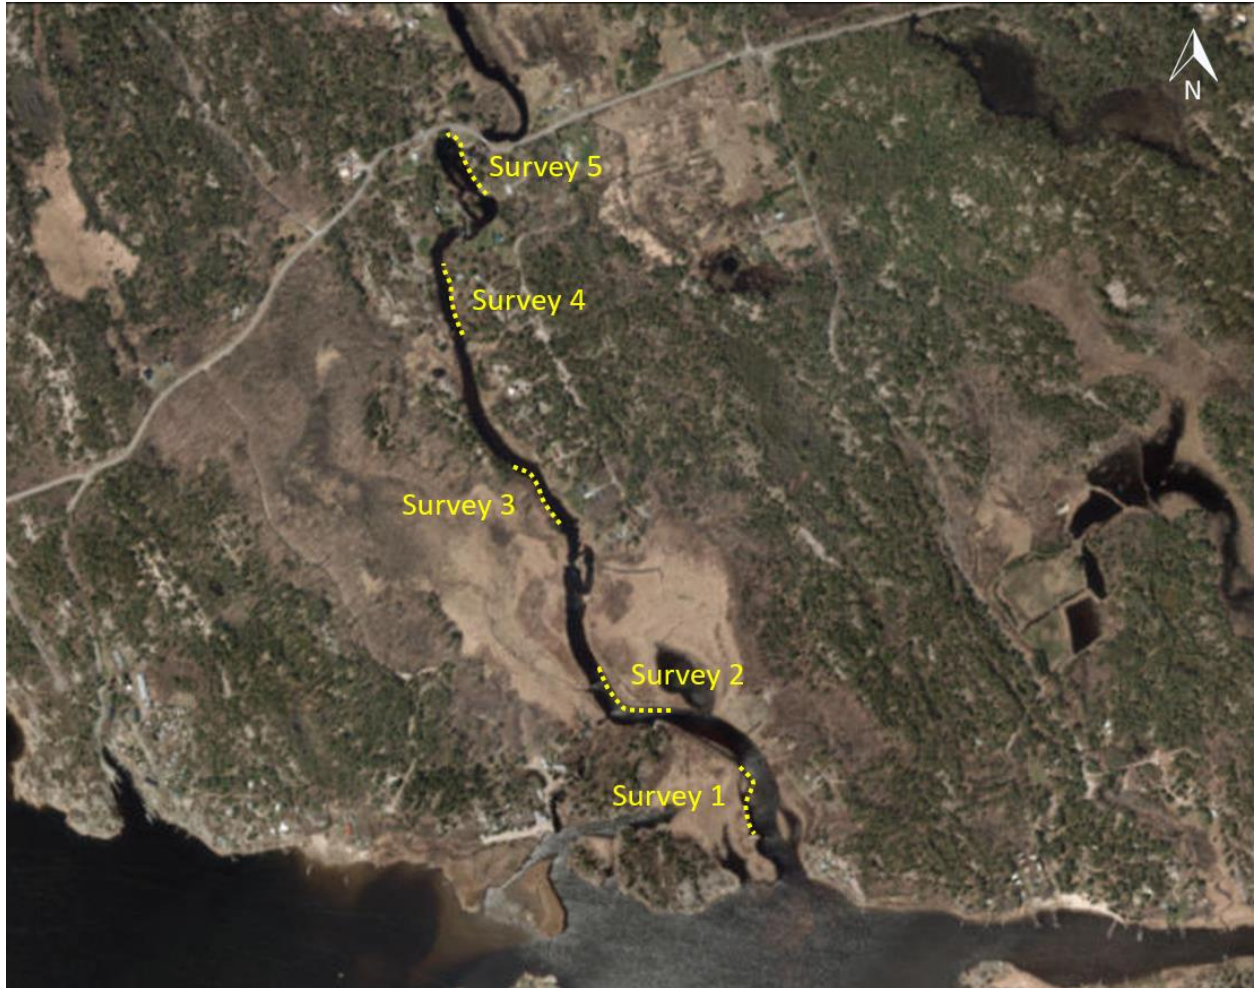
Bathymetry and side scan sonar data could only be collected from the mouth of the Shebeshekong River upstream to a point on the river referred to as Tumbling Rock (approximately 200 m downstream of Dillon Rapids). A shallow bedrock shelf across the rapids at Tumbling Rock prevented boat navigation farther upstream. Underwater videos were collected from this point up to Young's Rapids by canoe. Underwater videos were taken on a GoPro camera for approximately 100 m every 1 km. In total, EGBSC carried out nine underwater surveys. Underwater survey locations between Dillon Rapids and the outlet of the Shebeshekong River are identified in Figure 29. Survey locations between Dillon Rapids and Young's Rapids are shown in Figure 30. See [Appendix F](#) for bathymetry maps.

Figure 29. Underwater survey locations between the mouth of the Shebeshekong River and Dillon Rapids

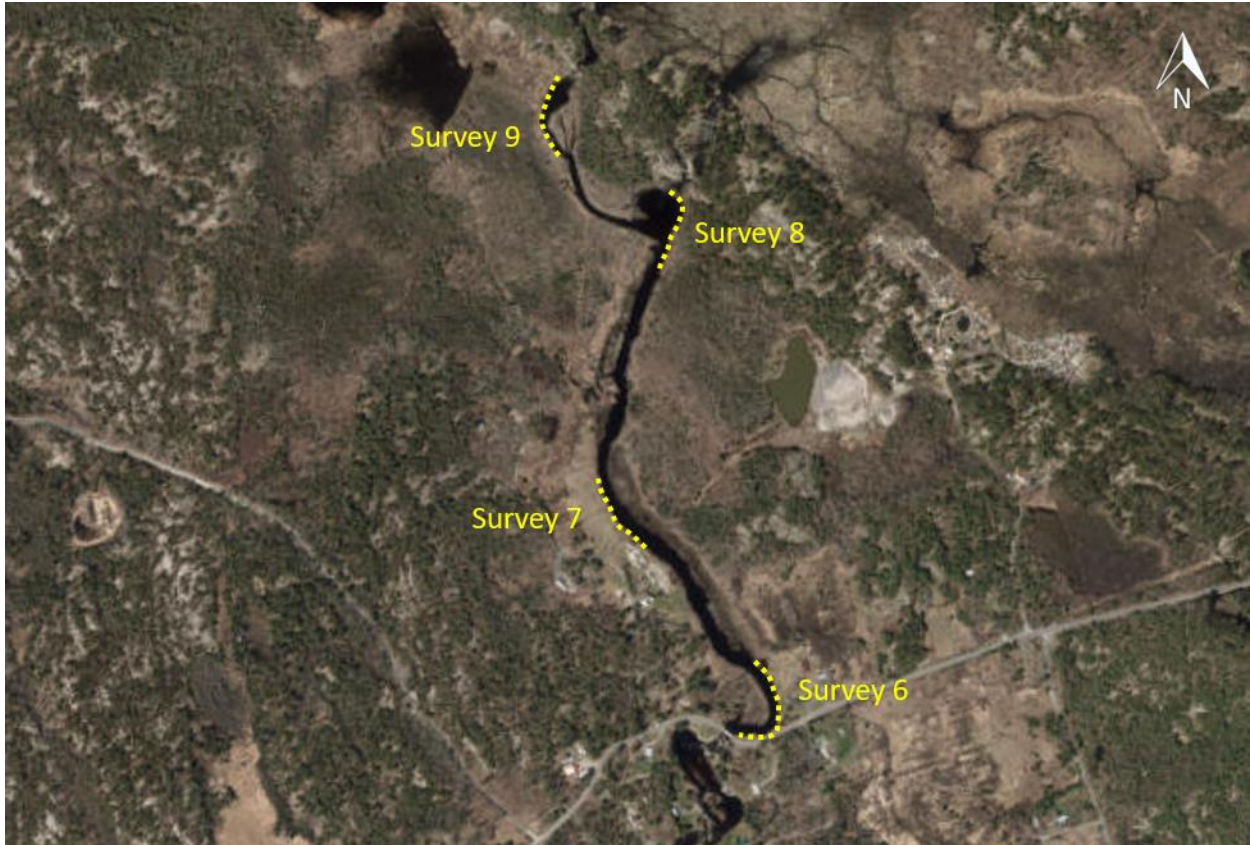
Figure 30. Underwater survey locations between Dillon Rapids and Young’s Rapids

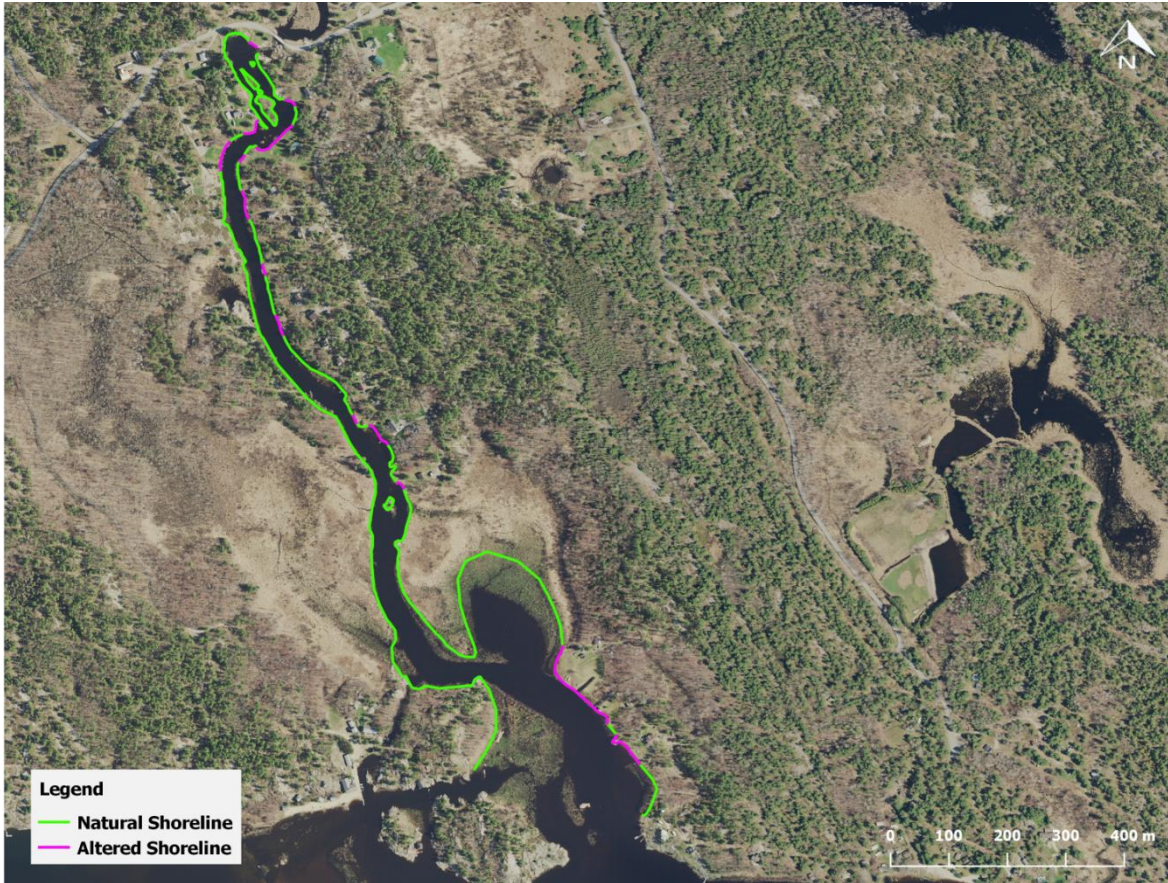
Along each of the nine underwater surveys, shoreline characteristics were also recorded and photographed. Between the mouth of the river and Dillon Rapids, the shoreline is a mix of both natural and altered shoreline (84% natural, 16% altered) (Figure 31). Observed alterations included the road at Dillon bridge and houses with mown grass close to the shoreline and/or cleared beaches. In this stretch, the shoreline varies between patchy bedrock and forest. Closer to the river outlet, there is an extensive wetland area. Approximately 900 m upstream of the outlet, wetlands gives way to a mix of bedrock and forested areas.

Figure 31. Natural and altered shoreline downstream of Dillon Rapids

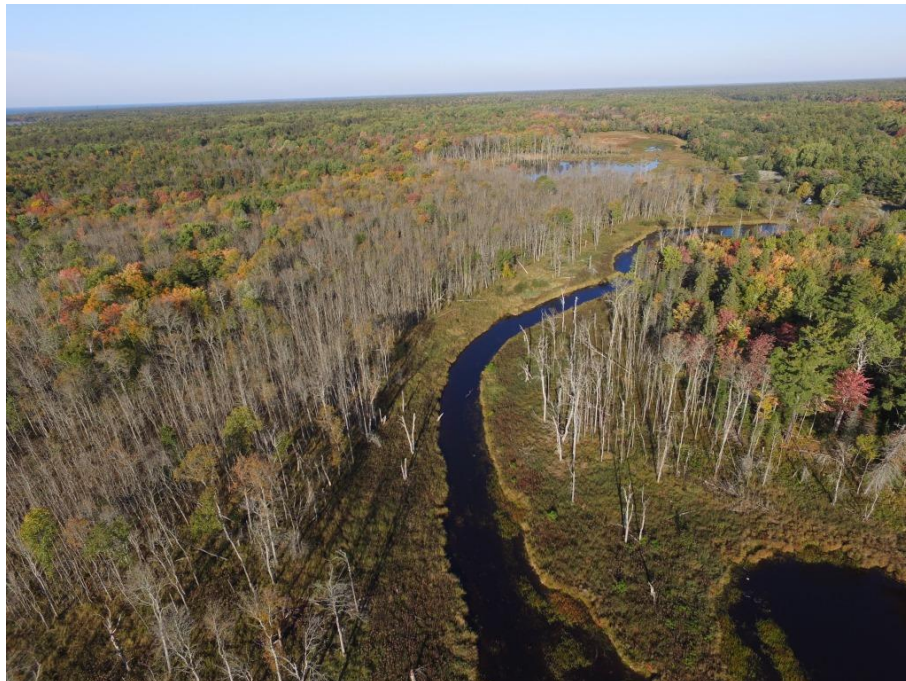
Figure 32. View of Shebeshekong River upstream of Dillon Rapids showing wet meadow shoreline with forest set farther back

Between Dillon and Young's Rapids, aside from two buildings and an area of mown grass, the shoreline is mainly natural with very few alterations. The shoreline is primarily wet meadow with forest set farther back from the shoreline (Figure 32) and a few areas with bedrock outcrops at the shoreline.

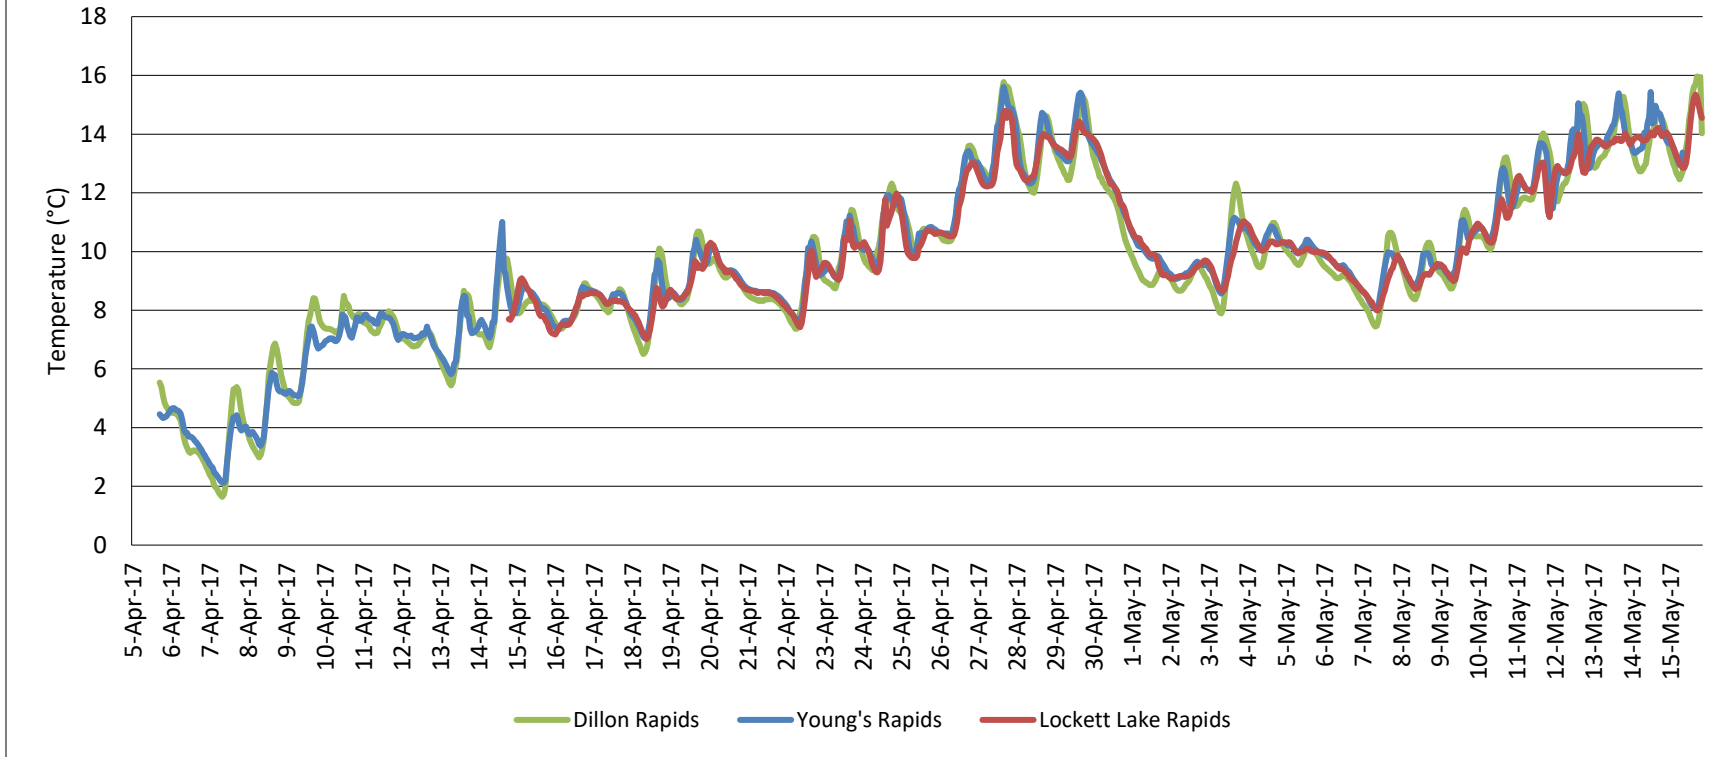
Shebeshekong River Hourly Temperature (°C) From April 5, 2017 to May 15, 2017

Note: The Young's Rapids temperature logger was found out of water and adjusted on April 14.
