Shebeshekong River Fish Habitat Assessment

Executive Summary

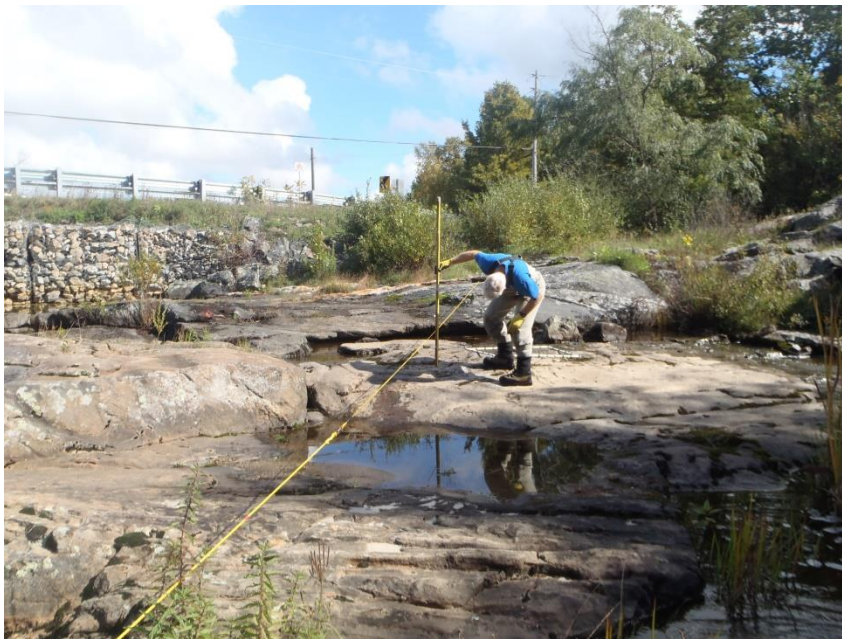
Transect 14

Point	Depth (m)		Particle sizes	Aquatic vegetation present
	Bankfull	Present		
(1) 1.31	0.29	0	100% bedrock	none
(2) 3.93	0.44	0	100% bedrock	none
(3) 6.55	0.51	0	75% bedrock, 25% soil	see p 145
(4) 9.17	0.33	0	100% bedrock	none
(5) 11.79	0.57	0.23	100% bedrock	none
(6) 14.41	0.13	0	100% vegetated	none

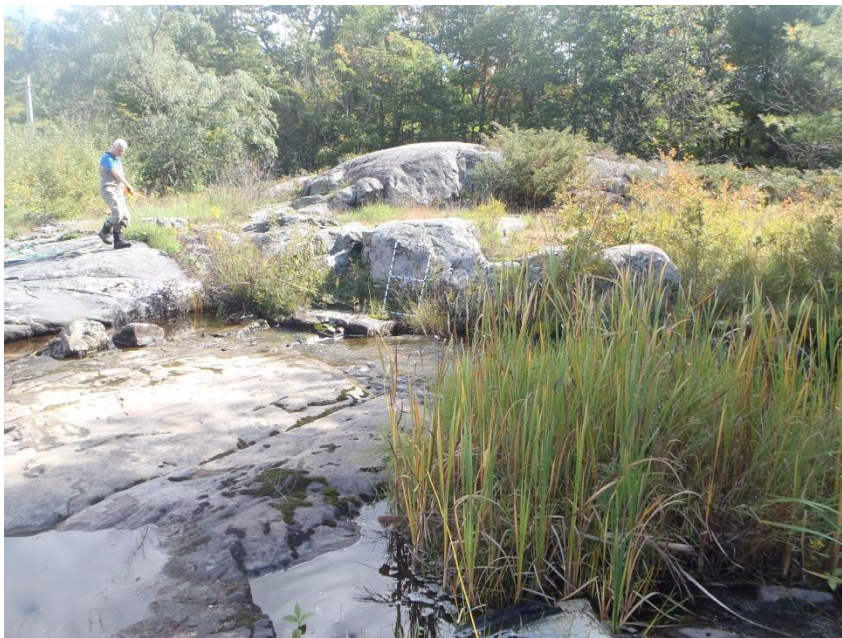
Transect 15

Point	Depth (m)		Particle sizes	Aquatic vegetation present
	Bankfull	Present		
(1) 1.33	0.72	0.39	70% cobble, 30% bedrock	none
(2) 4.0	0.63	0.31	80% bedrock, 20% sand	none
(3) 6.67	0.6	0.27	100% sand	none
(4) 9.34	0.59	0.21	60% sand/soil, 40% bedrock	none
(5) 12.01	0.14	0	100% vegetated	terrestrial veg
(6) 14.68	0.06	0	50% lg boulder, 50% soil/veg	terrestrial veg

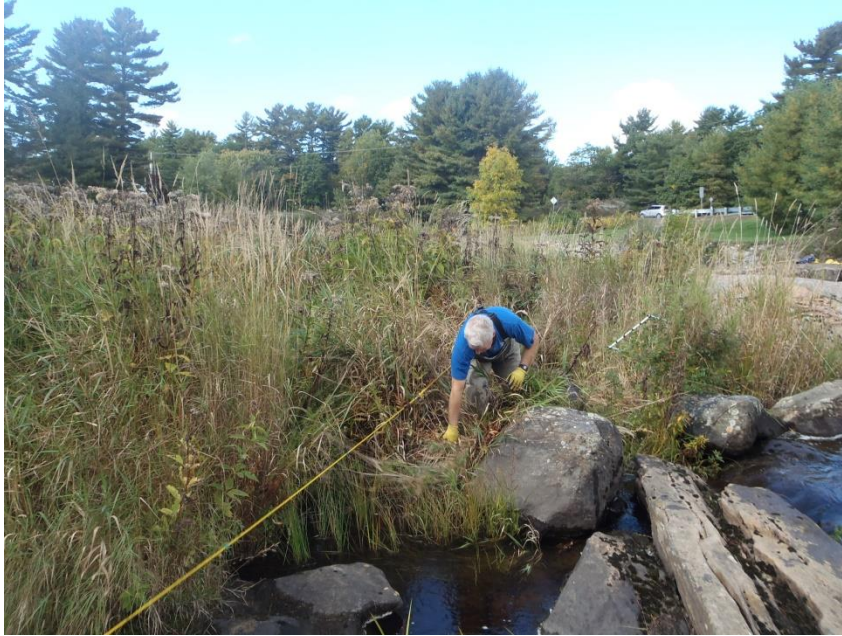
Transect 16

Point	Depth (m)		Particle sizes	Aquatic vegetation present
	Bankfull	Present		
(1) 0.83	0.73	0.35	50% lg boulder, 50% bedrock	none
(2) 2.50	0.89	0.5	60% cobble, 40% lg stone	none
(3) 4.17	0.85	0.47	80% bedrock, 20% cobble, too murky for photo	none
(4) 5.84	0.85	0.46	100% bedrock	none
(5) 7.51	0.3	0	100% vegetated	reeds
(6) 9.18	0.11	0	100% vegetated	reeds

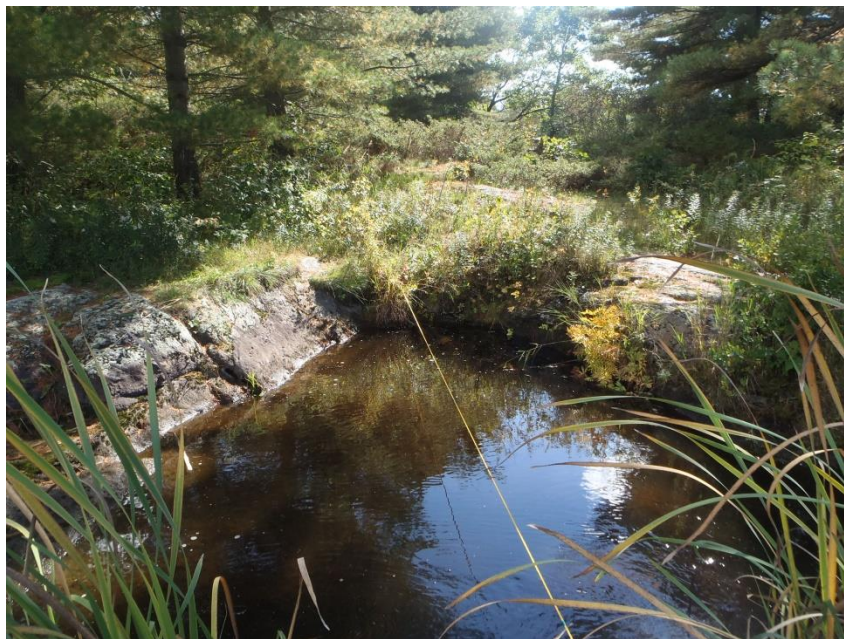
Transect 17

Point	Depth (m)		Particle sizes	Aquatic vegetation present
	Bankfull	Present		
(1) 0.42	0.27	0	100% bedrock	none
(2) 1.25	0.37	0	100% bedrock	none
(3) 2.08	0.67	0.26	100% bedrock	none
(4) 2.91	0.41	0	100% vegetated	see p 152
(5) 3.74	0.33	0	100% vegetated	see p 153
(6) 4.57	0.09	0	100% vegetated	see p 154

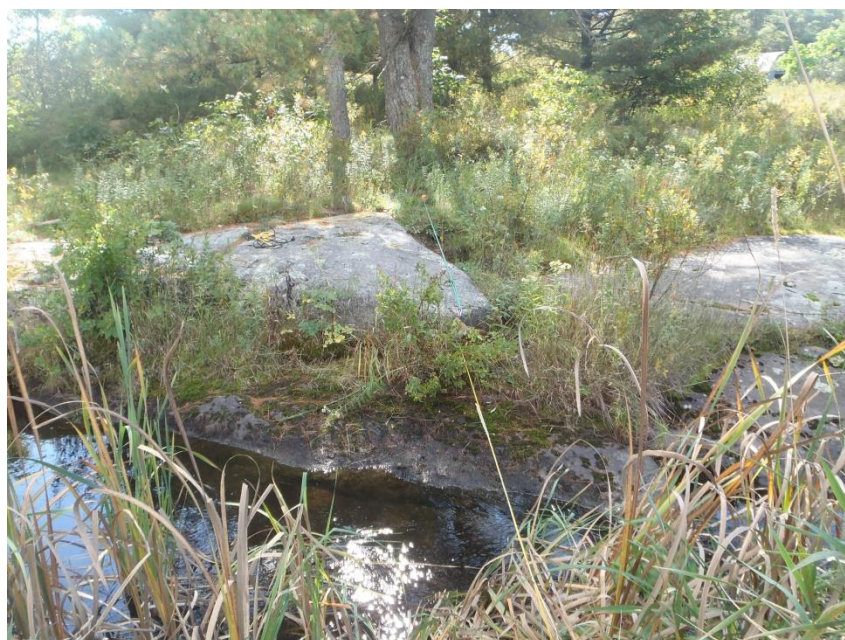
Transect 18

Point	Depth (m)		Particle sizes	Aquatic vegetation present
	Bankfull	Present		
(1) 0.27	0.04	0	100% bedrock	none
(2) 0.81	0.25	0	100% bedrock	none
(3) 1.35	0.36	0.07	100% bedrock	none
(4) 1.89	0.42	0.12	100% bedrock	none
(5) 2.43	0.22	0	100% vegetated	see p 161
(6) 2.97	0.3	0	100% vegetated	see p 162

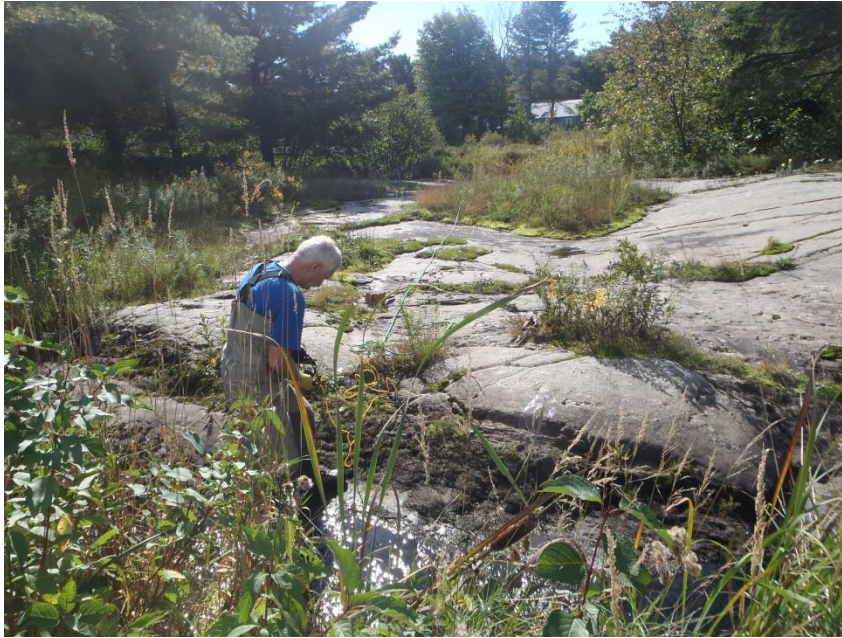
Transect 19

Point	Depth (m)		Particle sizes	Aquatic vegetation present
	Bankfull	Present		
(1) 0.24	0.17	0	100% bedrock	none
(2) 0.72	0.62	0.16	100% bedrock	none
(3) 1.20	0.75	0.28	100% cobble	none
(4) 1.68	0.58	0.12	100% bedrock	none
(5) 2.16	0.16	0	100% bedrock	none
(6) 2.64	0.02	0	100% bedrock	none

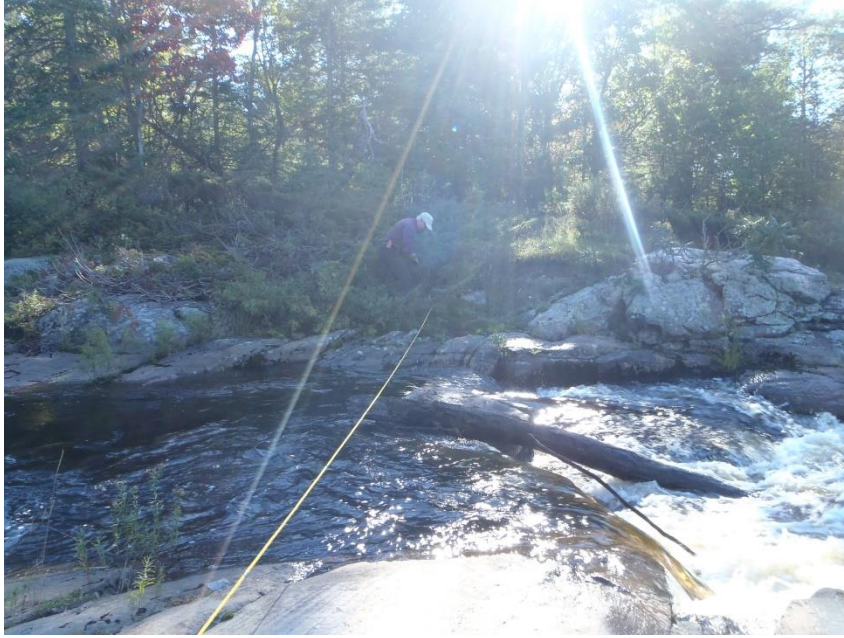
Transect 2

Point	Depth (m)		Particle sizes	Aquatic vegetation present
	Bankfull	Present		
(1) 1.32	0.24	0	100% bedrock	none
(2) 3.96	0.25	0	100% bedrock	none
(3) 6.60	0.62	0	100% bedrock	none
(4) 9.24	0.5	0.02	100% bedrock	none
(5) 11.88	0.78	0.35	100% bedrock	none
(6) 14.52	0.44	0	100% bedrock	none

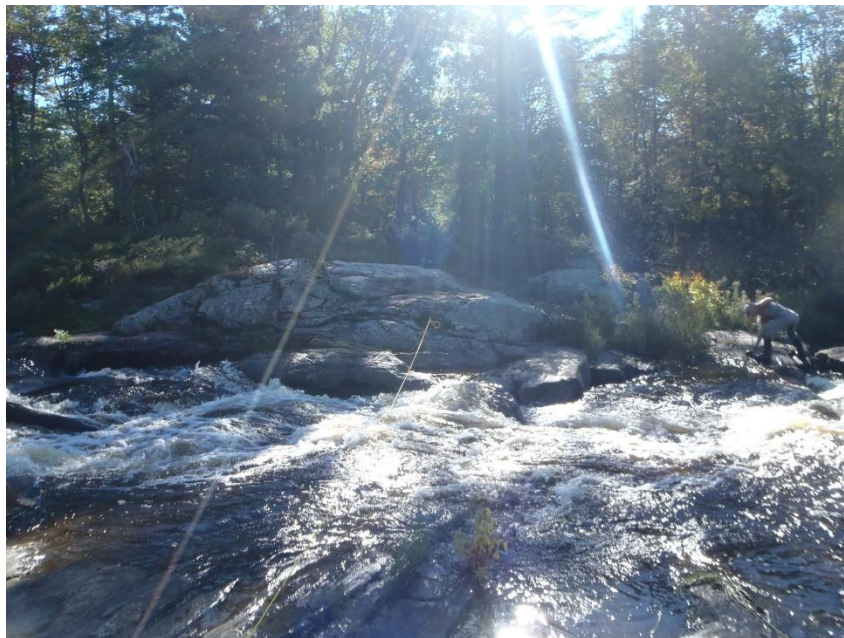
Transect 3

Point	Depth (m)		Particle sizes	Aquatic vegetation present
	Bankfull	Present		
(1) 1.89	0.17	0	100% bedrock	none
(2) 5.66	0.19	0	100% bedrock	none
(3) 9.43	0.19	0	100% bedrock	none
(4) 13.20	0.39	0.08	90% bedrock, 10% lg boulder	none
(5) 16.97	0.66	0.10	90% bedrock, 10% lg boulder	none
(6) 20.74	0.11	0	100% bedrock	none

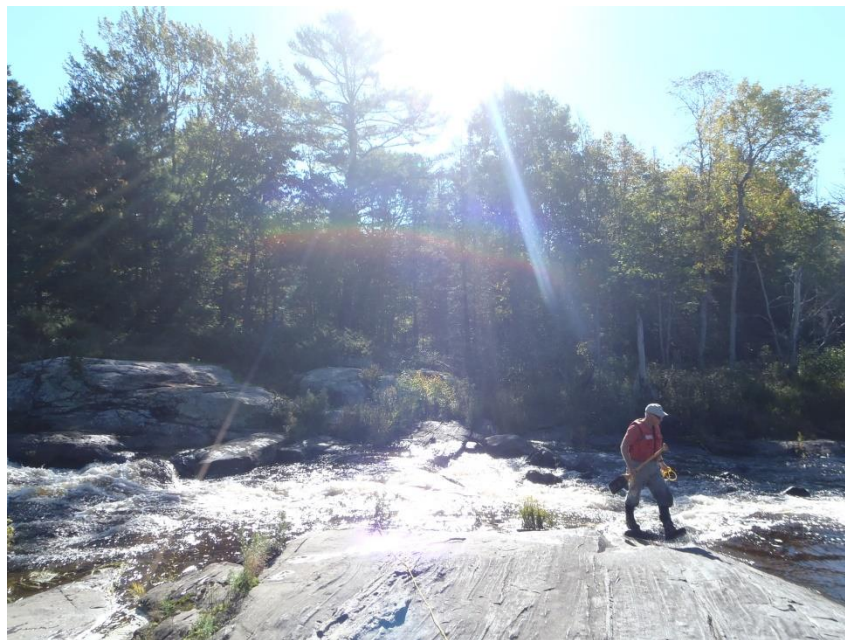
Transect 4

Point	Depth (m)		Particle sizes	Aquatic vegetation present
	Bankfull	Present		
(1) 1.96	0.09	0	100% bedrock	none
(2) 5.88	0.37	0	100% bedrock	none
(3) 9.80	0.33	0	100% bedrock	none
(4) 13.72	1.06	0.42	30% lg boulder, 10% sm boulder, 10% cobble, 50% bedrock	none

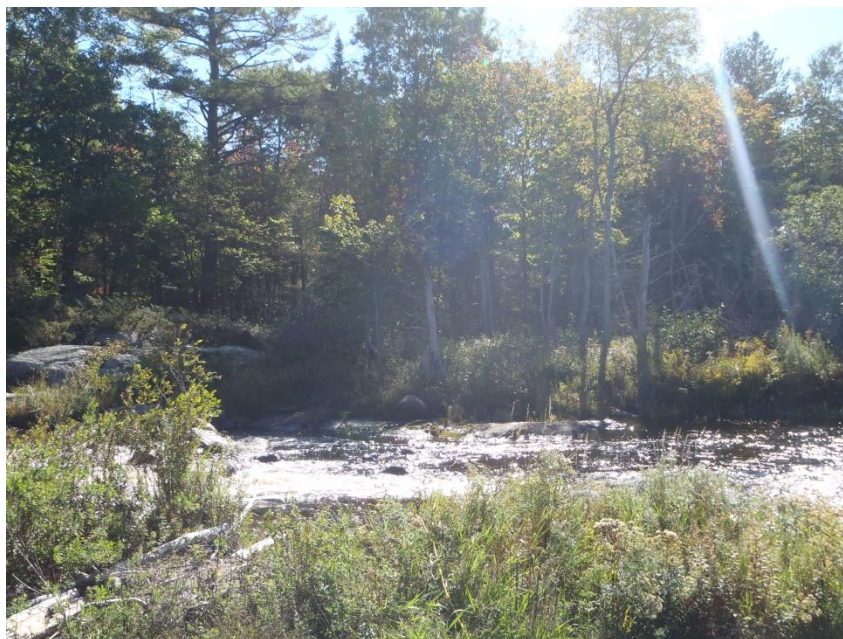
Transect 5

Point	Depth (m)		Particle sizes	Aquatic vegetation present
	Bankfull	Present		
(1) 2.04	0.12	0	Soil overlaying bedrock	see p 67
(2) 6.12	0.39	0	100% bedrock	none
(3) 10.20	0.4	0.07	100% sm boulder	none
(4) 14.28	0.66	0.47	33% sm boulder, 33% lg boulder, 33% cobble	none
(5) 18.36	0.48	0.30	100% lg boulder	none
(6) 22.44	0.46	0.22	50% lg boulder, 50% sm boulder	none

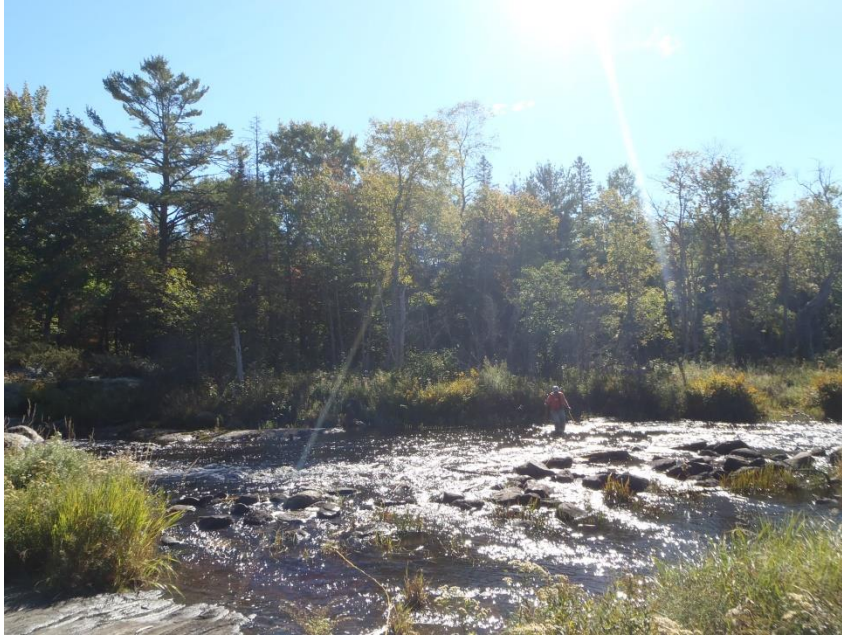
Transect 6

Point	Depth (m)		Particle sizes	Aquatic vegetation present
	Bankfull	Present		
(1) 1.81	0.52	0.29	80% bedrock, 10% lg boulder, 10% cobble	none
(2) 5.43	0.67	0.46	100% cobble	none
(3) 9.05	0.59	0.35	50% lg boulder, 50% sm boulder	none
(4) 12.67	0.35	0.19	100% lg boulder	none
(5) 16.29	0.42	0.21	80% lg boulder, 20% sm boulder	none
(6) 19.91	0.39	0.15	50% lg boulder, 50% sm boulder	Herbaceous veg overhanging /getting caught in flow

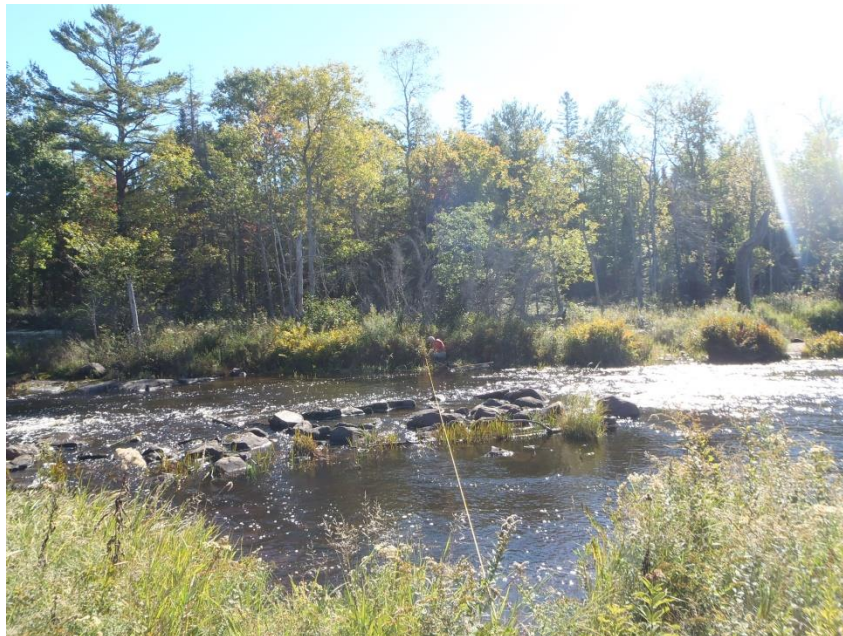
Transect 7

Point	Depth (m)		Particle sizes	Aquatic vegetation present
	Bankfull	Present		
(1) 1.53	0.62	0.34	30% bedrock, 50% lg boulder, 20% cobble	none
(2) 4.58	0.5	0.26	100% cobble	none
(3) 7.63	0.81	0.61	80% bedrock, 10% lg boulder, 10% cobble	none
(4) 10.68	0.53	0.32	60% sm boulder, 40% cobble	Same veg in p 67
(5) 13.73	0.41	0.17	30% sm boulder, 70% cobble	none
(6) 16.78	0.45	0.14	10% sm boulder, 90% cobble	none
