Sucker Creek Fish Habitat Assessment

Executive Summary

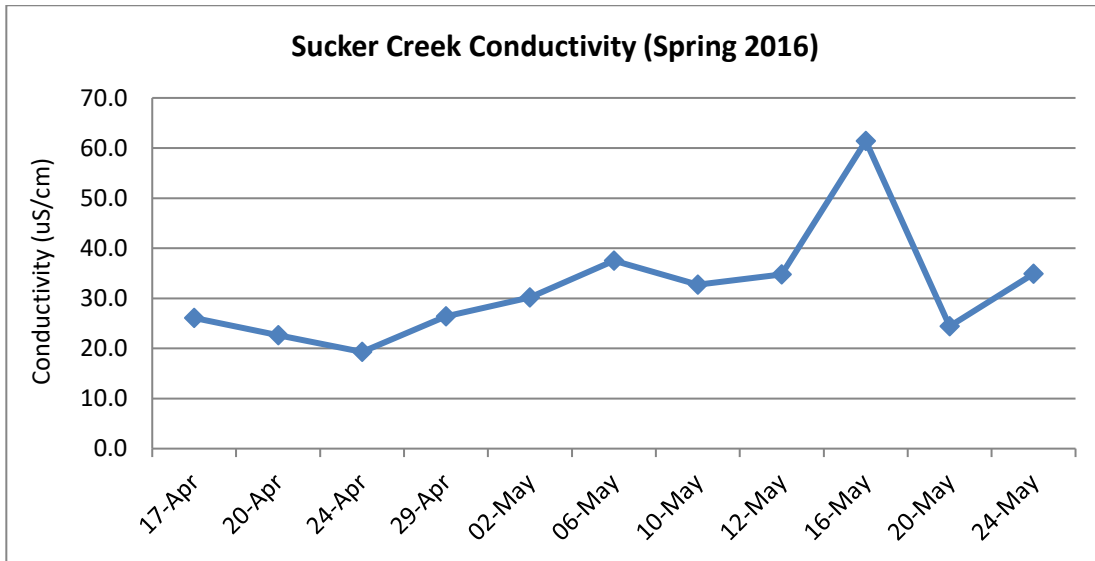
Figure 5. Conductivity measurements (uS/cm) at the Sucker Creek spawning bed in spring 2016

Conductivity was also measured at Sucker Creek in 2016 (Figure 5). Conductivity measures the ability of water to pass an electrical current and is influenced by geology. For example, a clay substrate will have a high conductivity because of a greater amount of ions in the water. Rivers within the Parry Sound District typically have low conductivity, but conductivity can be significantly affected by stormwater runoff, and a sudden increase or decrease can indicate issues in a waterbody. Conductivity was recorded between April 17 and May 24. Conductivity was consistently low throughout the study period, with the exception of one spike up to 61.4 uS/cm on May 16. This spike may have been related to a large rain event that occurred on May 14 and the resulting highway runoff. The lowest conductivity measured was 19.3 uS/cm on April 24. Overall, conductivity generally stayed within the low 20 to high 30 uS/cm range.

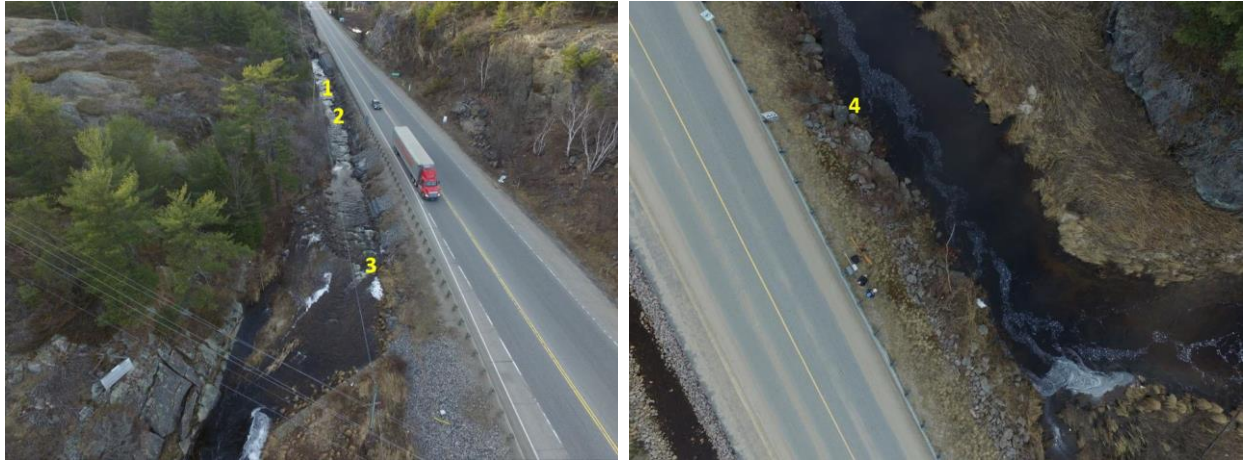
Figure 6. Water velocity (1-4) and water level stations (1,2,4) at the Sucker Creek spawning bed

Four stations were established at the Sucker Creek spawning bed to collect information on water velocity from April 20 to May 24 (Figure 6). Figure 7 displays velocity measurements recorded at each station. Complete water level and velocity data can be found in [Appendix B](#).

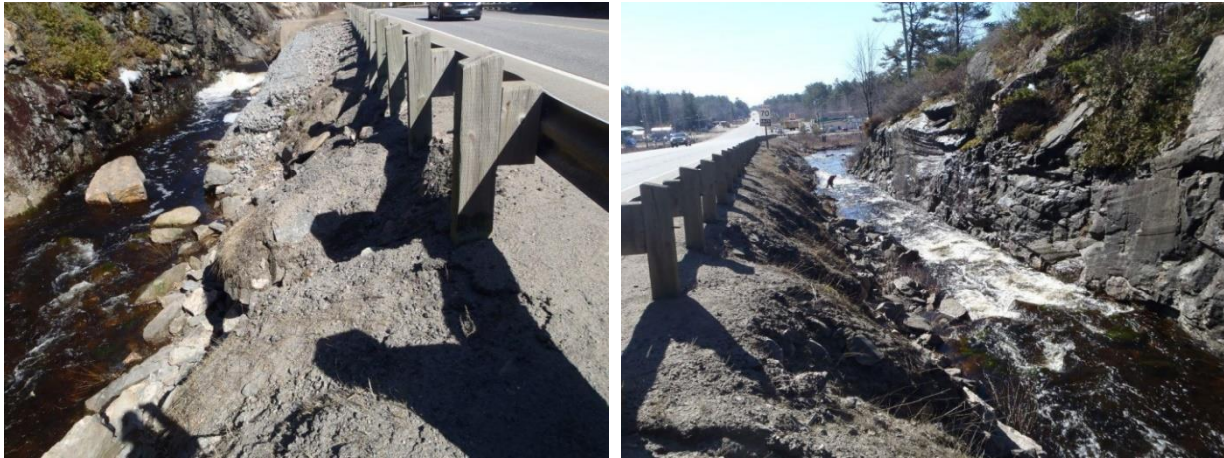
Figure 8. Erosion and runoff points into Sucker Creek between stations 1 and 2

between the highway and the creek, and it is possible that runoff was entering the creek between stations 1 and 2 (Figure 8). Station 4 also experienced an increase on May 16, but it was much less than the other stations. Station 4 was located below the spawning bed and was close to, or at, Georgian Bay water levels. Sucker Creek widens below station 3, which reduces velocities downstream. Overall, velocity was very low at station 4. There were no velocities recorded at Sucker Creek that would exclude Walleye or Sucker species from the spawning area.

There were two potential issues of concern observed at Sucker Creek. The first issue is the runoff from the highway and road straight into the creek. Erosion along the east side of the creek at the spawning bed got worse as the season progressed. This erosion would introduce sand and fine material which could accumulate in the spawning area over time, and reduce the amount of interstitial spaces needed for egg deposition. In addition, direct runoff from the highway would wash any contaminants straight into the creek.

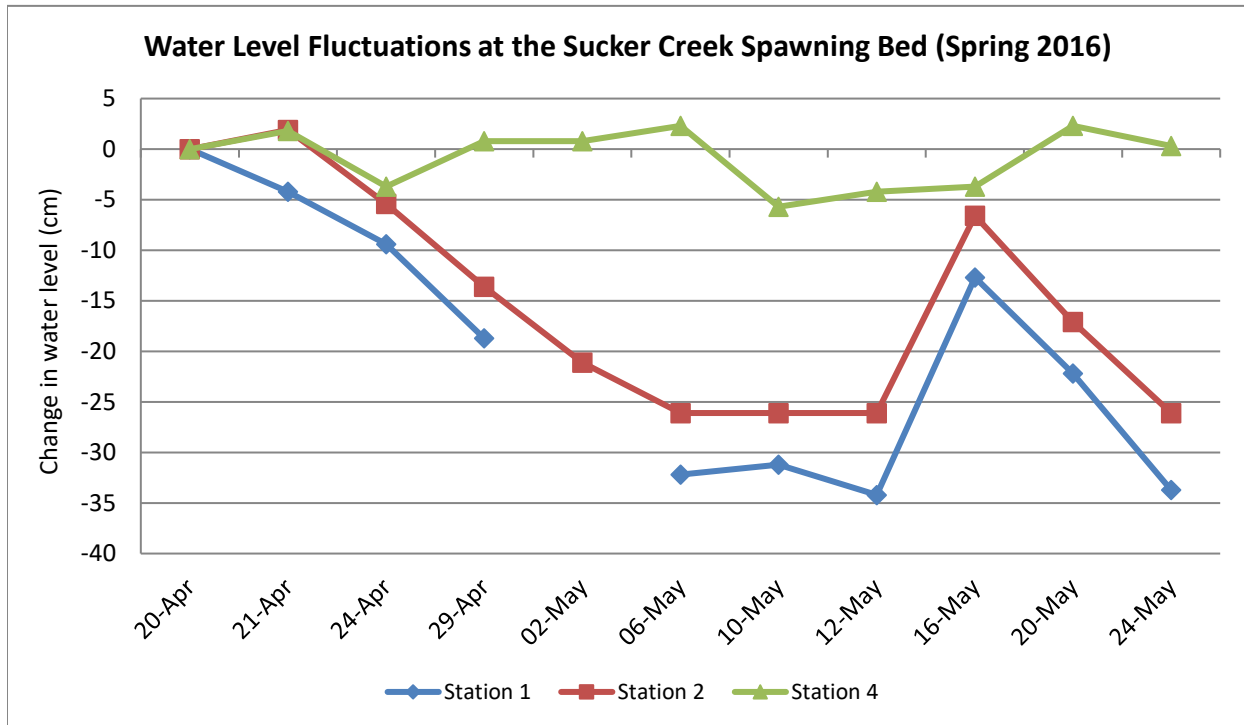
Figure 9. Water level fluctuations at the Sucker Creek spawning bed, measured at stations 1, 2, and 4. Measurements on the first site visit served as the benchmark against which future measurements were compared (i.e., water level up or down compared to the first site visit).

only increased by 0.5 cm and by another 5.5 cm by May 20. Water levels had declined slightly (2 cm) by the last field visit on May 24.

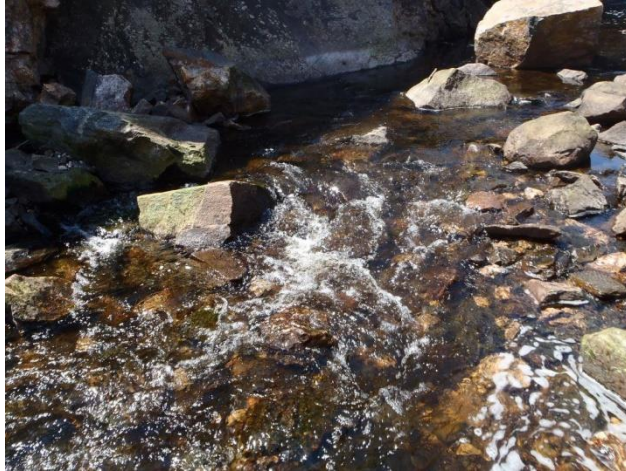
Figure 10. Ledge 1 on May 6, 2016

Ledge	Depth Range (cm)	Notes
1	10-15	White Sucker swimming upstream without issue
2	5-15	
3	4-15	15 to 30 cm ledge to ascend
4	4-15	15 to 35 cm ledge to ascend
5	12-25	25 cm ledge to ascend
6	8-15	20 to 25 cm ledge to ascend
7	13-25	gradual slope
8	5-20	20 cm drop
9	8-15	35 cm ledge to ascend

Along the Sucker Creek spawning area, there are a number of short ledges that fish need to ascend to get farther upstream. By April 20, water levels had dropped significantly in portions of the creek. By May 3, when several hundred White Sucker were spawning all along the spawning bed, water levels were much lower. On May 6, White Sucker were still actively spawning, and in many cases, their dorsal fins, and sometimes the upper portion of their bodies were above water due to reduced depth. EGBSC measured the range of water depth available at each ledge to investigate how much depth White Sucker had to navigate upstream. Table 1 lists the range of depths, and for most ledges, the height. Figures 10 - 18 illustrate the low water levels at each ledge on May 6.

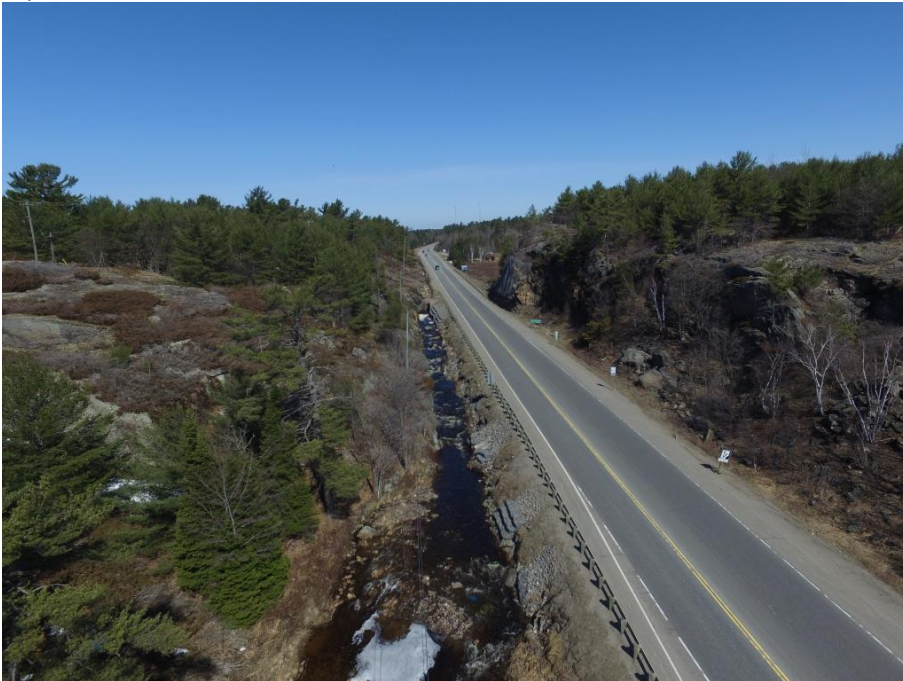
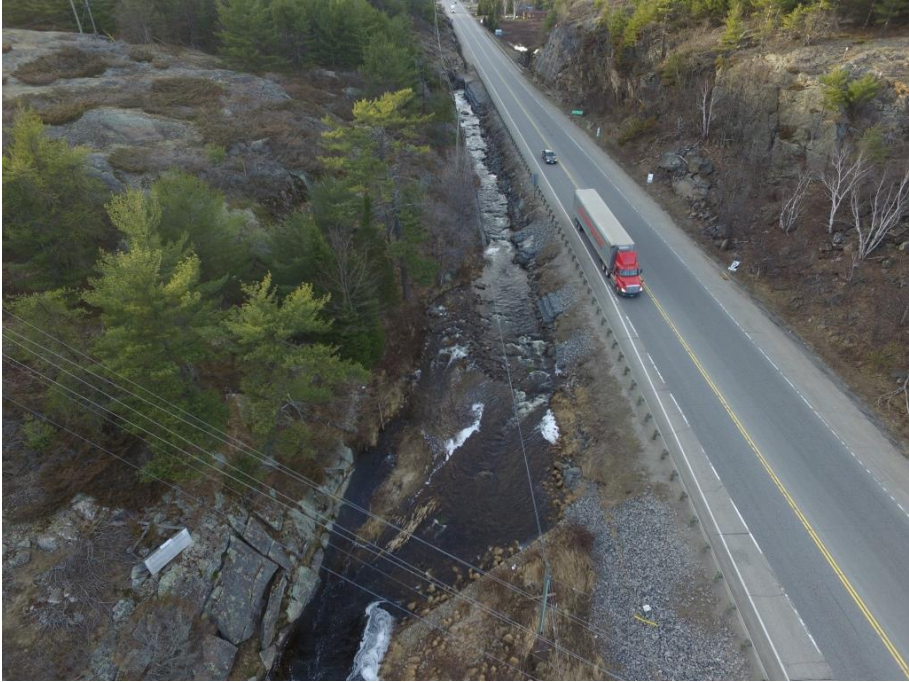
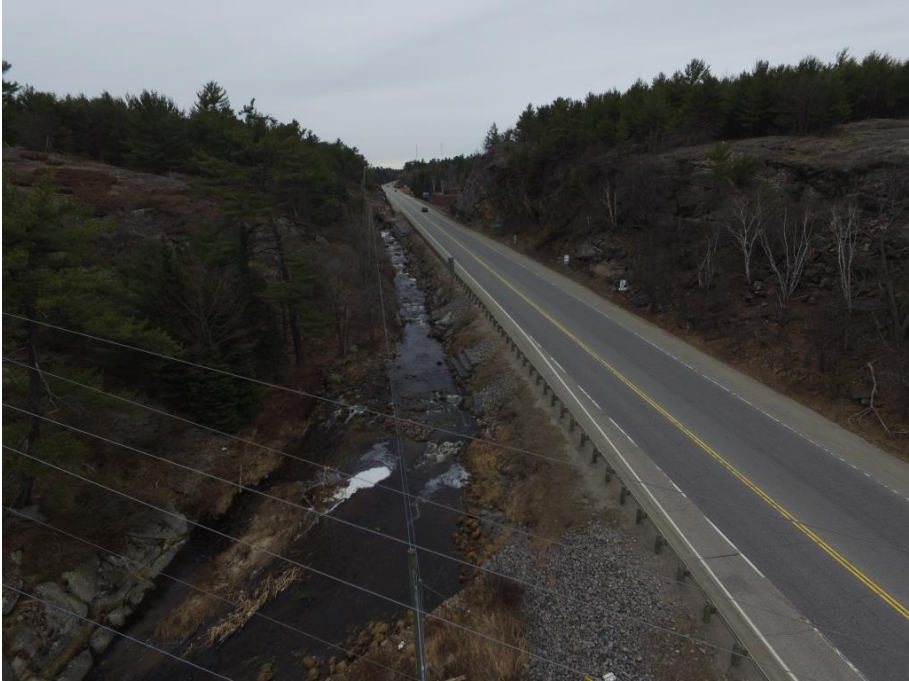
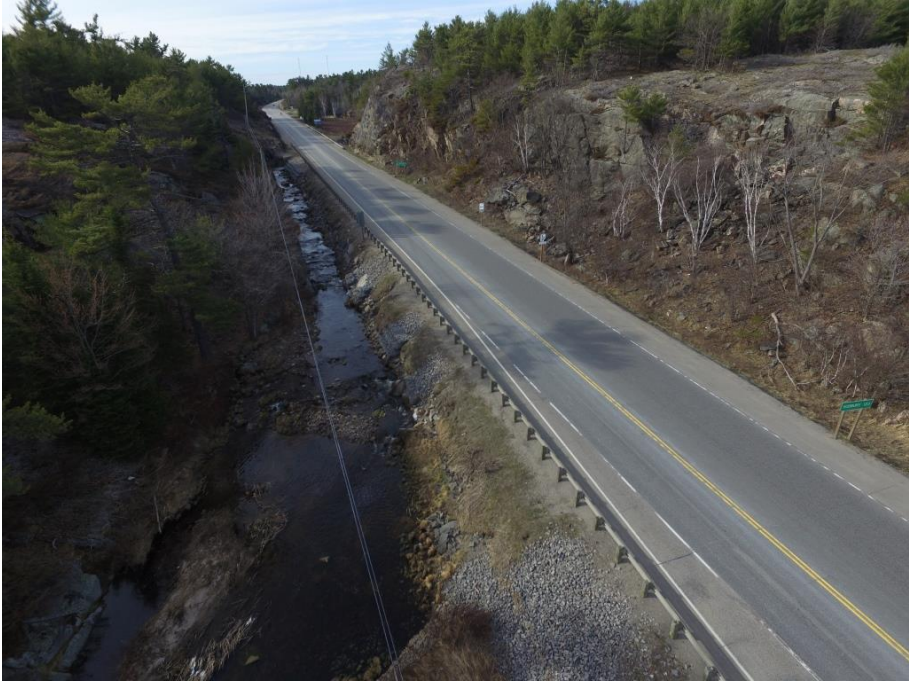
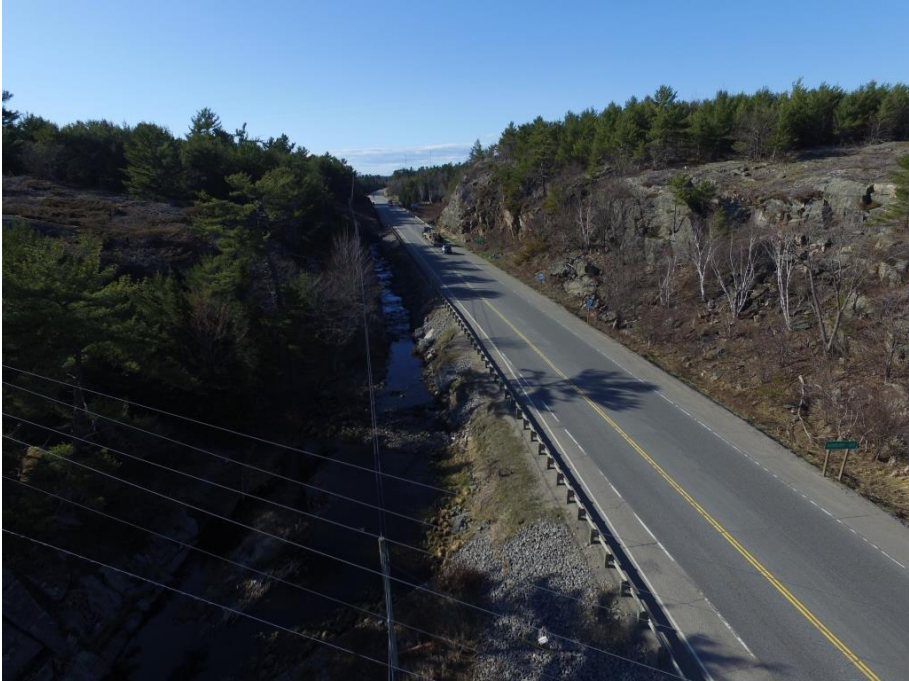
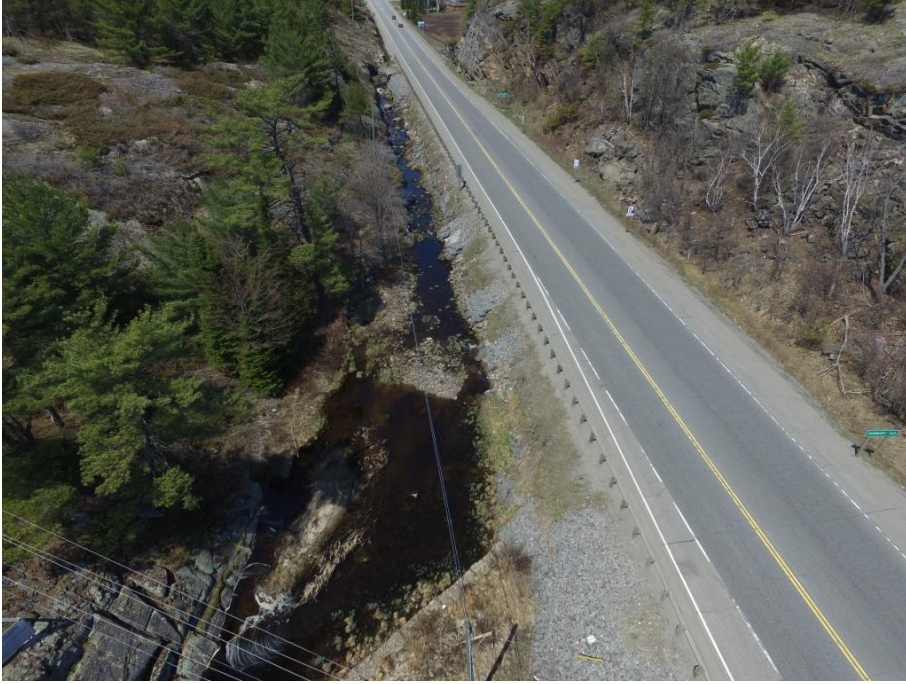
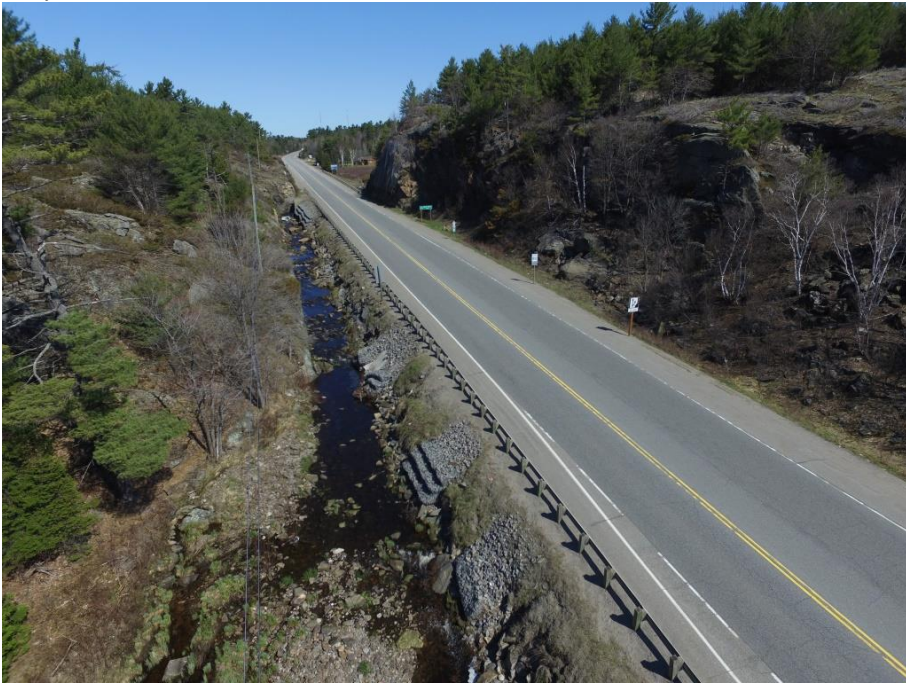
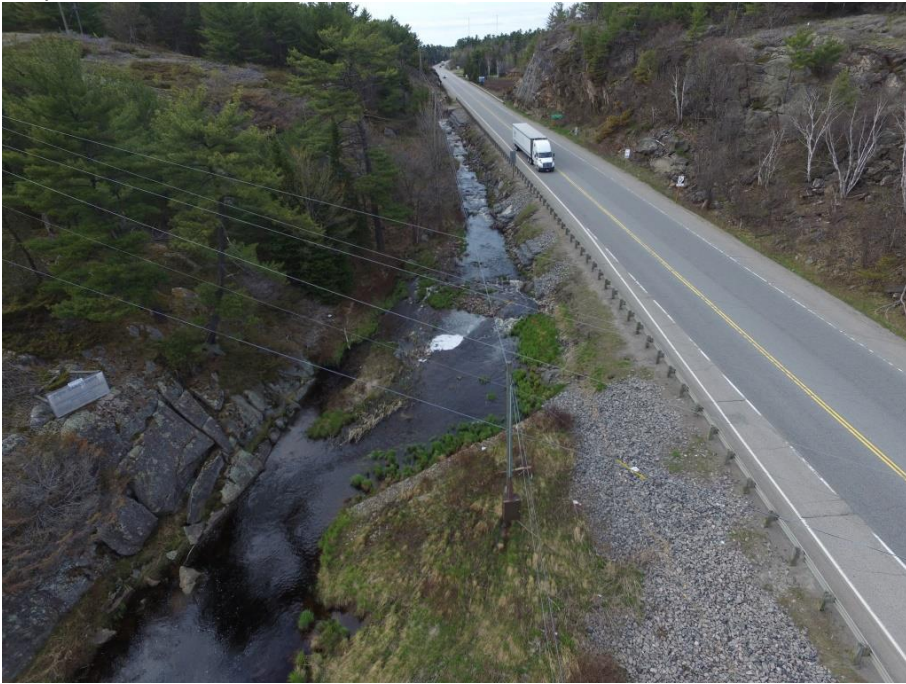
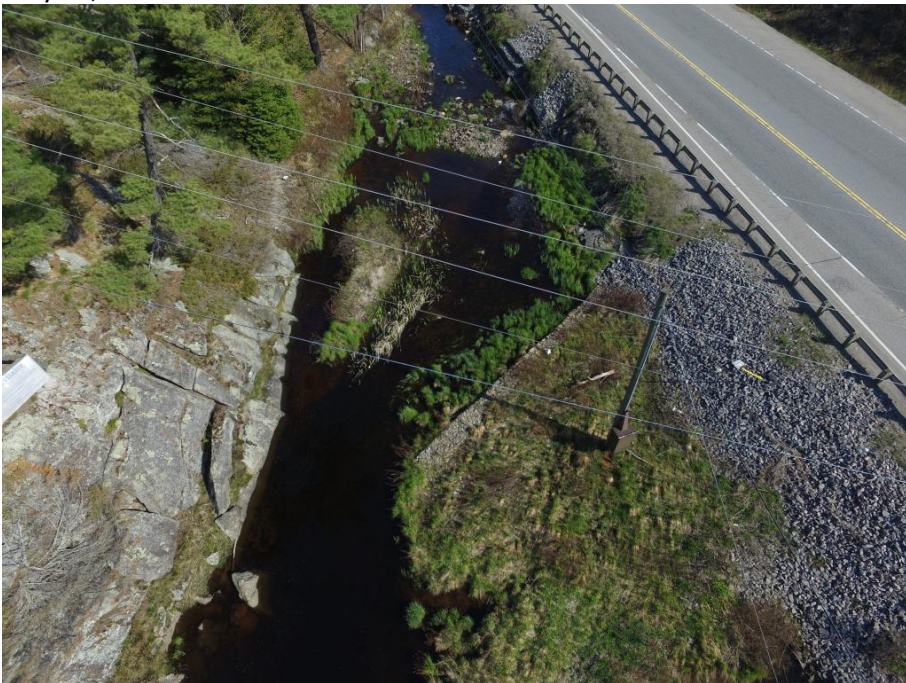
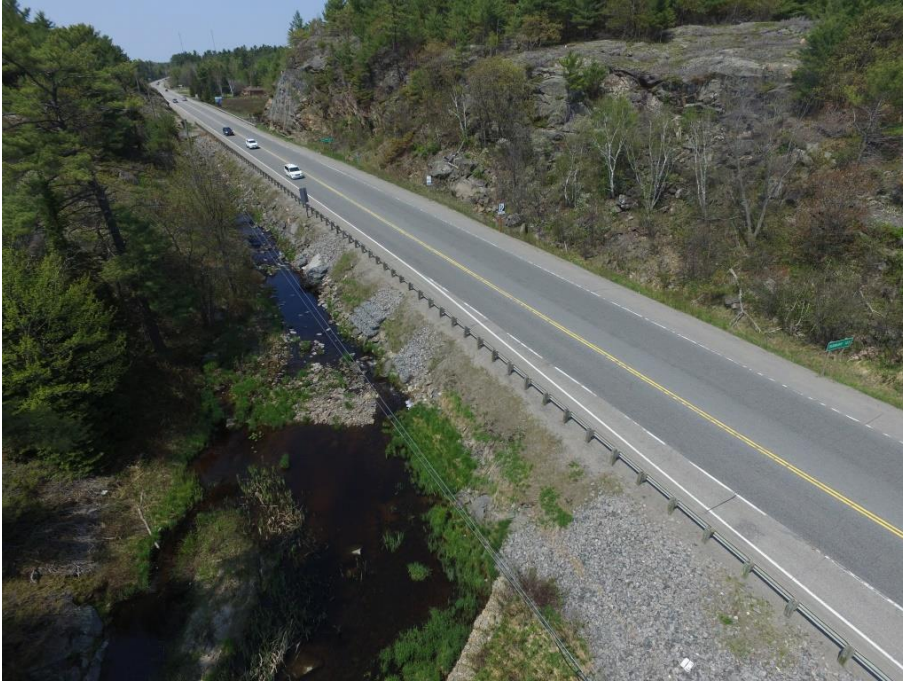
An important component of the spawning bed assessments was taking a series of drone photographs during the spawning and egg incubation period to help evaluate how the spawning area changed throughout the spring freshet. During each visit, weather permitting, EGBSC staff flew a drone to capture photos of the spawning bed. Unlike the other rivers, at Sucker Creek, EGBSC was unable to get overlapping photos of water levels due to the proximity of the creek to the highway. As a result, no orthomosaics can be created from the site. Instead, photos were taken looking upstream at the spawning bed.

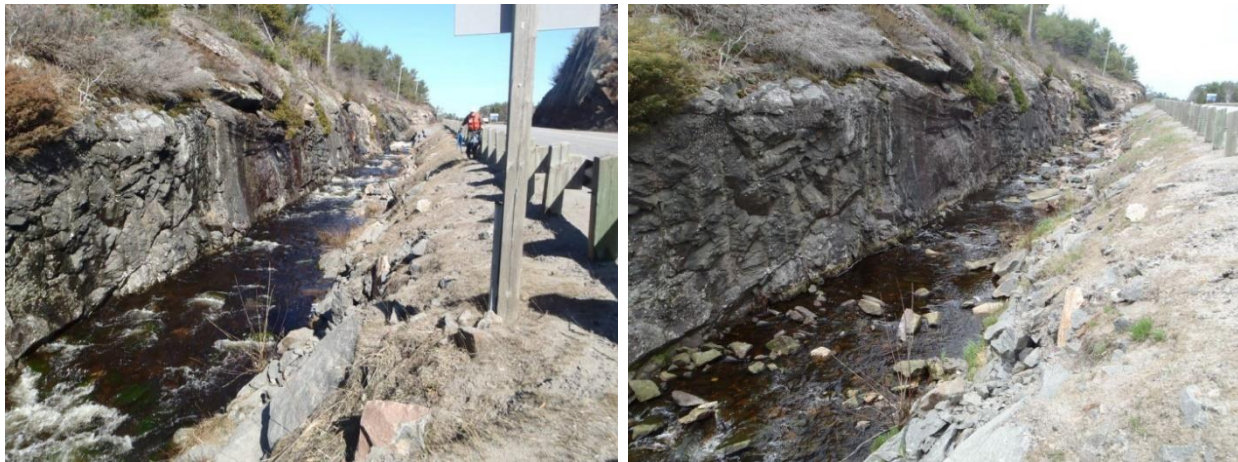
Figure 19. Sucker Creek spawning bed looking upstream. The photo on the left was taken on April 17, 2016 and the photo on the right was taken on May 12, 2016.

Several site photos taken looking upstream (Figure 19) and downstream (Figure 20) also show the change in water level at the Sucker Creek spawning bed.

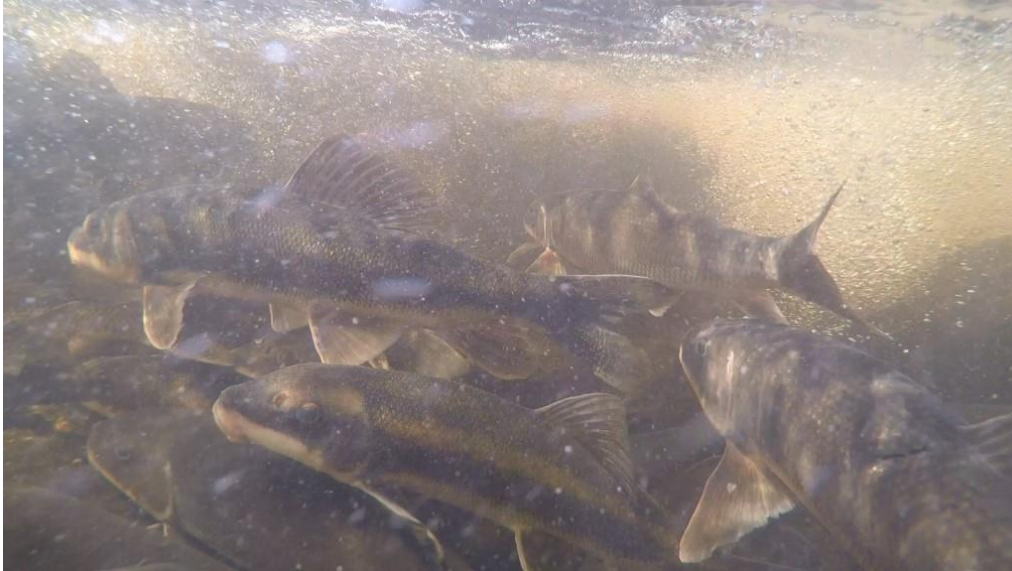
Fish observations were gathered visually during the day and night. Due to the narrow width and shallow depth of the spawning area, it was very easy to see fish movement (Figure 21). Night surveys for Walleye began on April 20 and continued until May 5. EGBSC looked for White Sucker during each daytime field visit, and visual observations for Redhorse Sucker species took place on site visits between May 16-24.

Figure 21. White Sucker observed at the Sucker Creek spawning bed

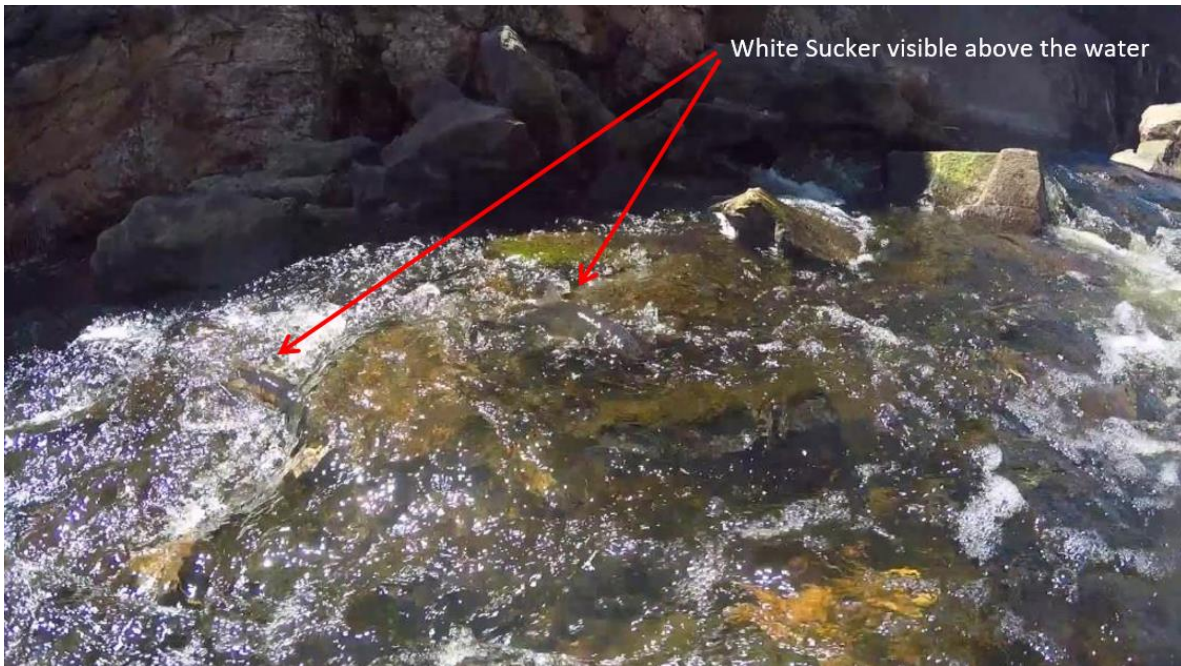
Figure 22. White Sucker observed partially out of water at the Sucker Creek spawning bed on May 3, 2016

Water levels declined fairly dramatically at Sucker Creek over the spawning and egg incubation period. This did not seem to prevent White Sucker from accessing the creek, but it may have limited movement and affected the success of reproduction. In many areas, dorsal fins of the fish were visible above the water, and in some cases, a portion of their upper bodies were out of water (Figure 22).

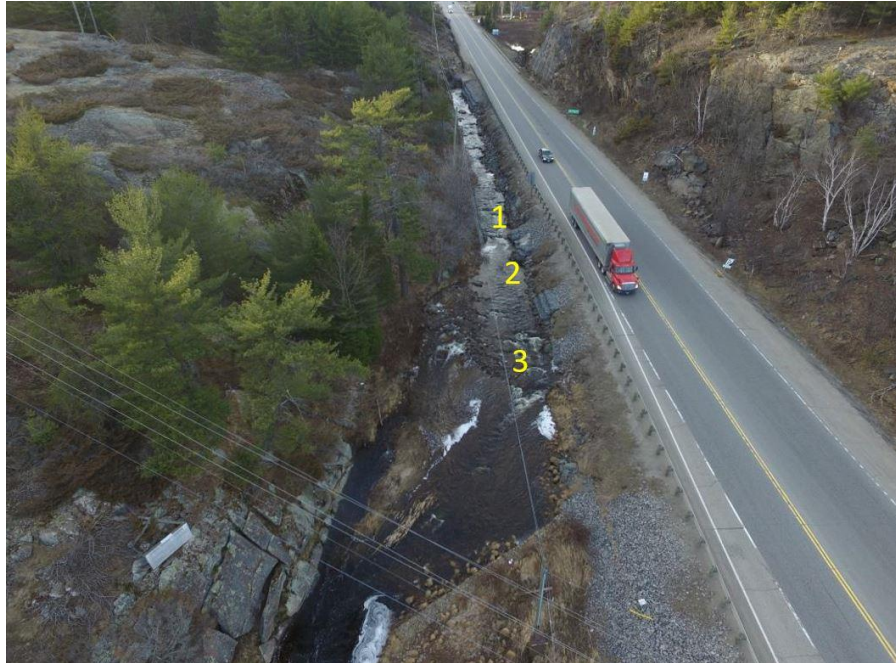
EGBSC set three egg mats at the Sucker Creek spawning bed to help assess the amount, type, and location of egg deposition (Figures 23-26). Egg mats were only placed on a small portion of the spawning bed, and therefore, only represent a small portion of the entire spawning area. Based on size, eggs could be differentiated between Walleye and Sucker species, but it was not possible to identify the Sucker eggs to species level. However, no Longnose or Redhorse Sucker species were observed during any of the site visits. Had Lake Sturgeon eggs been deposited, they would have also been distinguishable by size and colour.

Figure 23. Location of egg mats installed at the Sucker Creek spawning bed in 2016

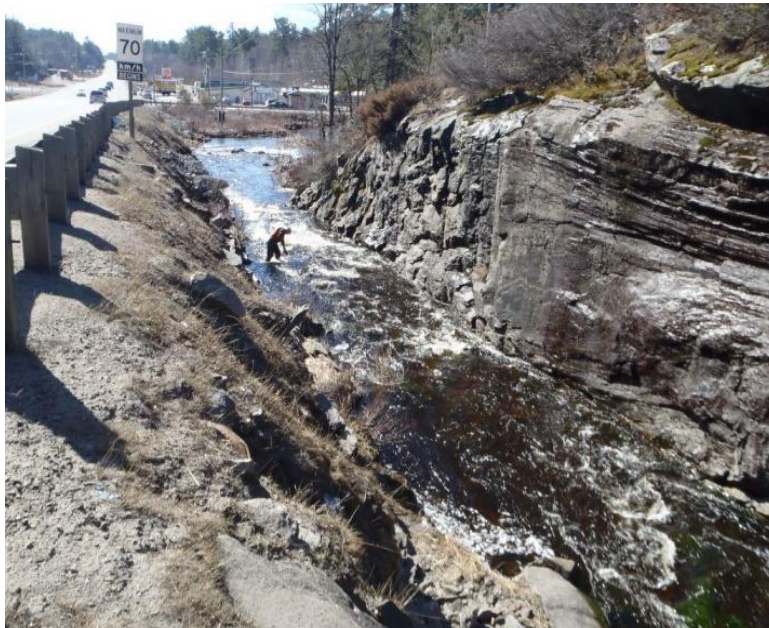
Figure 24. Egg mat 1 installed on April 17, 2016

Egg mats were installed on April 17. Table 3 details when egg mats were checked and the number of eggs counted. Although Walleye were last observed on April 23, Walleye continued to spawn at Sucker Creek at least up until May 6. In total, 248 Walleye eggs and 208 White Sucker eggs were counted at Sucker Creek. Much of the egg deposition was observed upstream of where the egg mats were placed (Figure 27).

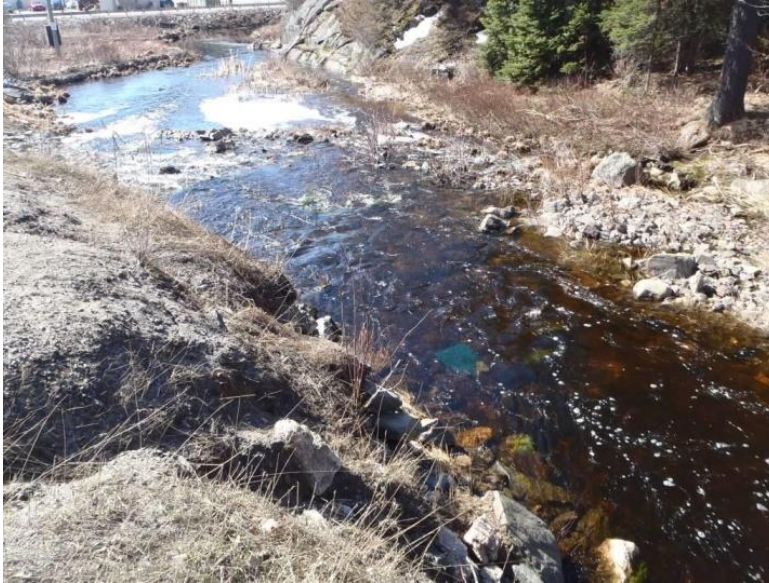
Figure 25. Egg mat 2 installed on April 17, 2016

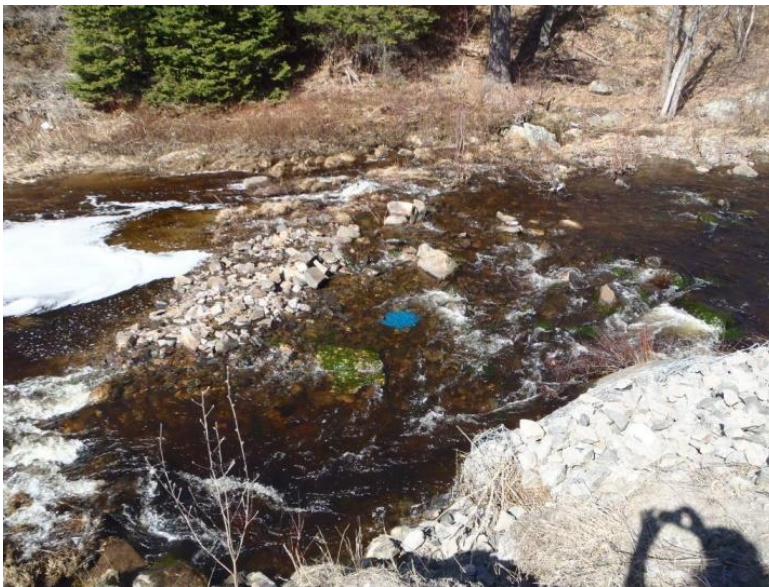
Figure 26. Egg mat 3 installed on April 17, 2016

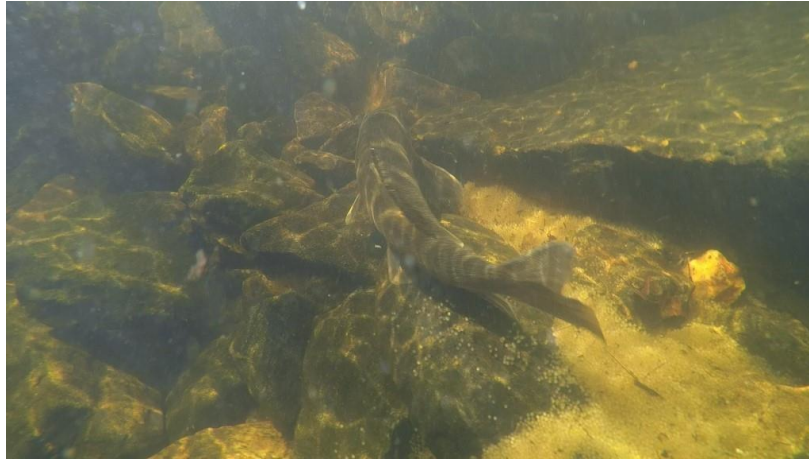
Figure 28. Sucker egg deposition at the Sucker Creek spawning bed

As previously mentioned, several hundred White Sucker were observed spawning at the Sucker Creek spawning bed. While there was not a lot of egg deposition on the egg mats (although egg mats 1 and 2 could not be counted following peak spawning activity), thousands of White Sucker eggs accumulated in a number of areas along the creek. Due to the narrow, gorge-like shape of the spawning bed, White Sucker eggs were deposited in any pooled or quiet areas along the shorelines, in the upper reaches of the spawning bed (Figures 28-29).

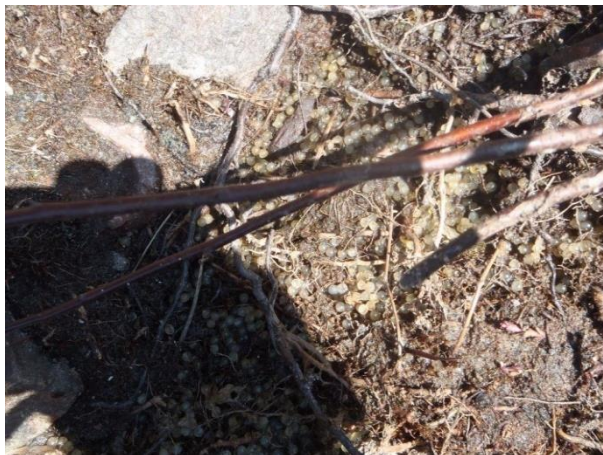
Figure 30. Stranded White Sucker eggs on May 6, 2016

With declines in water levels, some eggs were observed stranded out of water on May 6 (Figure 30). While there were many eggs stranded out of water along the edges of the creek, there were also many areas of egg deposition that remained underwater.

There was a substantial drop in water level at the two stations farthest upstream, and several pockets of White Sucker eggs were observed stranded out of water along the edges of the creek. However, most of the areas with egg deposition remained underwater. The steep shoreline and gorge-like nature of the spawning area minimizes the number of areas that are potentially vulnerable to egg stranding associated with decreasing water levels. On May 3, less water depth in the spawning bed made passage more challenging for White Sucker, and fish could be seen easily from the banks. Despite low water levels, White Sucker seemed to still be able to navigate upstream.

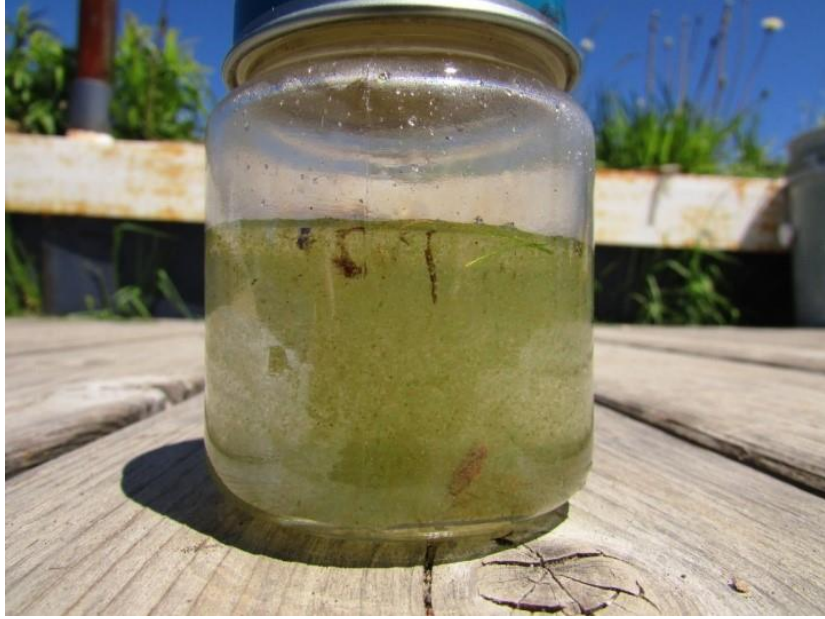
EGBSC did not identify and count the zooplankton in the samples. Only a visual observation of the samples could be made and compared with the four other rivers sampled in 2016. An example of a sample taken downstream of Sucker Creek is shown in Figure 32. Relative to the samples from the other four rivers sampled in 2016, Sucker Creek had plankton abundance similar to that of the Seguin and Shebeshekong Rivers. Plankton abundance downstream of Sucker Creek was less than at the Shawanaga River but more than at the Magnetawan River.

Figure 32. Plankton sample taken downstream of Sucker Creek in 2016

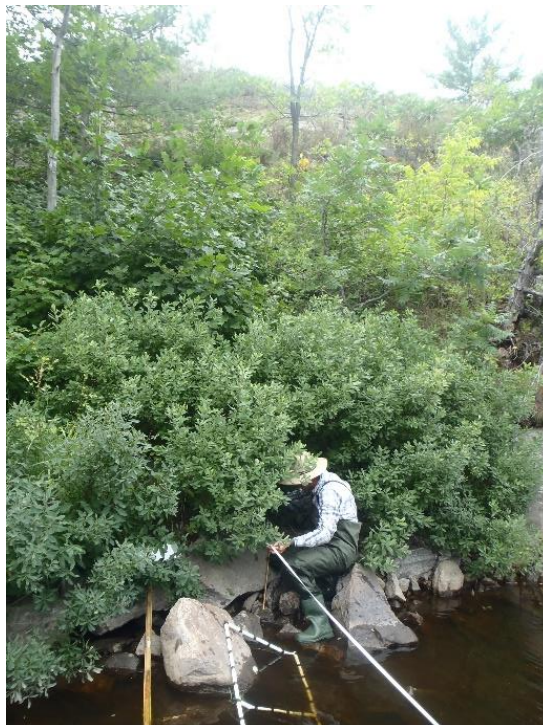
EGBSC completed twenty-one (21) transects across the spawning bed, spaced roughly 6 m apart. Along each transect (bankfull width), depth measurements were taken at five points (see Figure 33 for example). Substrate was estimated in percentages at two locations along each transect with the aid of a grid marked at 10 cm increments. In addition to depth and substrate, any aquatic vegetation was noted at each point, and shoreline vegetation was recorded for each transect.

Figure 33. Measuring bankfull width and depths along transect 17

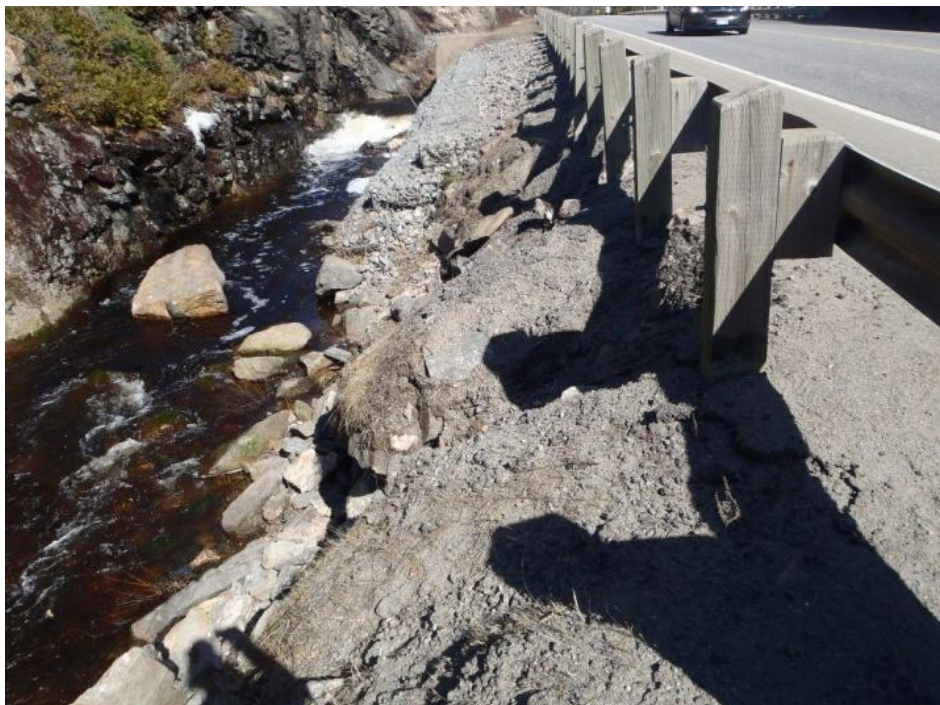
Figure 34. Areas of erosion between the highway and Sucker Creek (looking upstream)

The Sucker Creek spawning bed is confined by a steep rock cliff on the west side and Highway 69 on the east side. There is little room between the shoulder of the highway and the spawning bed. Erosion is an issue along much of the spawning area, due to highway runoff (Figures 34 and 35). Some of the gabion baskets that were installed have started to fail and landscaping cloth is visible where the riprap placed for erosion control has fallen into the water. Based on the state of the erosion, EGBSC anticipates that erosion control will be done in the future to protect the highway. It would be extremely important for that erosion control work to take the spawning area into consideration so that the spawning area is not negatively impacted. It would also provide an opportunity to mix native plant material in with the erosion control work to help control some of the runoff moving into the creek.

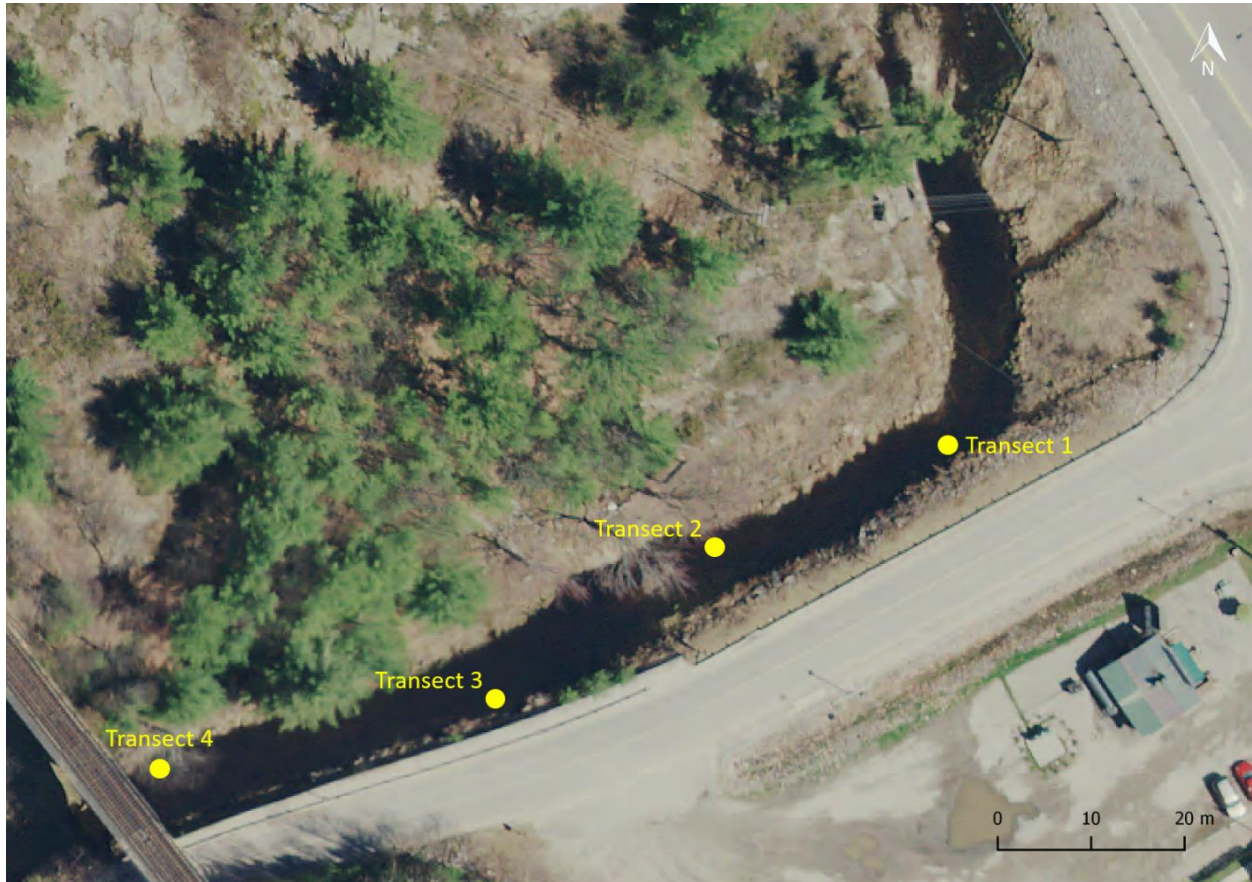
In addition to the five surveys described above, EGBSC also carried out four extra surveys in the channelized section of Sucker Creek, downstream of the spawning area and upstream of the outlet into Pointe au Baril Channel (Figure 39). Substrate was sampled from the boat at three points along each transect as this section was too deep for wading.

Figure 38. Additional surveys conducted immediately downstream of the Sucker Creek spawning bed

All transects had a sand bottom with some cobble, likely riprap used on the road side of the creek as bank stabilization that had washed into the creek. Transect 1 also had a small amount of muck (a mix of sand, silt, and clay).

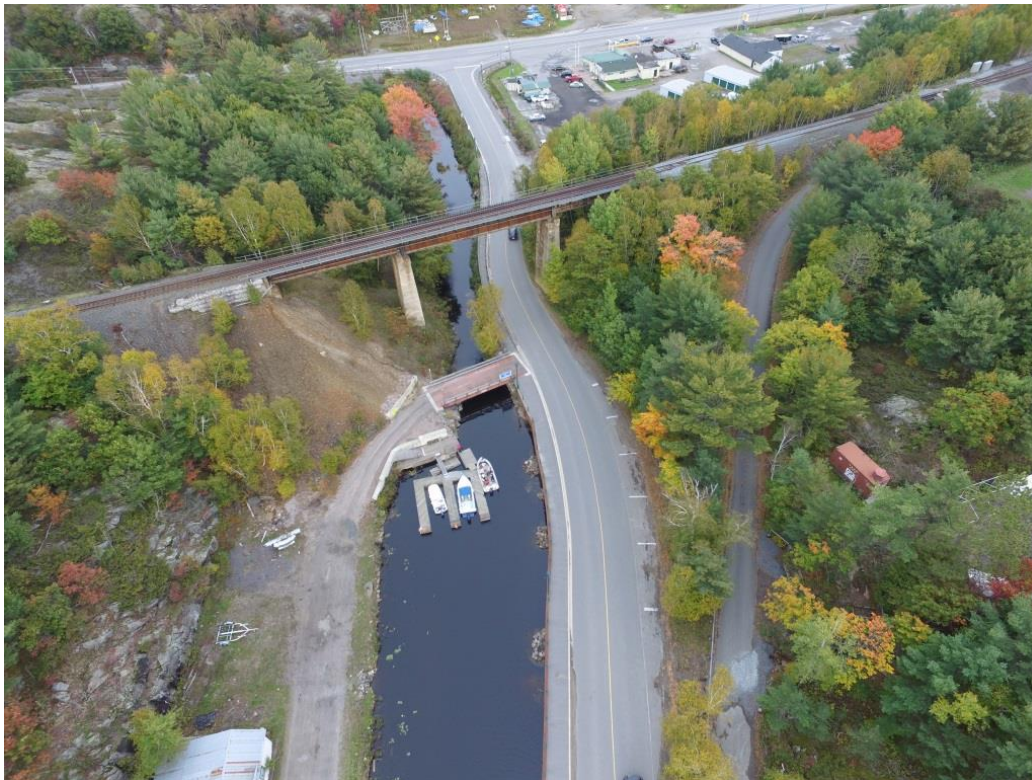
Figure 39. Sucker Creek looking upstream to Highway 69

In general, channelized systems without natural meanders or shorelines offer limited fish habitat. There are fewer overhanging branches to provide food for aquatic insects which in turn, feed many fish species. There is a short section upstream of the train bridge that has quite a lot of natural vegetation (Figure 40); however, downstream of the train bridge, there is no natural vegetation along the rest of the creek (Figure 41), and there is no shade at that part of the creek, which influences water temperature. With channelized banks, there are also fewer areas of shelter for fish.

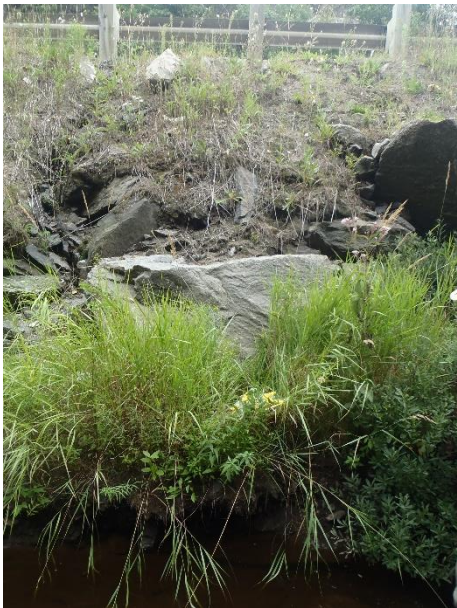
Transect 12

Point	Depth (m)		Particle sizes	Aquatic vegetation present
	Bankfull	Present		
(1) 0.48	0.52		Grid 1 - 60% lg boulder, 35% cobble, 5% sm stone	None
(2) 1.43	0.54			None
(3) 2.38	0.48		Grid 2 - 60% cobble, 35% large boulder, 5% sand	None
(4) 3.30	0.35			None
(5) 4.28	0.25			None

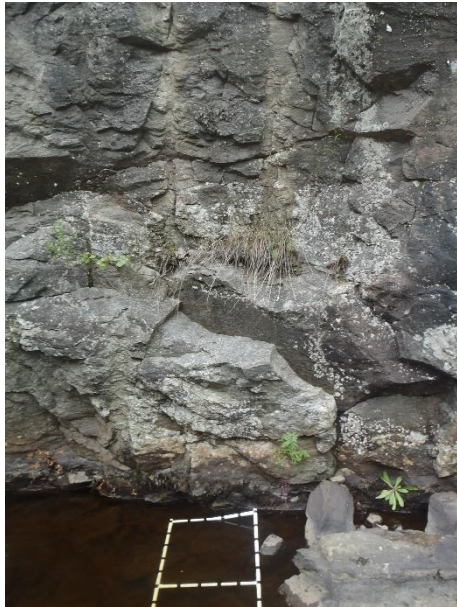
Transect 13

Point	Depth (m)		Particle sizes	Aquatic vegetation present
	Bankfull	Present		
(1) 0.40	0.28		Grid 1 - 65% cobble, 15% lg stone, 15% sm stone, 5% sand	Algae
(2) 1.19	0.14			None
(3) 1.98	0.29		Grid 2 - 45% lg boulder, 30% bedrock, 15% cobble, 10% lg stone	None
(4) 2.77	0.45			None
(5) 3.56	0.45			None

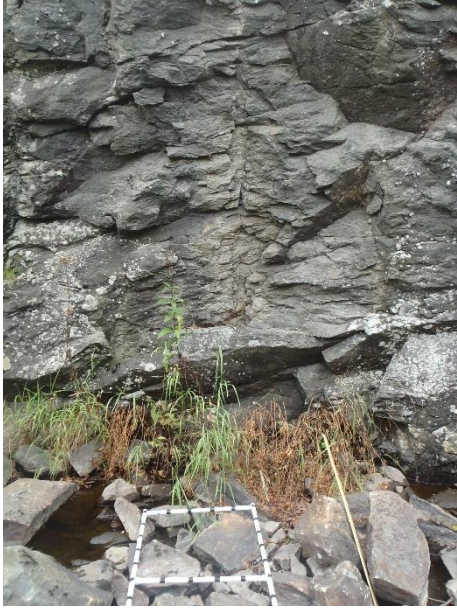
Transect 14

Point	Depth (m)		Particle sizes	Aquatic vegetation present
	Bankfull	Present		
(1) 0.49	0.05		Grid 1 - 70% lg boulder, 15% lg stone, 10% cobble, 5% sm stone	Algae
(2) 1.46	0.23			None
(3) 2.43	0.33		Grid 2 - 60% cobble, 25% lg boulder, 15% lg stone	None
(4) 3.40	0.12			None
(5) 4.37	0.33			None

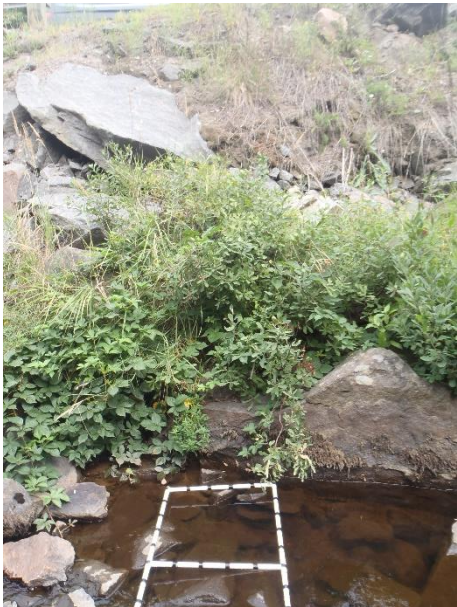
Transect 15

Point	Depth (m)		Particle sizes	Aquatic vegetation present
	Bankfull	Present		
(1) 0.41	0.38		Grid 1 - 50% cobble, 40% lg boulder, 5% lg stone, 5% sand	Algae
(2) 1.22	0.35			None
(3) 2.03	0.48		Grid 2 - 75% lg boulder, 15% cobble, 5% sm stone, 5% sand	None
(4) 2.84	0.34			None
(5) 3.65	0.33			None

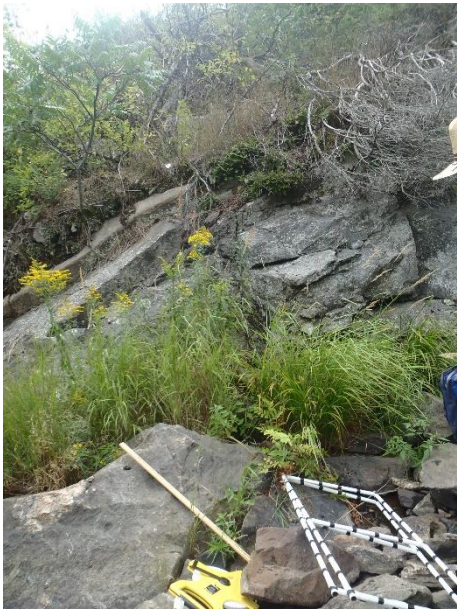
Transect 16

Point	Depth (m)		Particle sizes	Aquatic vegetation present
	Bankfull	Present		
(1) 0.39	1.01		Grid 1 - 80% bedrock, 20% lg boulder	None
(2) 1.17	0.87			None
(3) 1.95	0.59		Grid 2 - 35% bedrock, 30% sm stone, 25% cobble, 10% lg boulder	None
(4) 2.73	0.55			None
(5) 3.52	0.50			None

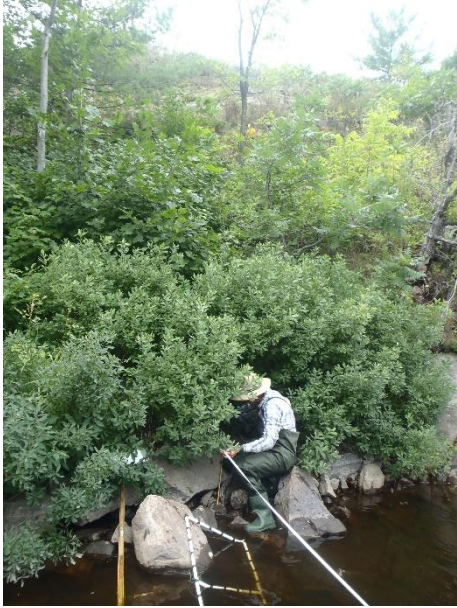
Transect 17

Point	Depth (m)		Particle sizes	Aquatic vegetation present
	Bankfull	Present		
(1) 0.49	0.90		Grid 1 - 70% cobble, 30% lg boulder	None
(2) 1.47	1.04			None
(3) 2.45	0.82		Grid 2 - 60% sm boulder, 40% cobble	None
(4) 3.43	0.59			None
(5) 4.41	0.20			None
