Sucker Creek Fish Habitat Assessment

Executive Summary

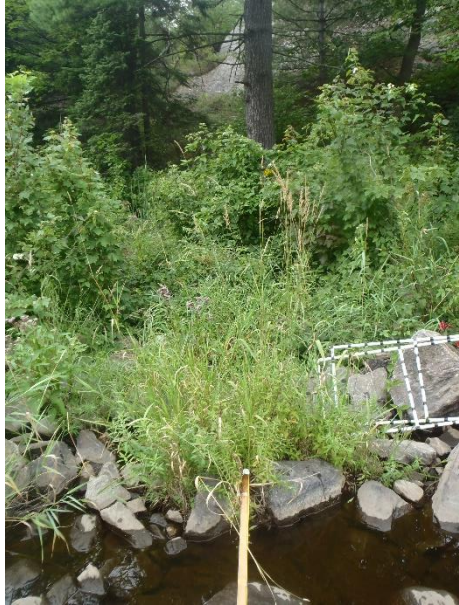
Transect 19

Point	Depth (m)		Particle sizes	Aquatic vegetation present
	Bankfull	Present		
(1) n/a	n/a		Grid 1 - 80% sm stone, 20% sand	None
(2) n/a	n/a		Grid 2 - 40% sm stone, 35% lg stone, 25% cobble	None
(3) n/a	n/a		Grid 3 - 50% cobble, 40% lg boulder, 10% lg stone	None
(4) n/a	n/a		Grid 4 - 50% cobble, 40% lg boulder, 10% lg stone	None
(5) n/a	n/a			None

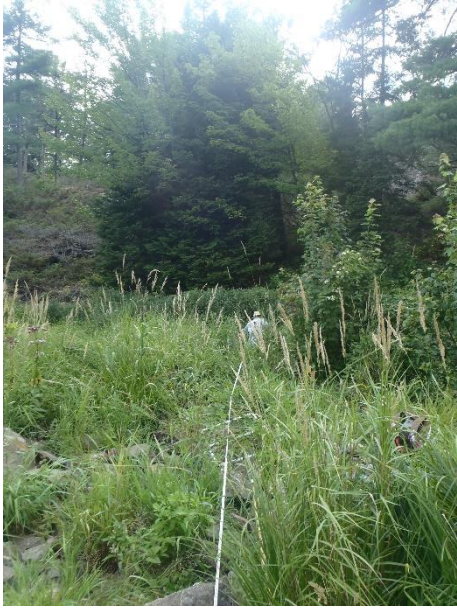
Transect 20

Point	Depth (m)		Particle sizes	Aquatic vegetation present
	Bankfull	Present		
(1) n/a	n/a		Grid 1 - dense veg - sand and rock (likely cobble) but roots to thick to measure	None
(2) n/a	n/a		Grid 2 - 60% cobble, 30% lg stone, 10% sm stone	None
(3) n/a	n/a		Grid 3 - 50% sm boulder, 40% cobble, 5% lg stone, 5% sm stone	None
(4) n/a	n/a		Grid 4 - 45% cobble, 40% sm boulder, 5% lg stone, 5% sm stone, 5% sand	None
(5) n/a	n/a			None

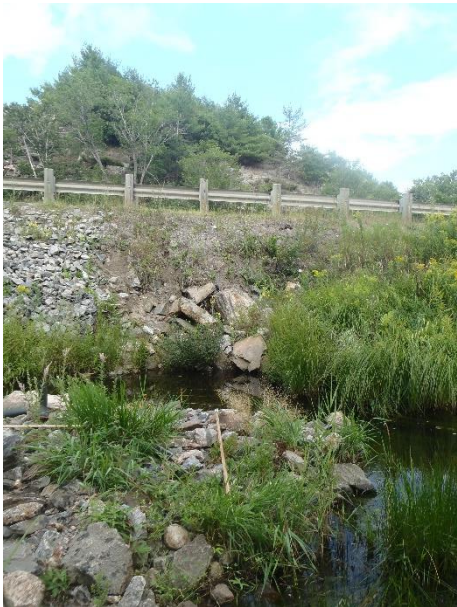
Transect 21

Point	Depth (m)		Particle sizes	Aquatic vegetation present
	Bankfull	Present		
(1) 1.82	0.73		Grid 1 - 80% sand, 20% small stone	None
(2) 5.46	0.85		Grid 2 - 100% sand	None
(3) 9.10	0.36		Grid 3 - 80% cobble, 10% lg stone, 5% sm boulder, 5% sm stone	None
(4) 12.74	0.83		Grid 4 - 40% bedrock, 40% lg boulder, 10% sm stone, 5% sand, 5% lg stone	None
(5) 16.38	0.29			None

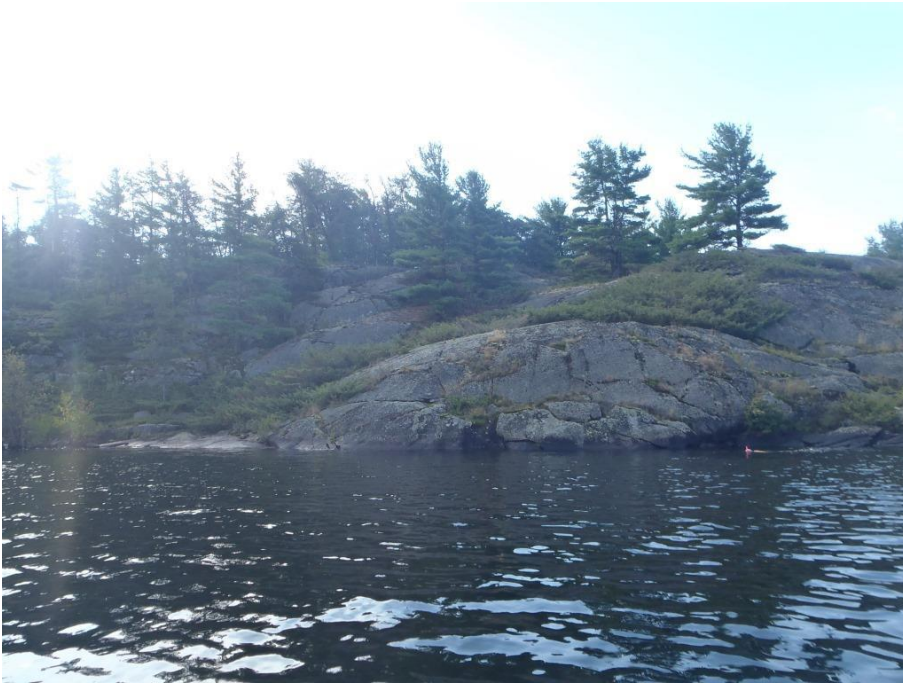
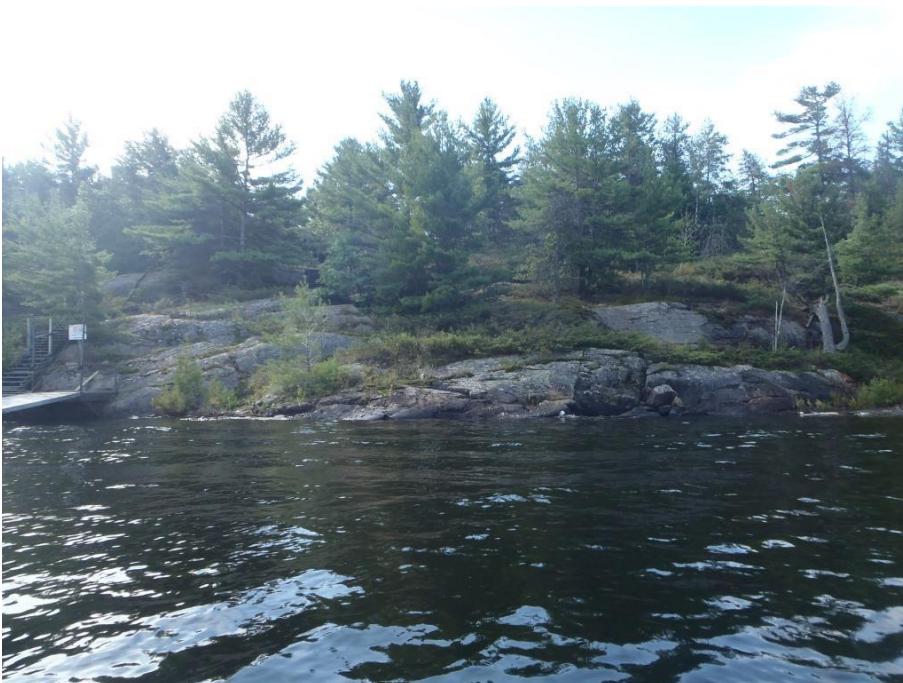
Survey 1

Along each of the five underwater surveys, shoreline characteristics were also recorded and photographed. Downstream of the Sucker Creek spawning bed to the outlet into Pointe au Baril Channel, the shoreline is approximately 37% natural (unaltered) and 63% altered (Figure 38). Types of shoreline alterations included docks, boathouses, boat launches, hardened walls, and riprap. Photos of the shoreline from each survey can be found in [Appendix F](#).
