2016 Spring Spawning Survey Summary Dillon Rapids, Shebeshekong River Eastern Georgian Bay Stewardship Council

MONITORING OVERVIEW

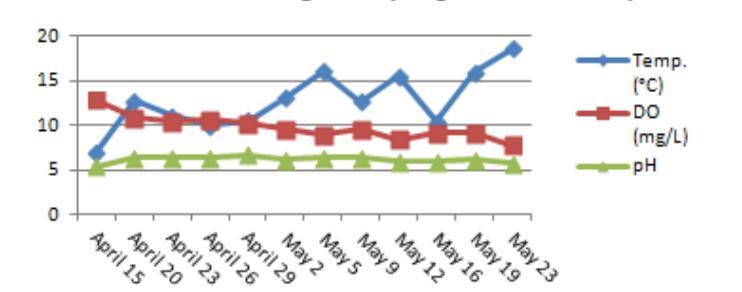
Shebeshekong River Spring Water Chemistry

As part of the survey, EGBSC monitored water chemistry (temperature, dissolved oxygen, pH, total dissolved solids and conductivity), water levels and speed of water flow. Water chemistry and flow were within the normal range for the region and were suitable for successful fish spawning and egg incubation.

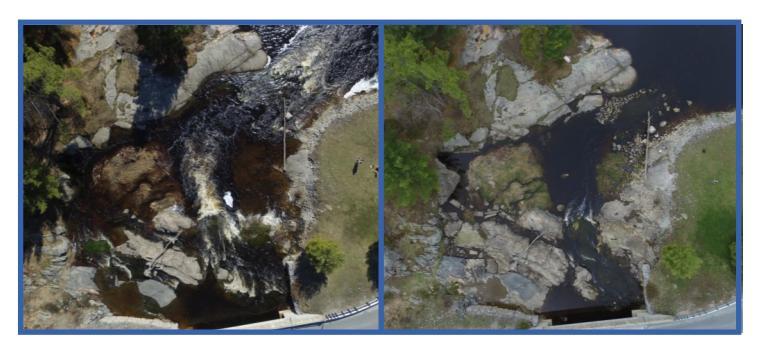
The Shebeshekong River drains a relatively small watershed and is strongly influenced by local conditions and weather events. In addition to depth measurements, aerial photographs were taken to track changes in water levels and calculate the change in spawning and egg incubation area as water levels and flow decreased over the survey period. This information will be available at a later date. Five stations at Dillon Rapids were measured for water level and flow. Over a period of 20 days, water levels at three stations dropped by 40 to 50cm, and one site dried up. The station farthest downstream was moderated by Georgian Bay water levels. On May 14th, a significant rain event caused water levels and flow to increase almost immediately. During the spawning and egg incubation period, the spawning bed experienced considerable water level and flow fluctuations, as illustrated in the photos below.

Aerial view of Dillon Rapids (left photo taken on April 20, 2016, right photo taken on May 12, 2016)

Field observations indicate the number of spawning Walleve in the Shebeshekong River is exceedingly low. EGBSC recommends enhancement work to help Walleye and Sucker species by-pass the Dillon site, where habitat is limited and of poor quality. Higher quality spawning habitat is present at Young's Rapids and upstream of Young's.

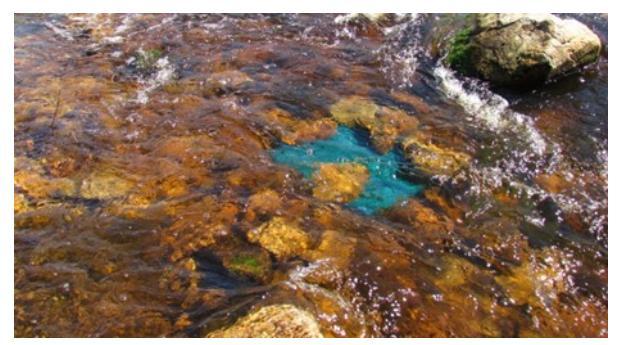
Walleye eggs were observed along the south shore, caught in algae and cracks in the bedrock. On May 2nd, water levels had declined and many of the eggs on the south shore were stranded out of water. Blue mats (furnace filters) were used to collect eggs. Three were placed at shallow areas along the shore, and a fourth was placed farther into the channel. Three of the four egg mats were removed by unknown persons from the river. From the fourth mat, a total of 28 Walleye eggs were counted. In comparison with other sites along Eastern Georgian Bay, the number of eggs was extremely low.

Egg mat used to collect eggs

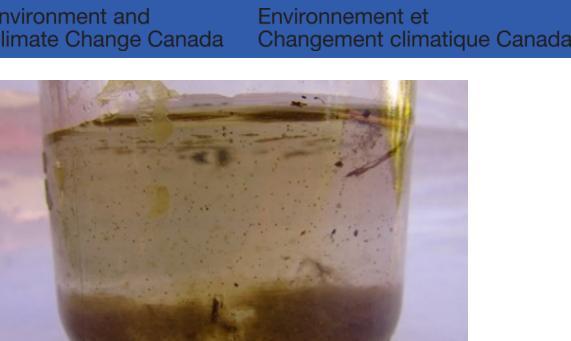
Once eggs incubate and hatch, the fish enter their larval stage. This stage is critical for Walleve and most other fish species. Larval Walleye have limited mobility and typically move by water current and wave action. Shortly after hatching, Walleye need to feed on zooplankton to ensure survival, growth and development. The availability of zooplankton is a major factor in surviving this life stage. To help evaluate the amount of zooplankton downstream of Dillon Rapids, four plankton samples were collected in late May. In comparison with other sites (Sucker Creek, Shawanaga, Shebeshekong and Seguin Rivers), the density of zooplankton in the Shebeshekong River sample was moderate.

Four plankton samples taken downstream of Dillon Rapids

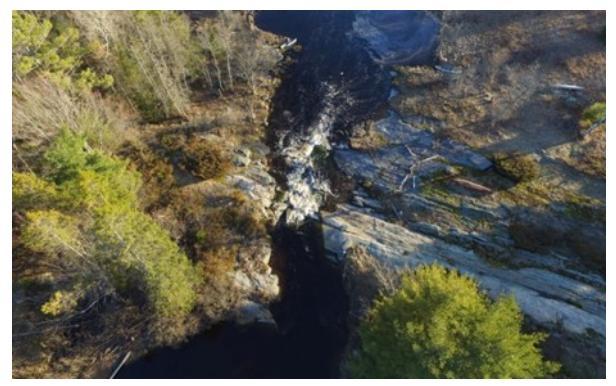
Field observations and measurements were taken at Young's Rapids, the next spawning area upstream of Dillon. On April 22nd, approximately 100 Common White Sucker were present at Young's and were observed by-passing the rapids. No Walleye were

observed. On the April 26th and 29th visits, no fish were observed at the site and were assumed to be upstream of the rapids. It is not known if Walleye could by-pass this site.

Aerial view of Young's Rapids
